RE: Title 19 complaint about the construction of the Mui Ho Fine Arts Library in Rand Hall, Cornell University, Ithaca, NY

List of major violations

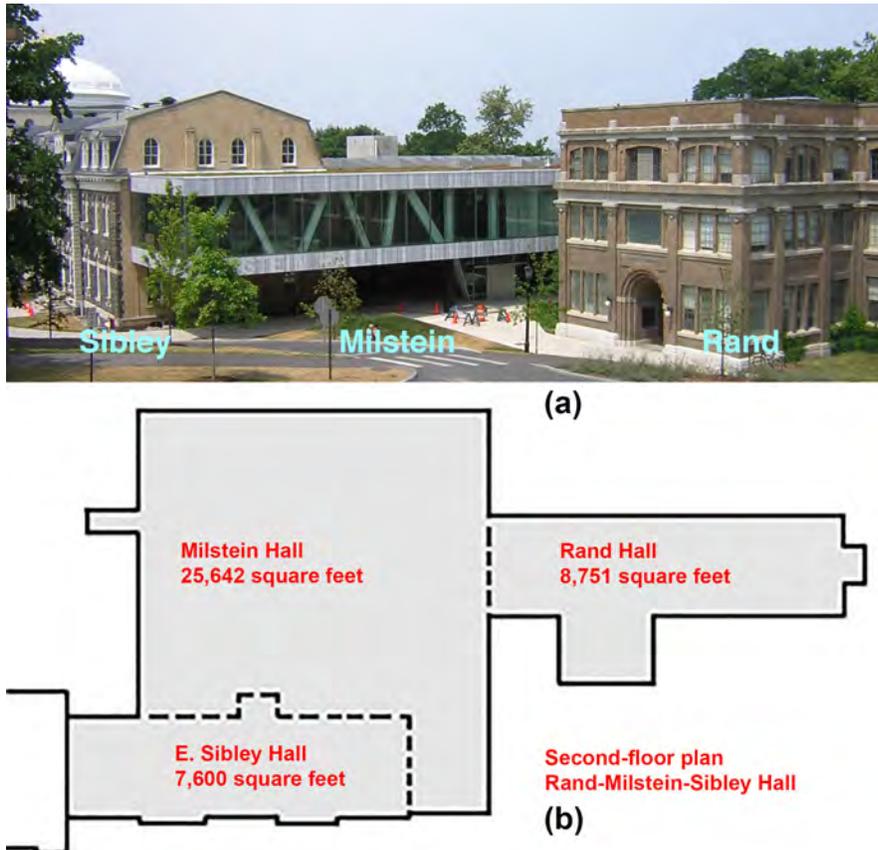
Before being connected to Milstein Hall in 2011, Rand Hall was a 3-story Type IIB non-fireproofed steel frame building and E. Sibley Hall was a 3-story Type VB building (with non-fireproofed wood exterior bearing walls at the third floor). Since the two buildings were connected to 2-story Milstein Hall without fire walls (Figure 1), Rand-Milstein-Sibley Hall became a *single building* with Type VB construction.

Figure 1. (a) View, from left to right, of interconnected Sibley, Milstein, and Rand Hall; and (b) second-floor plan showing net second-floor areas of Milstein, E. Sibley, and Rand Halls.

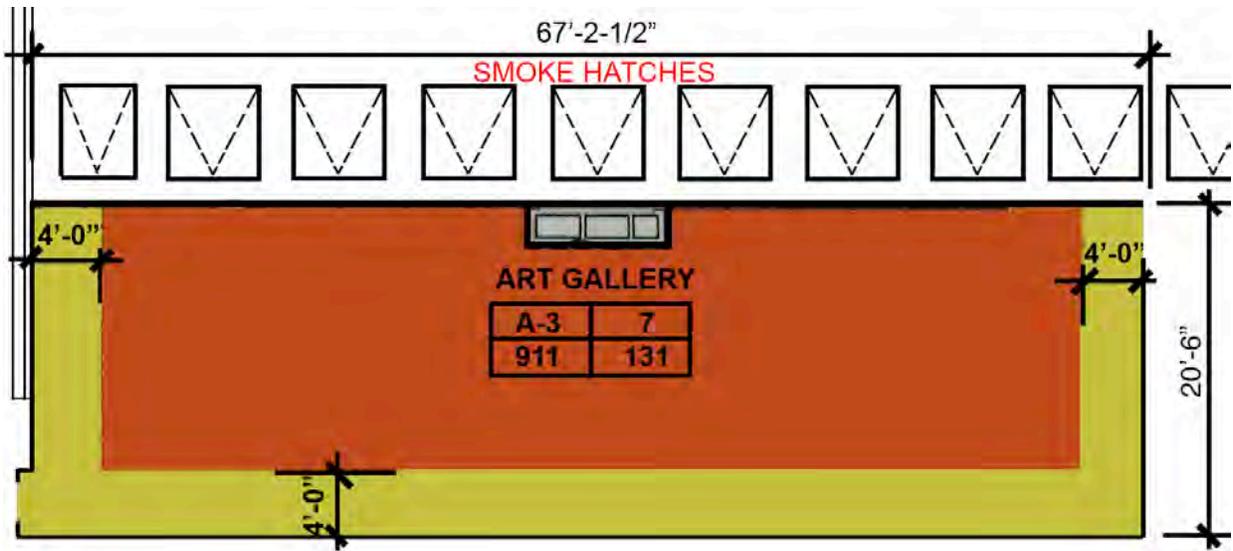
Explanation: The stated occupancy for the roof-top art gallery of 131 is found by using an incorrect gallery area of 911 square feet and an incorrect occupant load factor of 7 square feet per occupant (Figure 2). The actual occupancy is 263, based on an actual area of $67'-2\frac{1}{2}" \times 20'-6" = 1,315$ net square feet and an occupant load factor of 5. In this calculation, I have computed the gallery area by first subtracting 6 inches from the circulation zone edges and then subtracting 20 square feet for a utility enclosure on the north side of the gallery. This actual area includes the hypothetical egress pathways at the perimeter of the gallery space that are colored yellow on the architect's plans, sheet LSP-103, apparently (and deceptively) to imply that they might represent something literally separated from the orange-colored main gallery space (Figure 2). In fact, the entire *actual* gallery area—i.e., both the orange and yellow zones drawn by the architects—must be accounted for when computing the occupancy of the space.

Figure 2. Portion of architect's roof plan showing the roof-top art gallery with fictitious circulation zones (colored yellow) that have been subtracted from the actual occupiable gallery area, along with a tabulation of occupancy group (A-3), occupancy load (7 occupants per square foot), gallery area (911 square feet), and number of occupants (131). Plan drawn by Jonathan Ochshorn based on architect's roof plan, sheet LSP-103. Colors, dimensions, and room data matrix appear in the original.

The architects inappropriately *subtracted* this yellow colored circulation pathway area from the actual gallery area and used the incorrect load factor of 7 to compute the fictitious values shown on sheet LSP-103, and reproduced in Figure 2, i.e., 911 square feet for the art gallery area and $911/7 = 131$ occupants.

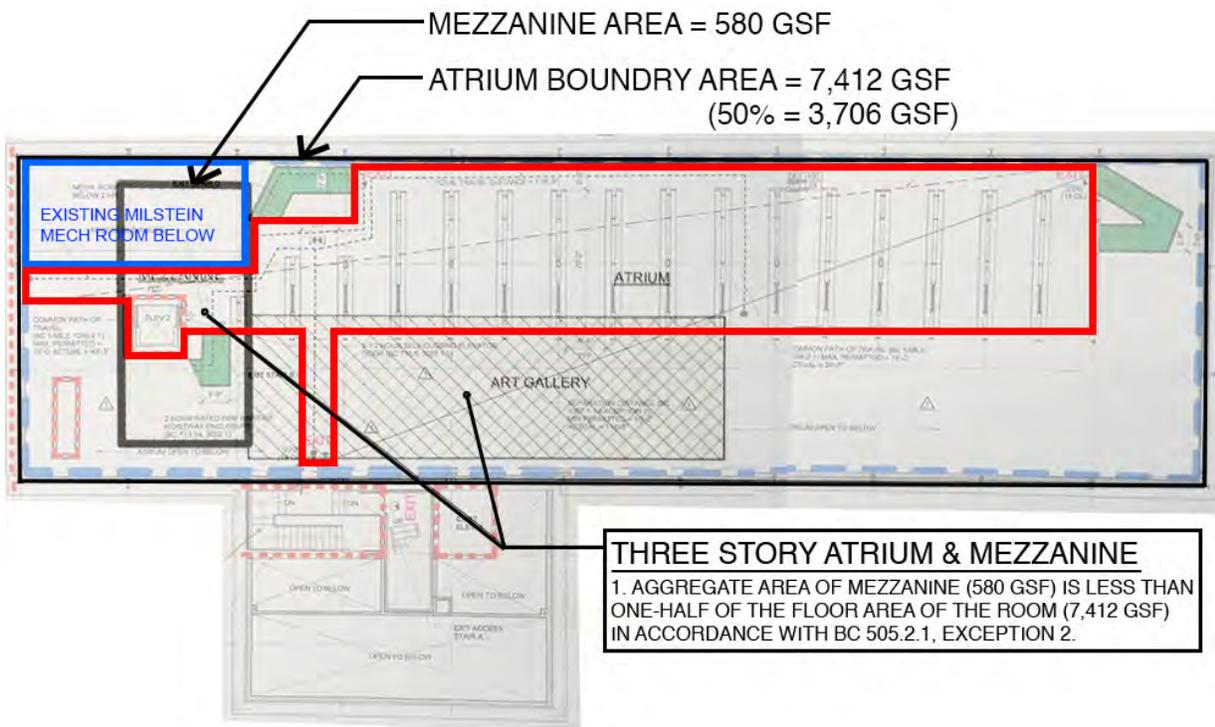
2
LSP-103 1/16" = 1'-0"
MEZZANINE DIAGRAM

Explanation: The enclosed area on the roof is improperly classified as a mezzanine. To be a mezzanine, it would have to be “an intermediate level or levels *between the floor and ceiling* of any story,” as the definition in Chapter 2 of the code requires it to be. Instead, it is *on top of* the ceiling of the fourth floor. The explanation provided by the architects in an email states: “The enclosed area at the roof level is a mezzanine to the fourth floor. The fourth floor is open to and part of the atrium.” The architects write in their “Mezzanine diagram” on LSP-103 (see Figure 4) that the “aggregate area of the mezzanine (580 GSF) is less than one-half the floor area of the room (7,412 GSF) in accordance with BC 505.2.1, exception 2.” This room of 7,412 GSF that is shown on the architect’s diagram is labeled as the “atrium” rather than as the fourth-story, although the boundary shown for the 7,412 GSF corresponds neither to the fourth story nor the atrium. This statement reveals two principal errors. First, a mezzanine *cannot be in an atrium*, since a mezzanine is “an intermediate level or levels *between the floor and ceiling of any story*,” and an atrium is not a “story”; rather, an atrium is an “*opening connecting two or more stories*.” Second, the roof-top enclosed spaces cannot be a mezzanine within a fourth-story room or space since there are no double-height fourth-story spaces in which a mezzanine could be placed.

Figure 4. Mezzanine Diagram from sheet LSP-103 with the fourth-floor plan superimposed in order to clarify the relationship between the enclosed roof-top spaces (black rectangle) the fourth-floor bookstacks (bounded by a red line), and the third-floor mechanical room for Milstein Hall (bounded by a blue line). Text has been enlarged, red and blue boundaries added, and the 4th floor has been superimposed by the author. The black boundary line is in the original mezzanine diagram.

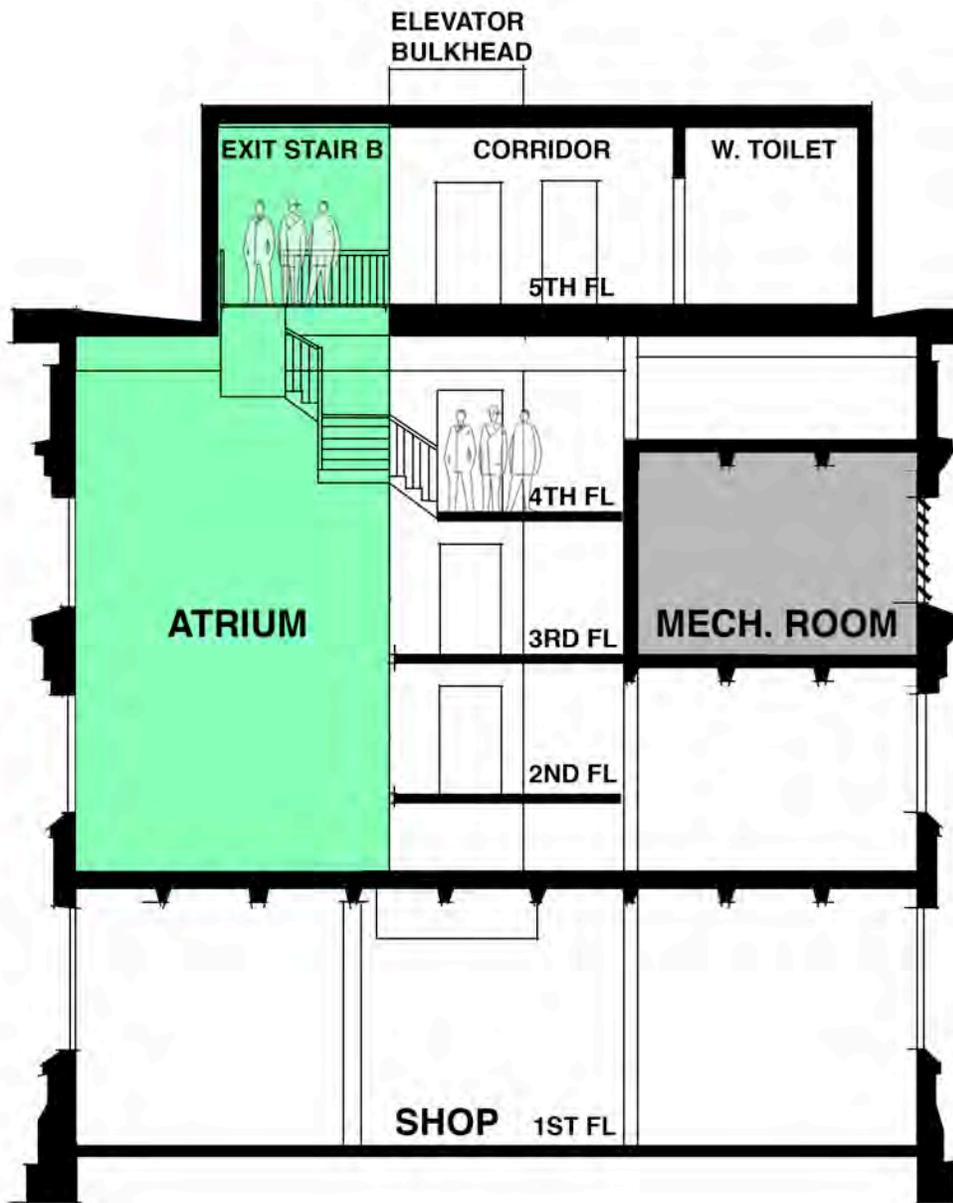
A schematic section through the roof-top enclosed space is shown in Figure 5. This section clearly shows that there are no double height spaces in the fourth story within which a mezzanine could be placed. In other words, the architects are inappropriately using the *atrium* area to demonstrate conformance with Section 505.2.1, rather than using an area within a fourth-floor room or space as the section requires. Both Figures 4 and 5 show that the story incorrectly labeled “mezzanine” (bounded by a black line in Figure 4) is only marginally *above* any fourth-floor room or space (bounded by a red line), and is not *between* the floor and ceiling of any fourth-floor room or space, as required by the code. The fourth story below the enclosed roof-top spaces is little more than a corridor, while the greater part of the enclosed roof-top spaces are directly above—not the fourth floor—but rather the ceiling of a third-story mechanical room. The exit access stairway (“Exit Stair B”) connecting the fifth-story roof-top spaces to the fourth story is *in the atrium*, not in any mezzanine, as can be clearly seen in Figure 5.

Figure 5. Schematic section through the fifth-story roof-top enclosed spaces and atrium. (Drawn by Jonathan Ochshorn)

There are two immediate code violations that follow logically from the mis-labeling of the fifth story as a mezzanine within the fourth story. First, the part of the atrium that extends into the fifth story must be separated from the enclosed roof-top spaces with 1-hour fire barriers, since only three floors can be open to the atrium per Section 404.6, exception 3. Second, as explained in Violation #7, the entire building must be built with Type I construction, rather than with Type IIB or Type IIA construction.

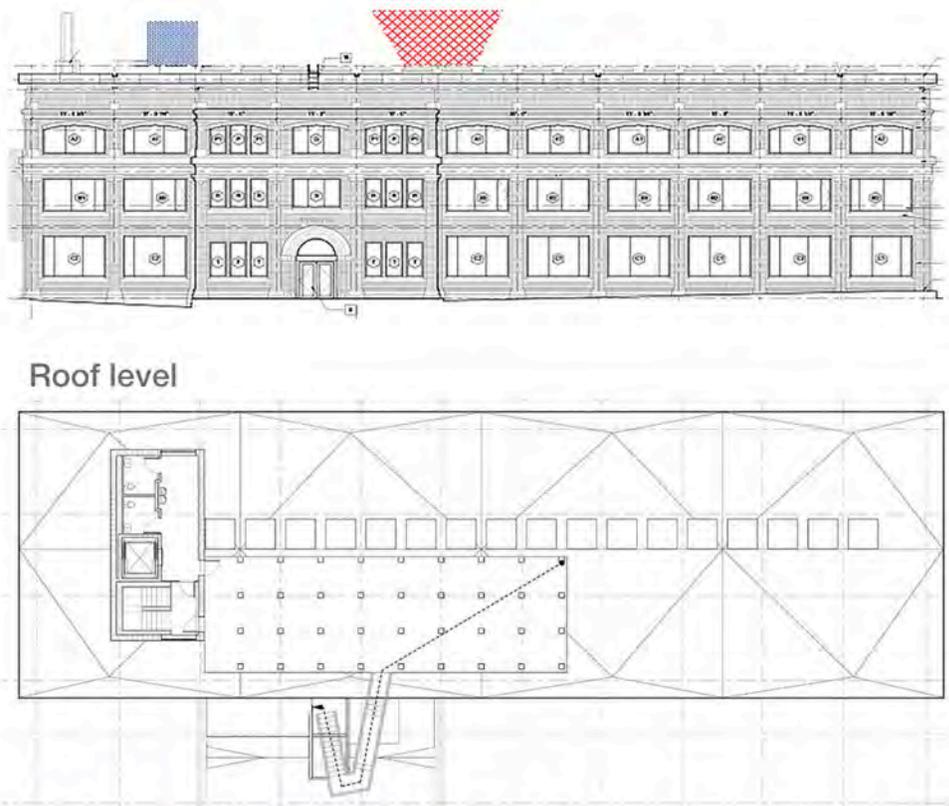
Figure 6. (top) Cornell’s elevation of the Mui Ho Fine Arts Library shows roof-top pavilions intended to be built every few years; (bottom) Cornell’s schematic roof plan is labeled “Experimental pavilion roofscape,” explicitly indicating their intention to use the outdoor roof deck to support enclosed, occupiable spaces that would constitute a fifth story.

Pavilions, even if temporary (i.e., “erected for a period of less than 180 days”), still need to follow the requirements outlined in Section 3103, including conforming “to the structural strength, fire safety, means of egress, accessibility, light, ventilation and sanitary requirements of this code as necessary to ensure public health, safety and general welfare.” In any case, whether “temporary” or exceeding the 180-day time limit, such covered structures would count as part of a fifth-story, since they are *on top of* the roof, and could not possibly be designated as mezzanines *between* the floor and ceiling of the fourth story below, as the definition of a mezzanine in Chapter 2 of the code requires. The current scheme, in fact, contains sprinkler and utility hook-ups *at the roof level* in anticipation of these future enclosed pavilions. For this reason, a designation of the current fifth-story bathrooms, corridor, and elevator as a mezzanine within the fourth story is not only improper on its own merits, but by implicitly suggesting that the intended future roof-top pavilions will also count as fourth-story mezzanines, Cornell is effectively inviting the Ithaca Building Department to acknowledge and agree, in advance, to that noncompliant vision.

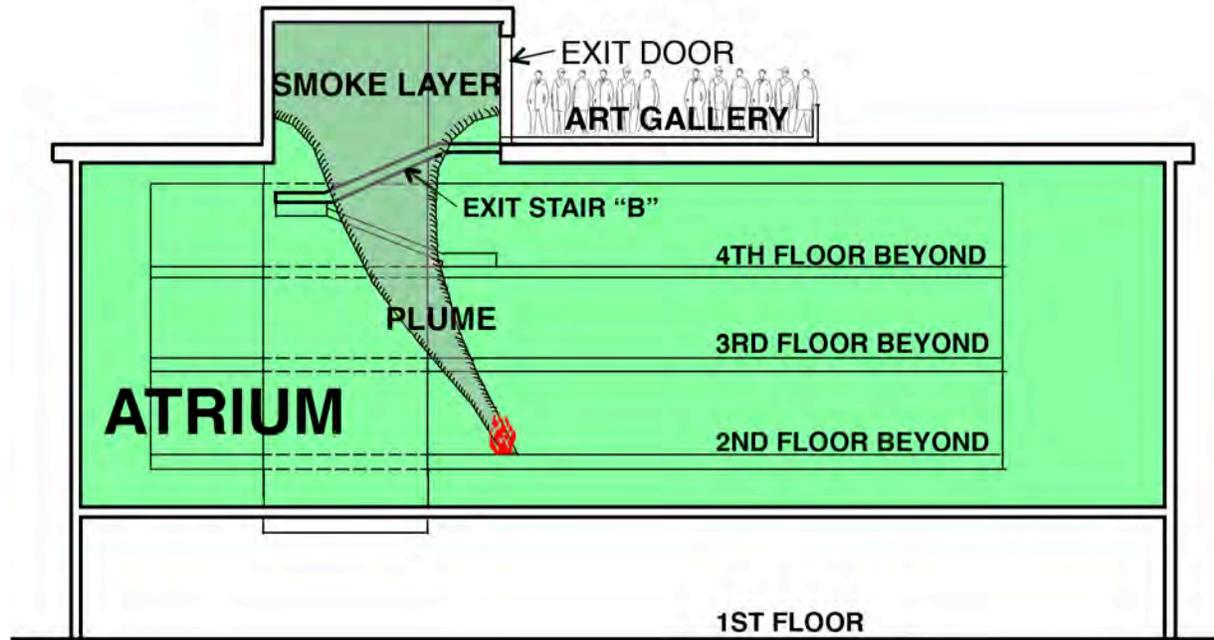
In addition to providing a 1-hour horizontal assembly between the atrium and the roof gallery, the part of the atrium that extends into the fifth story (see Figure 7 below) must also be separated from the adjacent outdoor roof gallery by a 1-hour fire barrier.

Explanation: Section 909.1 requires that the atrium smoke control system “provide a tenable environment for the evacuation or relocation of occupants.” The smoke exhaust system not only does *not* “provide a tenable environment” for emergency egress, but actually places occupants attempting to egress from the roof-top gallery directly in the path of toxic smoke and other exhaust products. This happens in two ways. First, many of the roof-top atrium smoke hatches are immediately adjacent to the occupied roof-top art gallery (see Figure 2 and Figure 8), so that smoke being exhausted through these hatches could blow directly onto roof-top occupants. Second, since the atrium extends into the fifth floor (Figure 7), it will act as a primary smoke exhaust vent when the exit door from the roof-top art gallery is opened,

even though this door is not labeled, or intended, as an exhaust vent. This smoke control system is entirely passive, with no mechanical exhaust; as a result, art gallery occupants attempting to exit through Exit Stair B will likely encounter toxic smoke emerging from the exit door, which is at the highest point in the atrium and therefore the most likely location for the hot smoke layer to migrate.

Figure 7. Schematic section through atrium showing how the smoke layer would migrate to the highest point of the atrium, directly in the path of egress from the roof-top art gallery through Exit Stair "B"

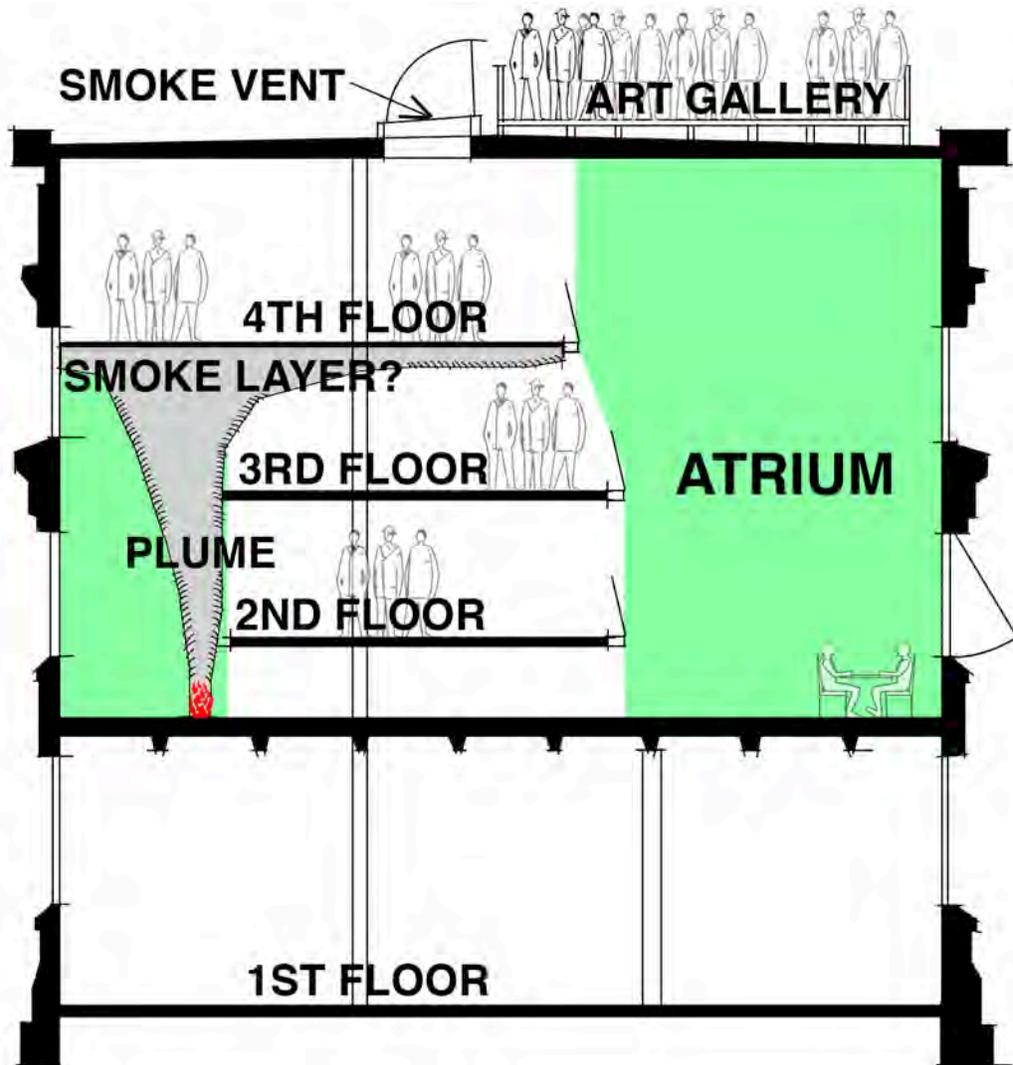
What the atrium smoke control report also doesn't model is a fire location at the *north* side of the book stacks (Figure 8). This is important because the fourth floor extends all the way to the exterior wall on the north side, thereby potentially blocking movement of smoke into the smoke vents at the atrium roof.

Figure 8. Schematic section through atrium illustrating scenario with fire location at north side of building that was not modeled in the smoke control report prepared for Cornell by GHD

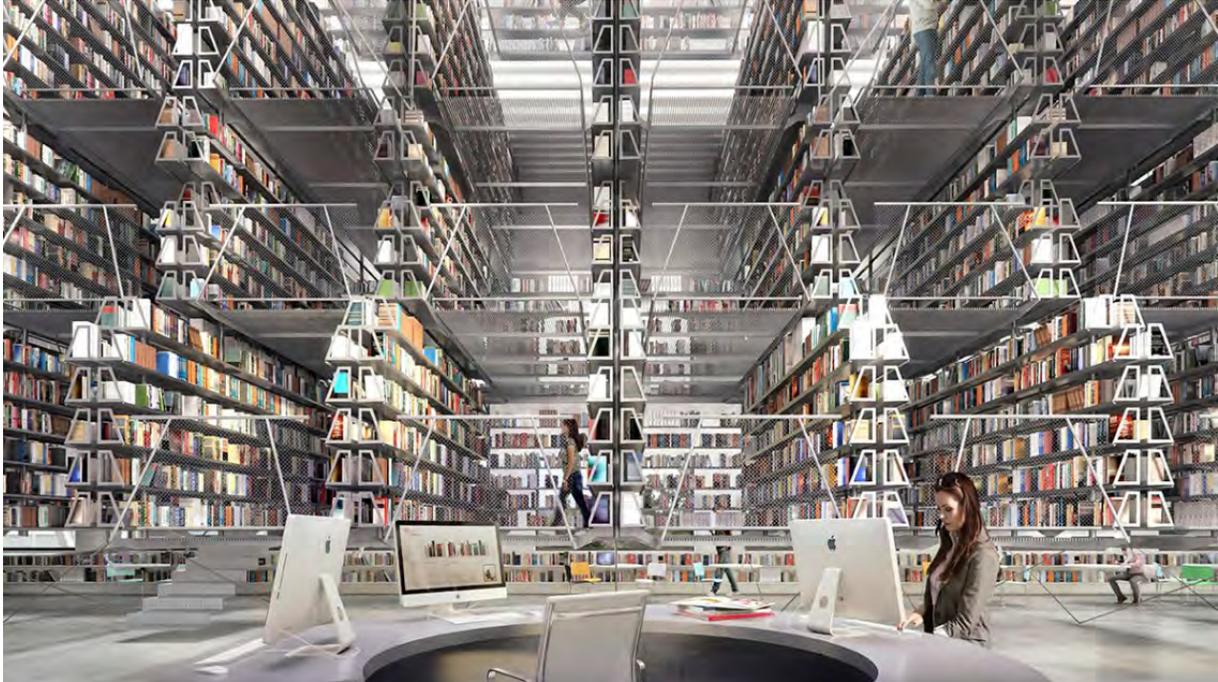
Explanation: Section 712 permits vertical openings in floor-ceiling assemblies only when they are “in accordance with one of the protection methods in Sections 712.1.1 through 712.1.16.” The three bookstack stories all have openings in their floor-ceiling assemblies, not only the “6-inch flues” below each bookstack, but also throughout the floor-ceiling construction. These levels do not provide assemblies that are “continuous without vertical openings” as required by Section 711.2.2, but rather consist of perforated (open) metal floor panels made with metal bars spaced one half inch apart (Figure 12). Section 712.1.9 (Two-story openings) states that “a vertical opening that is not used as one of the applications listed in this section shall be permitted if the opening ... does not connect more than two stories...” The bookstack floor perforations and larger openings under the bookstacks connect more than two stories and are therefore in violation of this section.

The fact that three bookstack stories are open to an atrium does not allow them to violate the requirements in Section 712 regulating vertical openings *between* stories.

Figure 12. Renderings provided by the architect show perforated floor panels that violate basic principles of compartmentation by connecting more than two stories; larger “6-inch flue” openings also appear in each story under the bookstacks.
