OMA'S MILSTEIN HALL

A CASE STUDY OF ARCHITECTURAL FAILURE

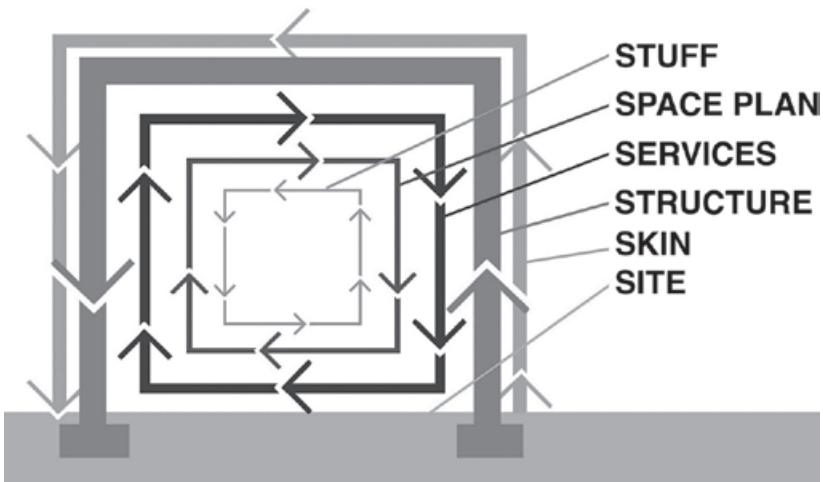
Figure 2.1. Stewart Brand’s revised diagram of time-based building systems, based on Frank Duffy’s categories, but with two more S’s and some changed names (“site, structure, skin, services, space plan, and stuff”), each with its own characteristic time-frame for repair, maintenance, or replacement.

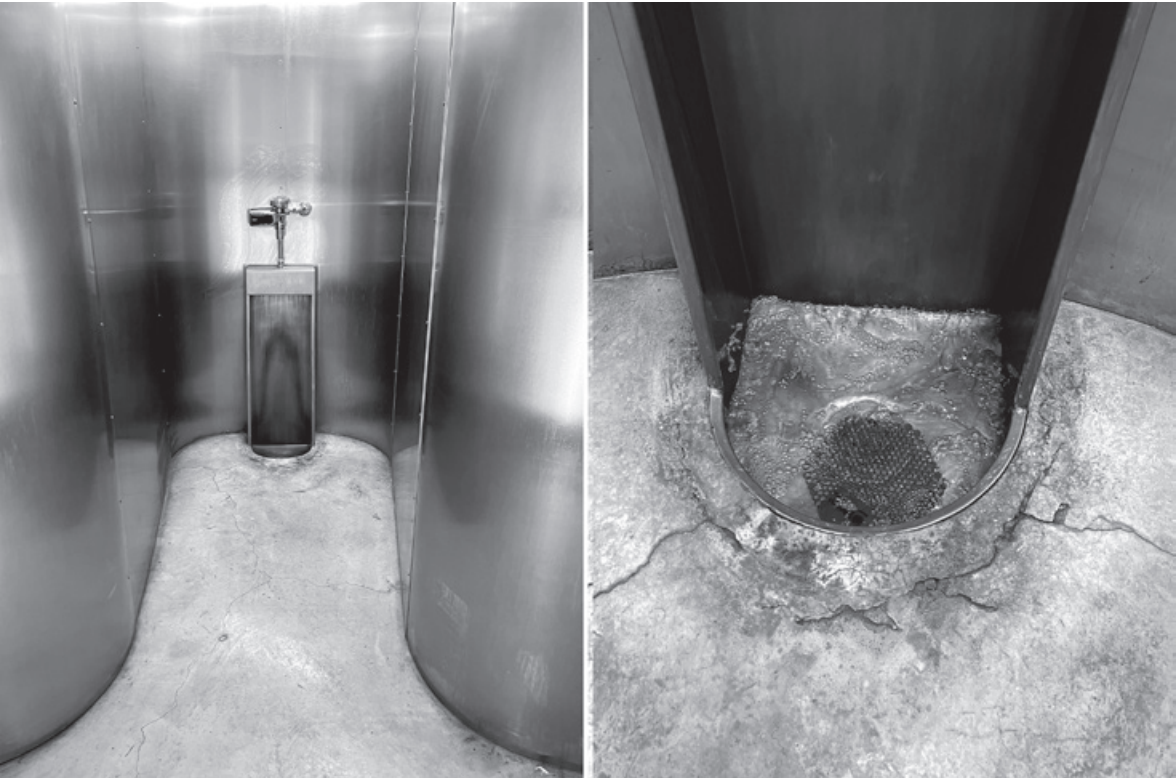
Figure 2.2. Stainless steel urinals in Milstein Hall are built into the noncompliant (cracking) concrete floor slab and cannot easily be repaired or replaced.

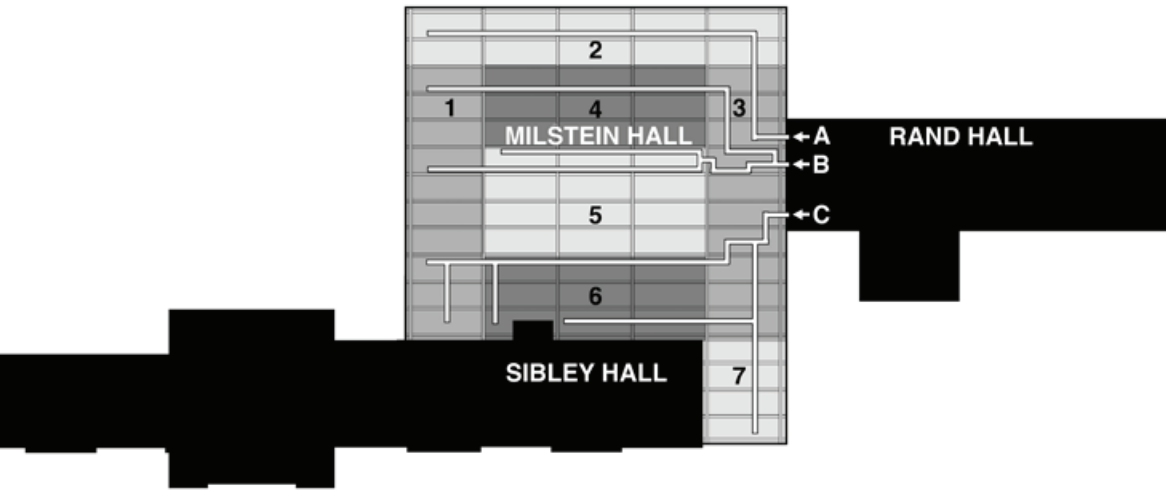
Figure 2.3. The second-floor studio space is subdivided into three zones for fresh air distribution, originating in a mechanical room placed on the third floor of Rand Hall (labeled *A*, *B*, and *C*); and divided into seven zones for heating and cooling (labeled 1–7).

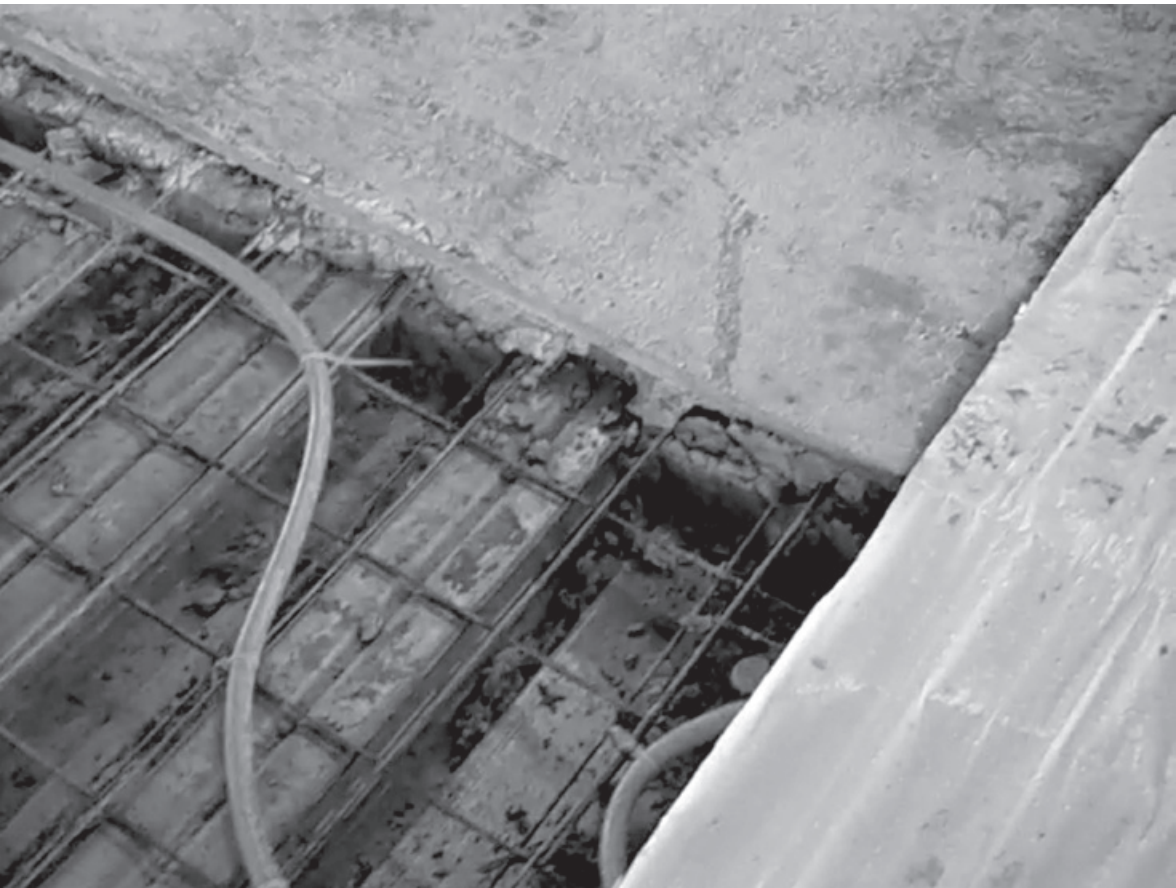
Aside from the ducts providing fresh air, and radiant heating tubes embedded in the floor slab, fire sprinkler pipes and electrical conduits are embedded within concrete slabs, ducts for the auditorium are buried under concrete slabs-on-ground or built into the auditorium seating structure, and stormwater drainpipes are embedded between the double concrete faces of the Crit Room dome. In the Crit Room itself, lighting fixtures are carved into the concrete surface, so that their dimensions and locations are fixed forever and conduits that provide them with power are inaccessible—buried within the concrete. The structure of the dome

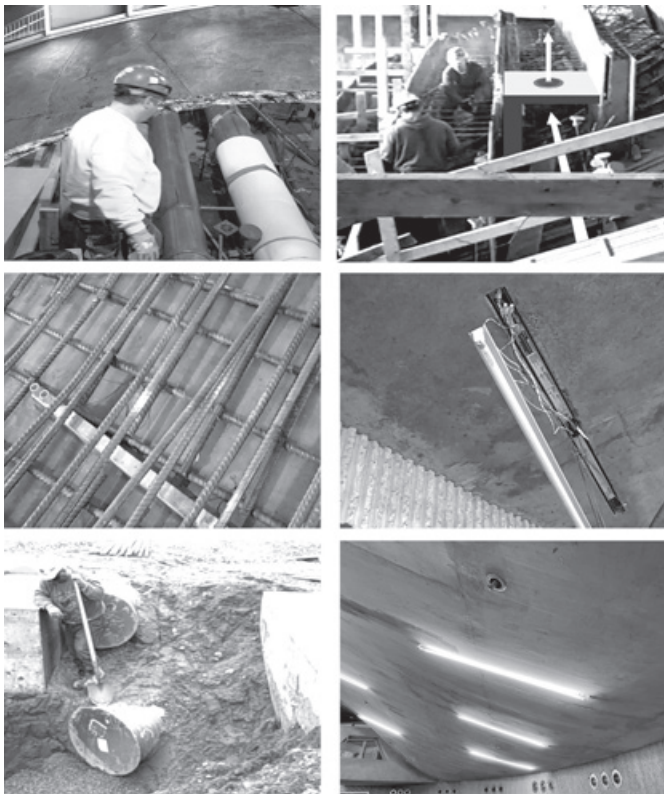
Figure 2.6. Mechanical, electrical, and fire safety items buried within structure: storm drainpipes within concrete dome (*top left*); conditioned air plenum within concrete seating structure in auditorium (*top right*); lighting fixture cut-outs in the Crit Room dome placed in formwork (*middle left*); cutout in dome concrete, (*middle right*); mechanical ducts below slab-on-ground (*bottom left*); and sprinkler pipes embedded in concrete ceiling above Crit Room and elsewhere (*bottom right*).

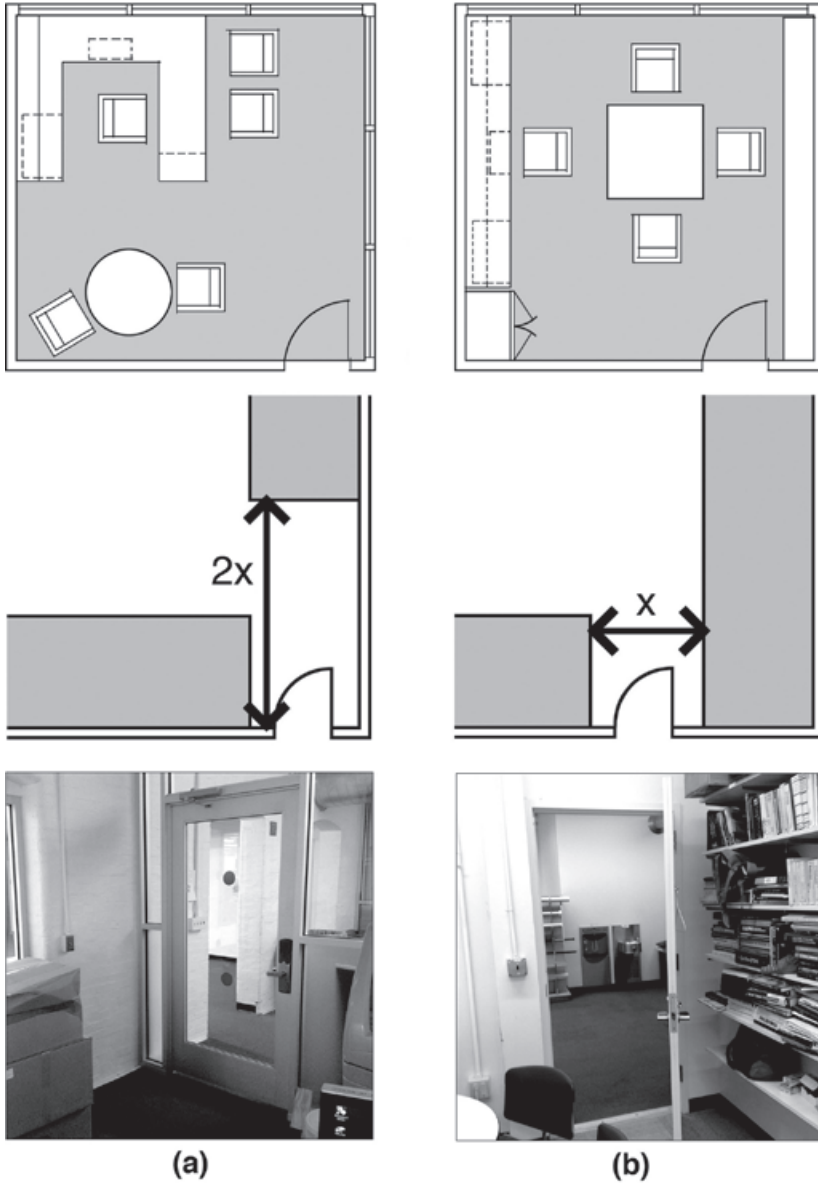
Figure 3.1. The position of a door in a room can affect its functionality, by allowing more or less use of wall space: A door placed at the corner (a) is less efficient than a door moved away from the corner (b); middle diagrams show schematically how more wall space becomes available in case b compared to case a; and photos at the bottom show two rooms representing these two door placement conditions.

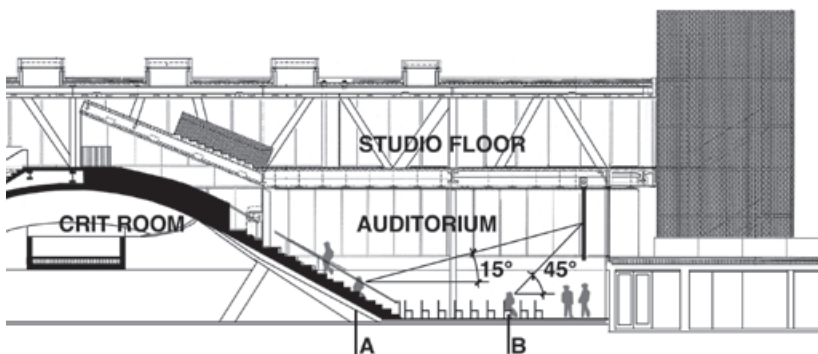
Figure 3.6. The seats at line “A” are the lowest acceptable seats in the auditorium, providing the maximum 15° inclined sightline to the midpoint of the screen; all seats below line “A,” e.g., those shown at line “B,” are uncomfortable and unhealthy.

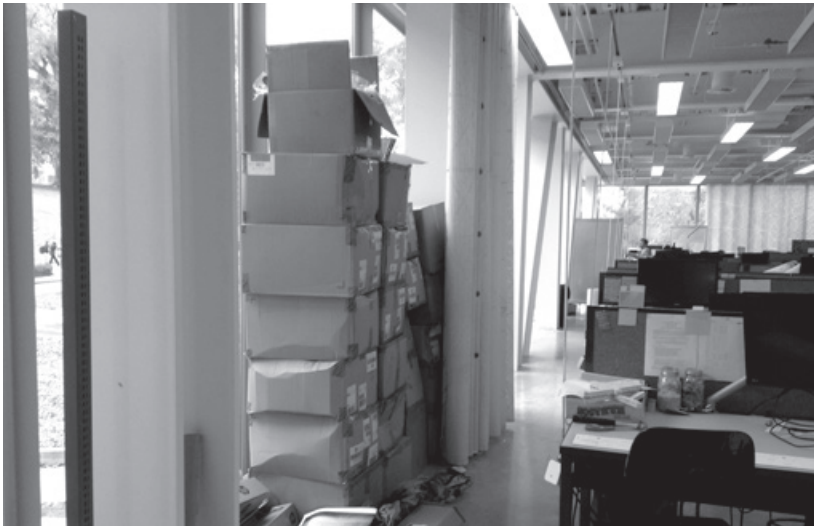
Figure 3.7. Excess space between windows and hybrid trusses in Milstein Hall encourages illicit storage of material.

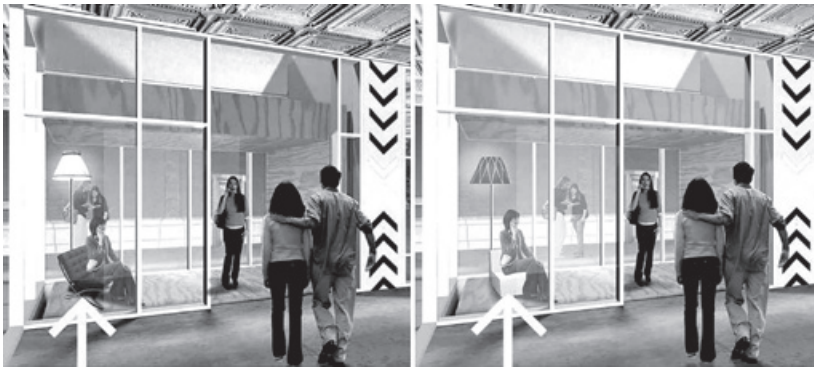
Figure 3.10. OMA’s original rendering (*left*) showing Barcelona chair in the Milstein Hall elevator; this was ultimately replaced with a plain vanilla chair (*right*). Neither the chair nor the lamp was ever actually purchased and installed (but a floor-mounted electric outlet in the elevator’s plywood floor, located precisely where the lamp would have been, survived the budget cuts).

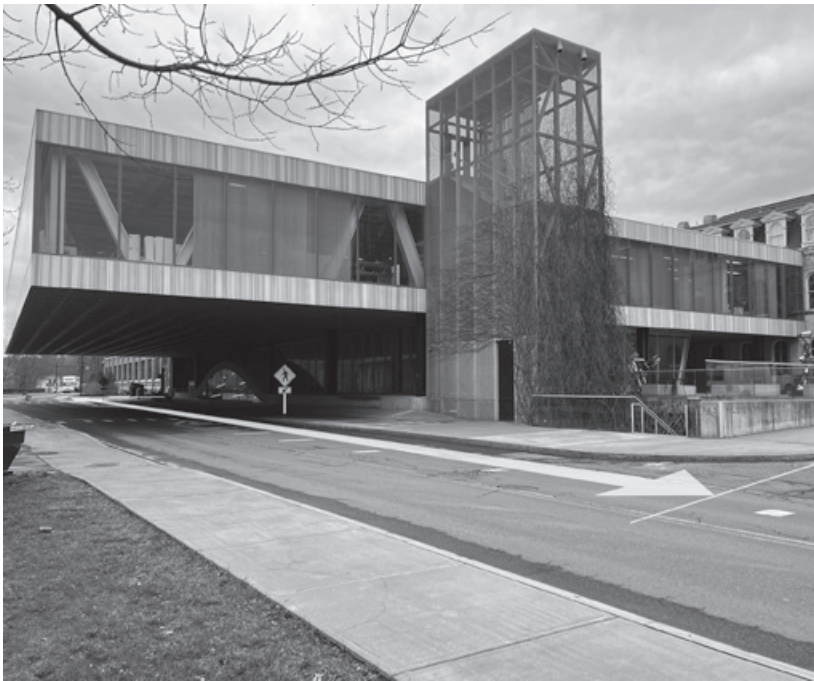
Figure 4.1. Because the sidewalk adjacent to Milstein Hall's auditorium on University Avenue does not extend in either direction beyond Milstein Hall itself, there are virtually no people who use it, and therefore virtually no passersby who might look into the auditorium or through the eyebrow window into the Crit Room. The extent of the sidewalk is indicated by the white arrow.

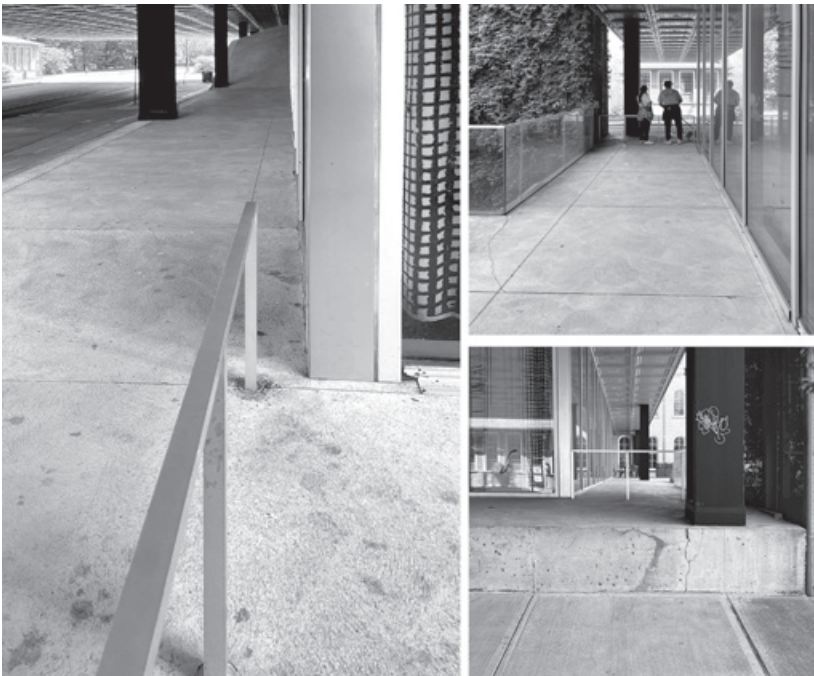
Figure 4.2. Two visitors walk to the end of Milstein Hall’s path to nowhere (*top right*); the guard rail blocking access to the auditorium windows on the north facade can be seen from University Avenue (*bottom right*); and even if one hopped over, or slid under, this guard rail, the upper sidewalk/platform/podium parallel to University Avenue also leads nowhere, terminating in the curved concrete surface of the dome (*left*).

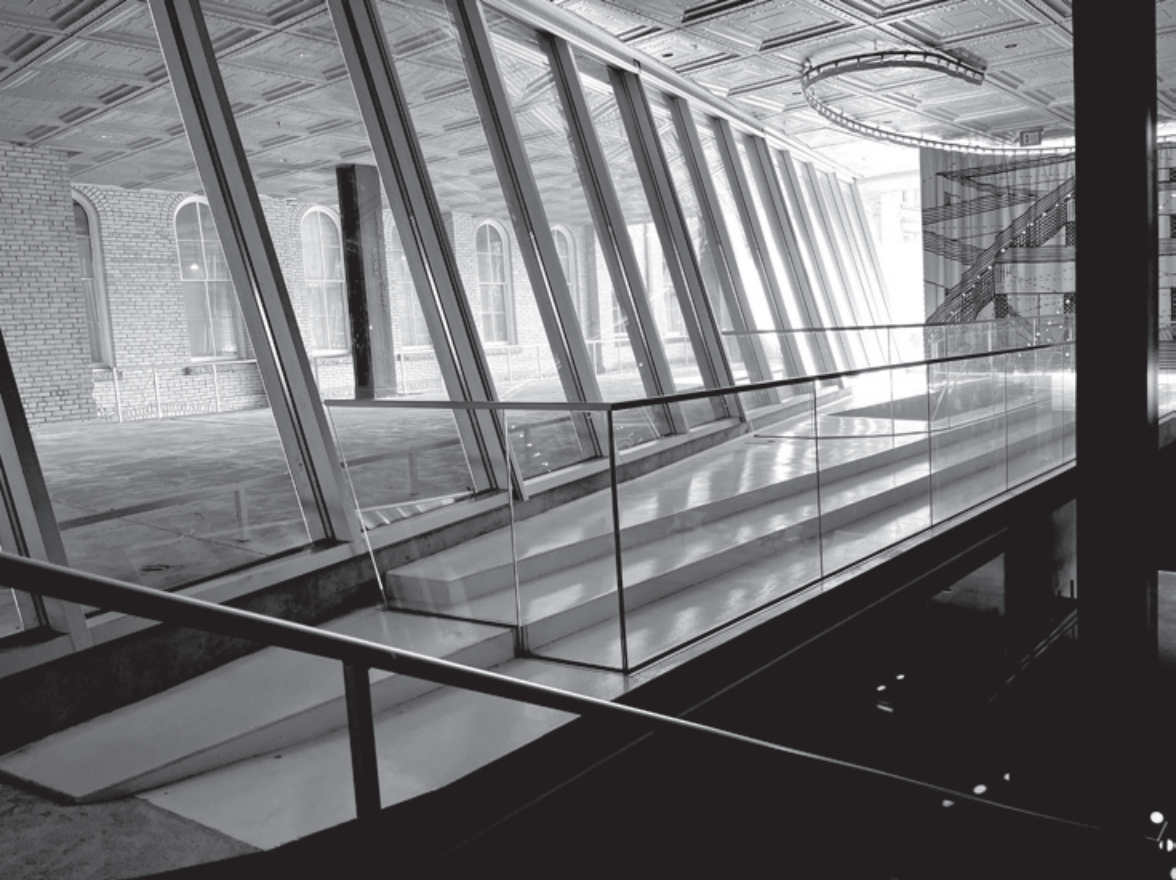
Figure 4.3. Windows on the south side of Milstein Hall’s auditorium face the “Duane and Dalia Stiller Arcade,” a dismal and dark outdoor covered space that is almost always empty.

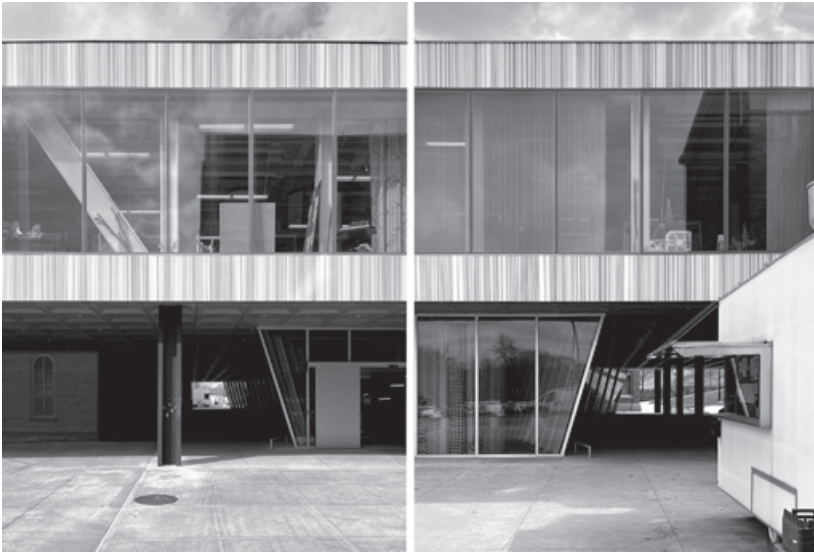
Figure 4.4. Milstein's arcade, viewed from the Milstein plaza (*right*) and from outside Rand Hall (*left*), remains dark and uninviting, even with soffit lights and integral curtain wall mullion fixtures turned on.

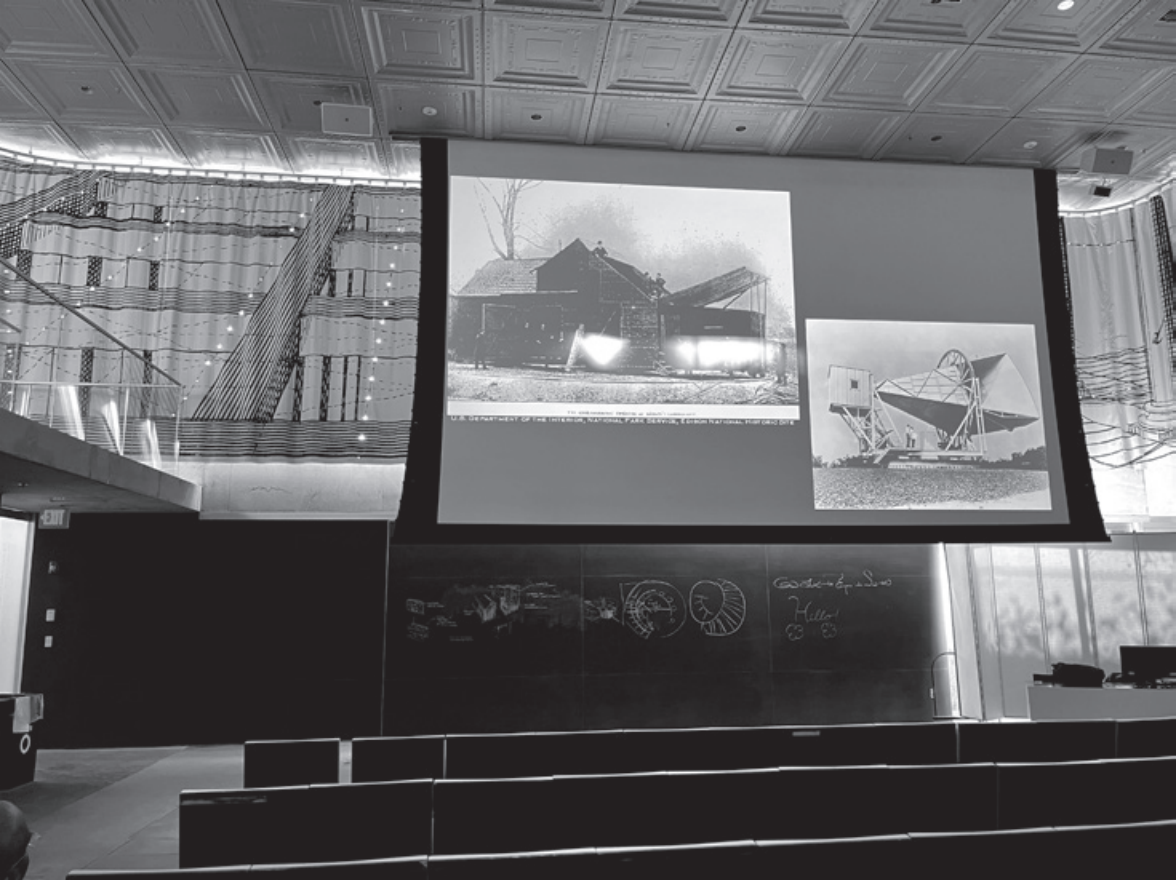
Figure 4.6 Glare on the projection screen in Milstein Hall’s auditorium is presumably caused by the low western light working its way through decorative grommets in the curtains and bouncing off reflective surfaces in the auditorium.

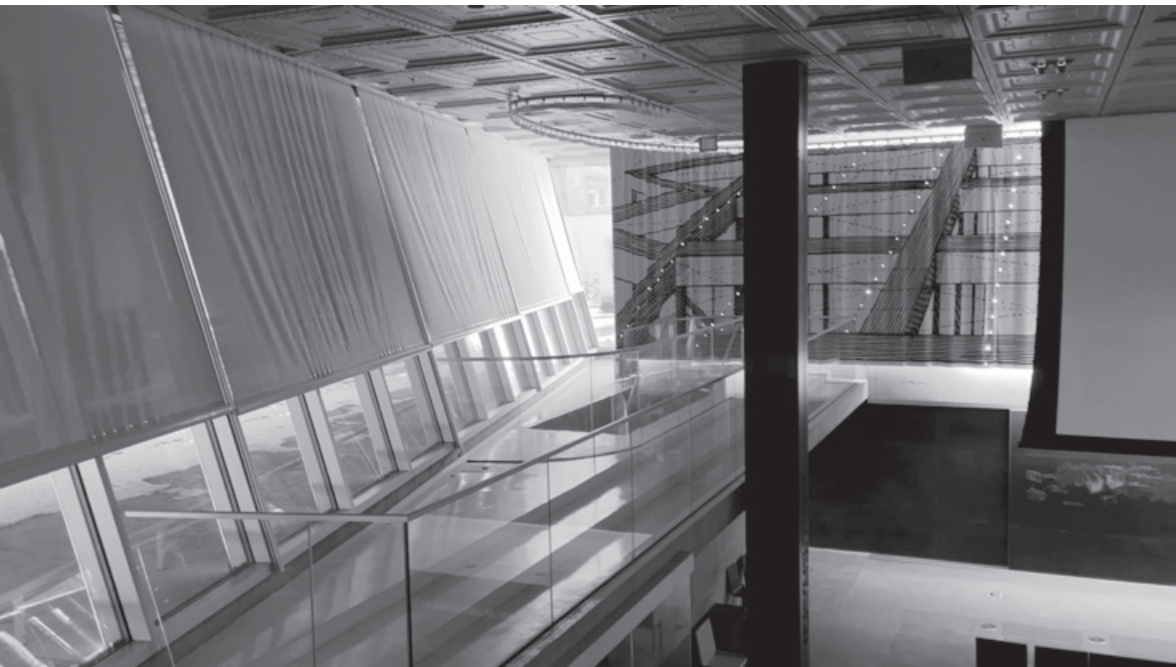
Figure 4.7. Blinds and curtains are often deployed in the Milstein Hall auditorium, blocking all views, both in and out, and thereby negating the rationale for wrapping the auditorium with glass in order to allow this hypothetical and counterproductive visual interconnection.

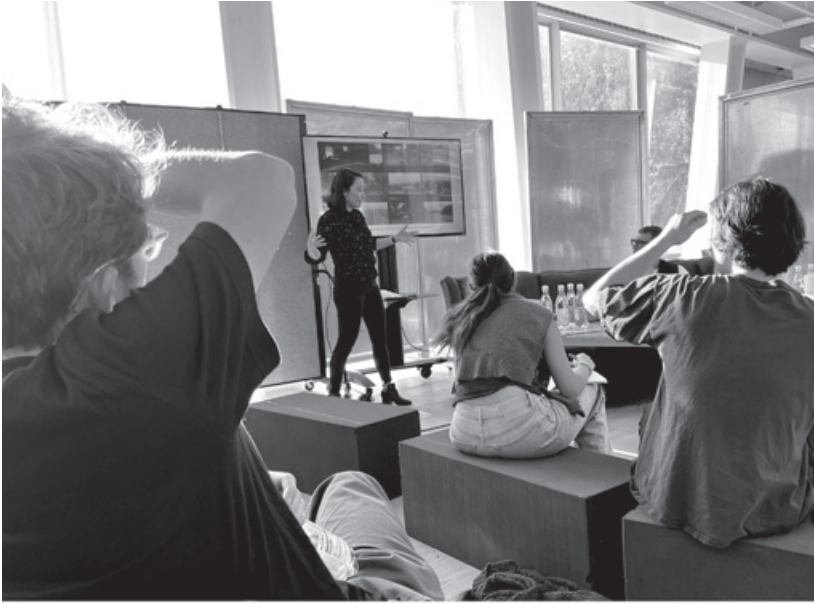
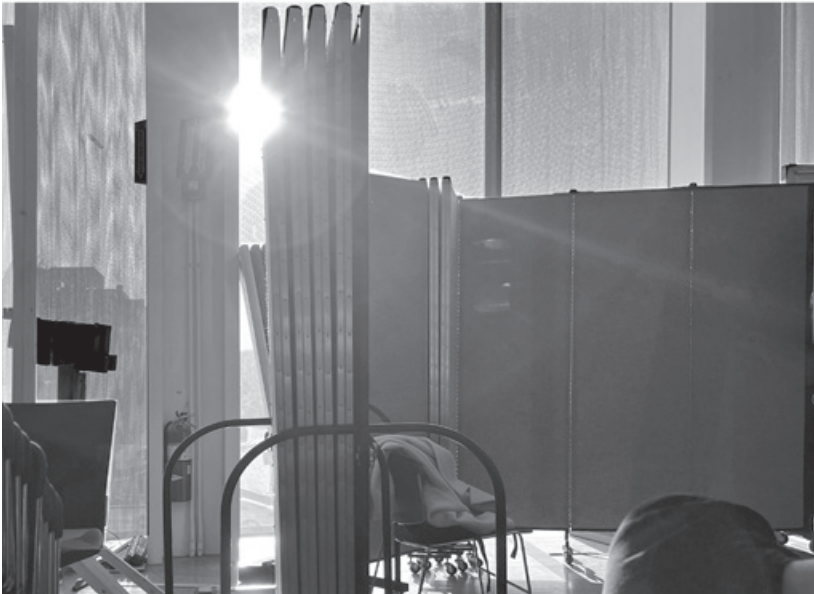
Figure 4.8. The special wood floor assembly area in Milstein Hall becomes uncomfortable and dysfunctional in late afternoon and early evenings as the western sun penetrates through the floor-to-ceiling glazing, even with curtains drawn and ad hoc barriers placed in front of the curtains. Students at this “Living Room” event held on April 19, 2023, with Nancy Lin and Curt Gambetta, shield their eyes (*top*) against the sun and its glare (*bottom*).

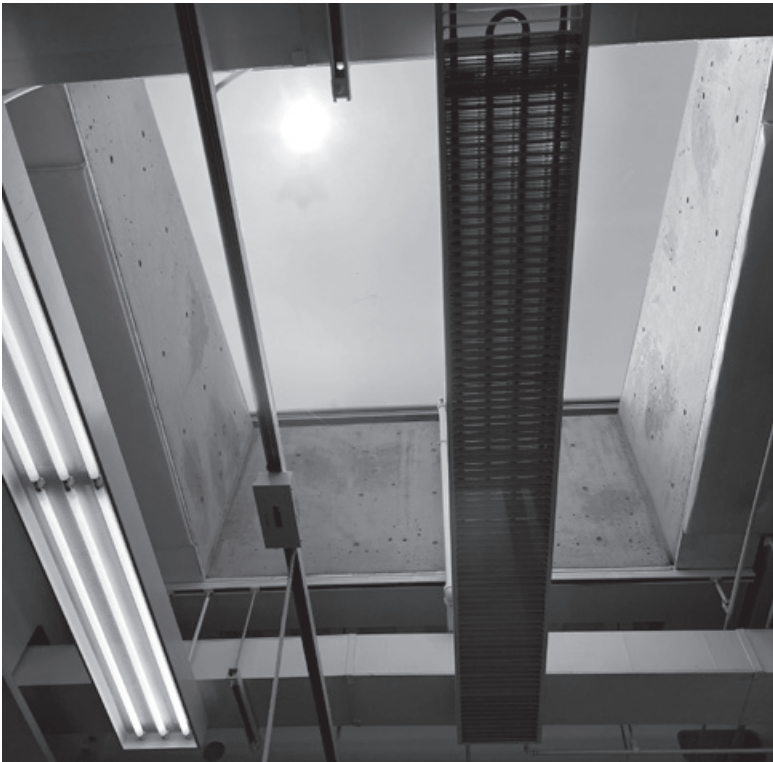
Figure 4.9. The southern sun penetrates through the glazed skylights, creating conditions of glare.

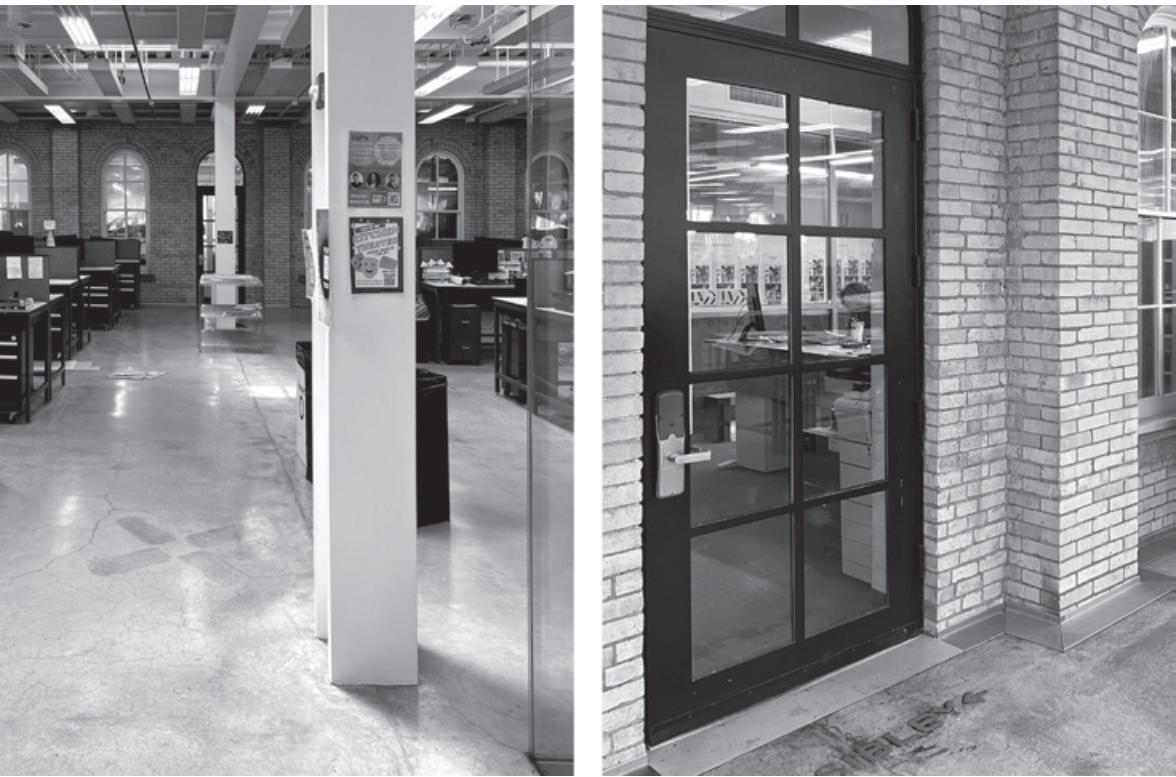
Figure 5.5. One of the four doors linking Milstein and Sibley Halls provides access to an IT support room, visible behind the glass door (*right*); in Milstein Hall, the circulation aisle to this door is bisected by a row of steel columns (*left*).

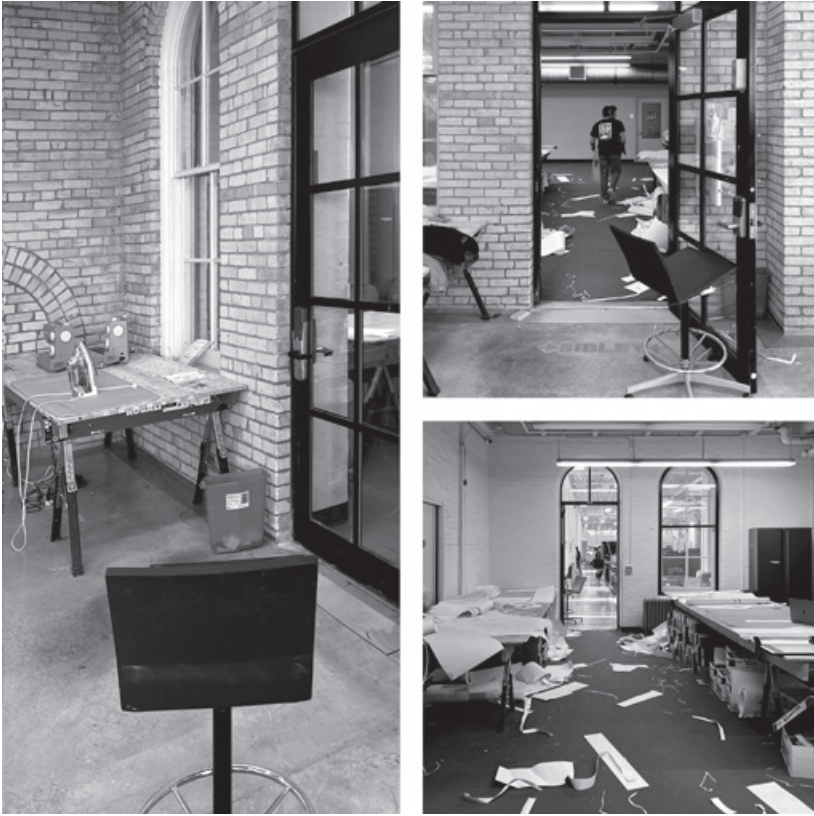
Figure 5.6. A second unlocked door between Milstein and Sibley Halls provides access to a room used for trimming large-format prints, shown as viewed from Milstein Hall (*top right*) and from Sibley Hall (*bottom right*). The latter view shows how other potential uses such as office and classroom space are precluded by the need for spaces that can function for circulation. Both views also show that this door, a protected opening in a fire barrier that is required to be closed, has been improperly (and dangerously) propped open to facilitate access between the two buildings; the danger is heightened by the mass of combustible material left on tables and on the floor of Sibley Hall, and by the iron on the table adjacent to the door (*left*).

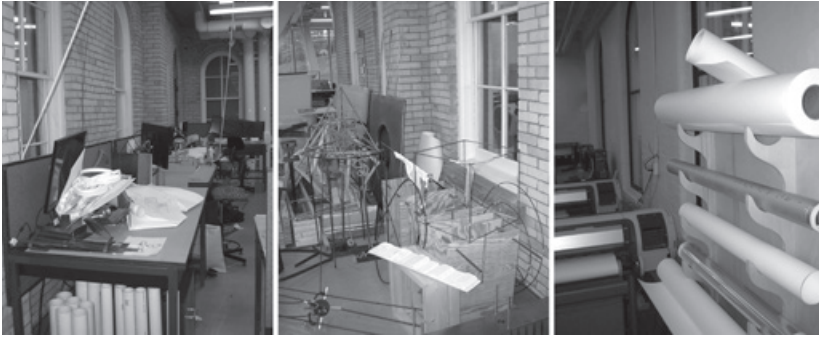
Figure 5.7. Combustible material placed in front of locked doors and windows in the fire barrier wall between Milstein Hall and Sibley Hall.

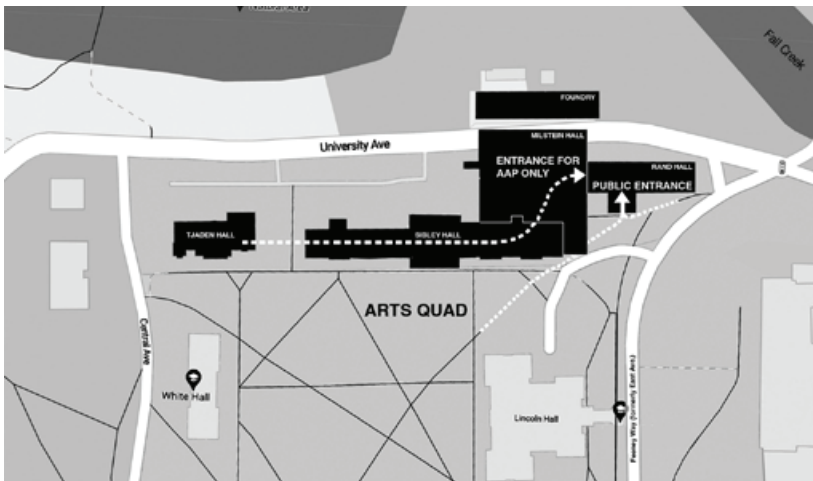
Figure 5.8. Site plan showing college buildings and purported circulation paths to the Fine Arts Library in Rand Hall.

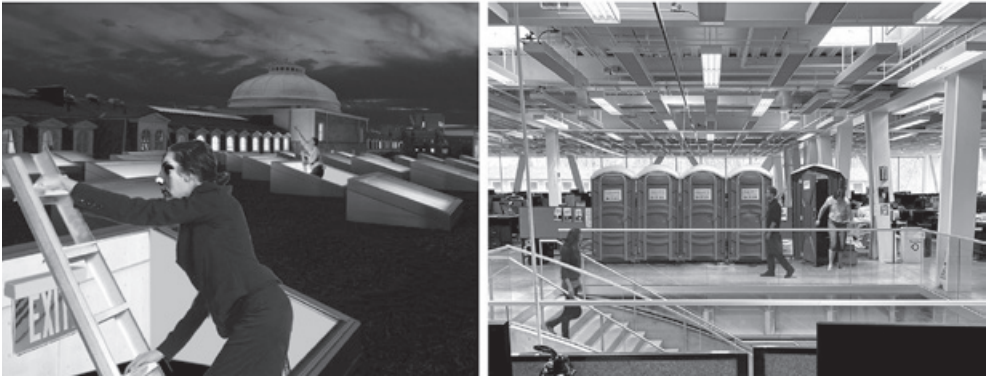
Figure 5.13. Photoshopped parody images for Rem Koolhaas’s proposal advocating architectural fundamentals in Milstein Hall: exits (*left*) and toilets (*right*) accompanied the parody article reproduced below.

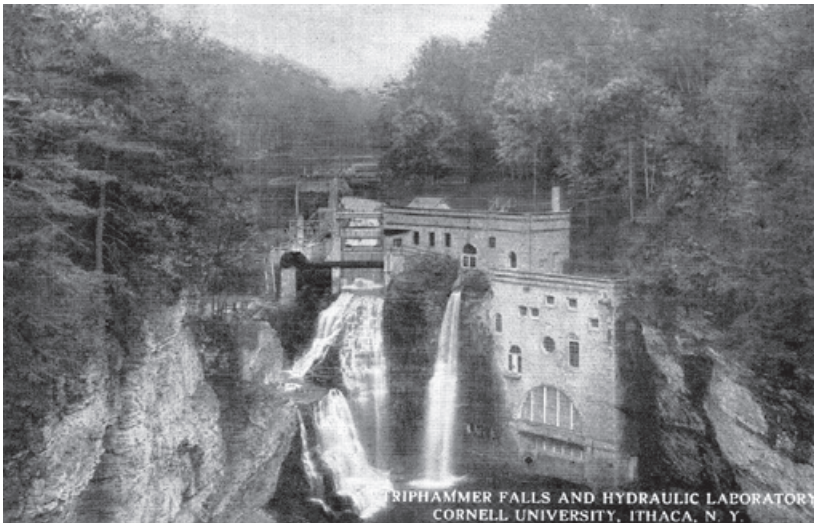
Figure 6.3. The gorges bounding Cornell were appreciated as scenic attractions, but their utilitarian aspect, providing power for mills and water for hydraulic experiments—the Hydraulic Laboratory in Fall Creek from around 1898 is shown here—was more important for early campus planning. Tragically, this amazing structure was allowed to decay and collapsed in 2009.

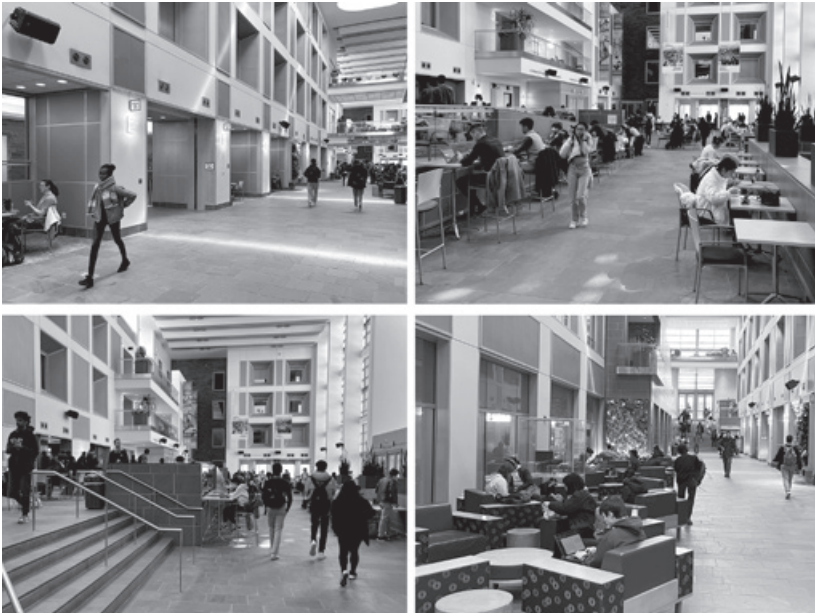
Figure 6.9. The arcade in Duffield Hall is constantly filled with activity.

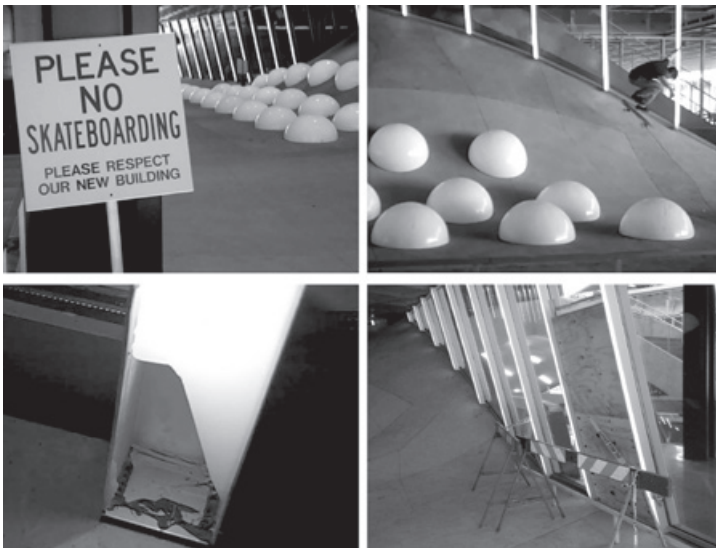
Figure 6.10. Skateboarders are warned away from Milstein Hall's dome (*top left*) but show up anyway (*top right*); lighting fixtures and glazing panels have been damaged (*bottom left and right*), possibly from collisions with skateboards.

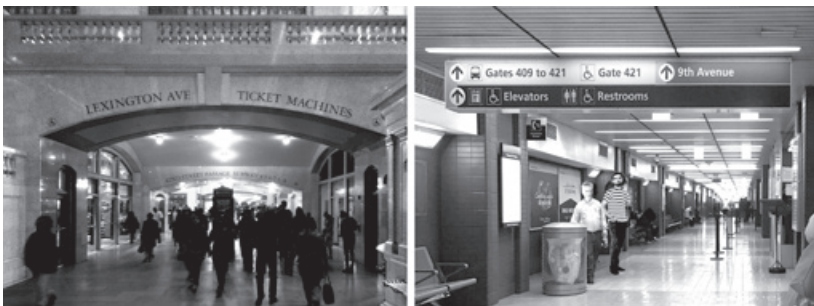
Figure 6.11. Signs are needed in Grand Central Terminal (*left*) and at the Port Authority Bus Terminal (*right*), both in New York City.

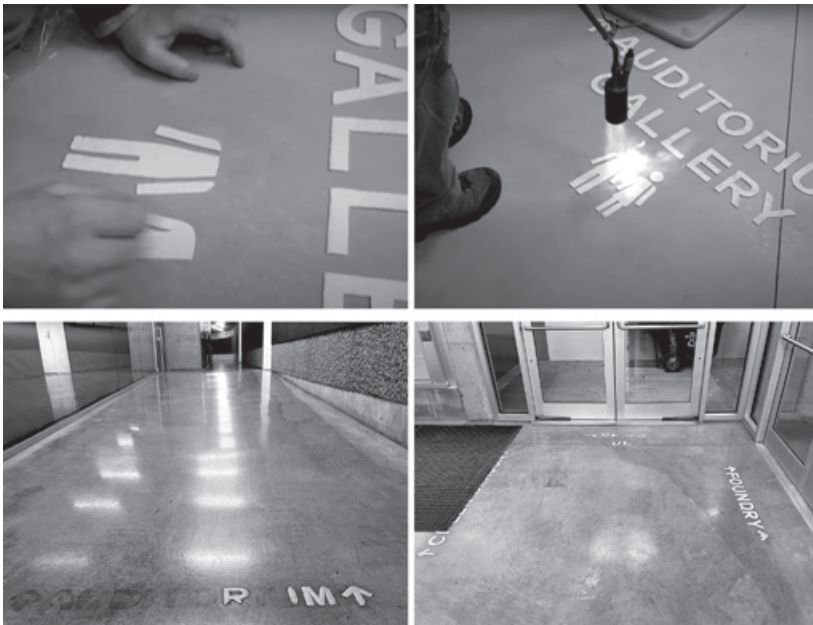
Figure 6.12. Milstein Hall’s signage system is assembled with individual letters and symbols that are placed on the concrete slab (*top-left*), torched onto the concrete surface (*top right*), and then left to be damaged or destroyed by foot traffic and cleaning protocols (*bottom left and right*).

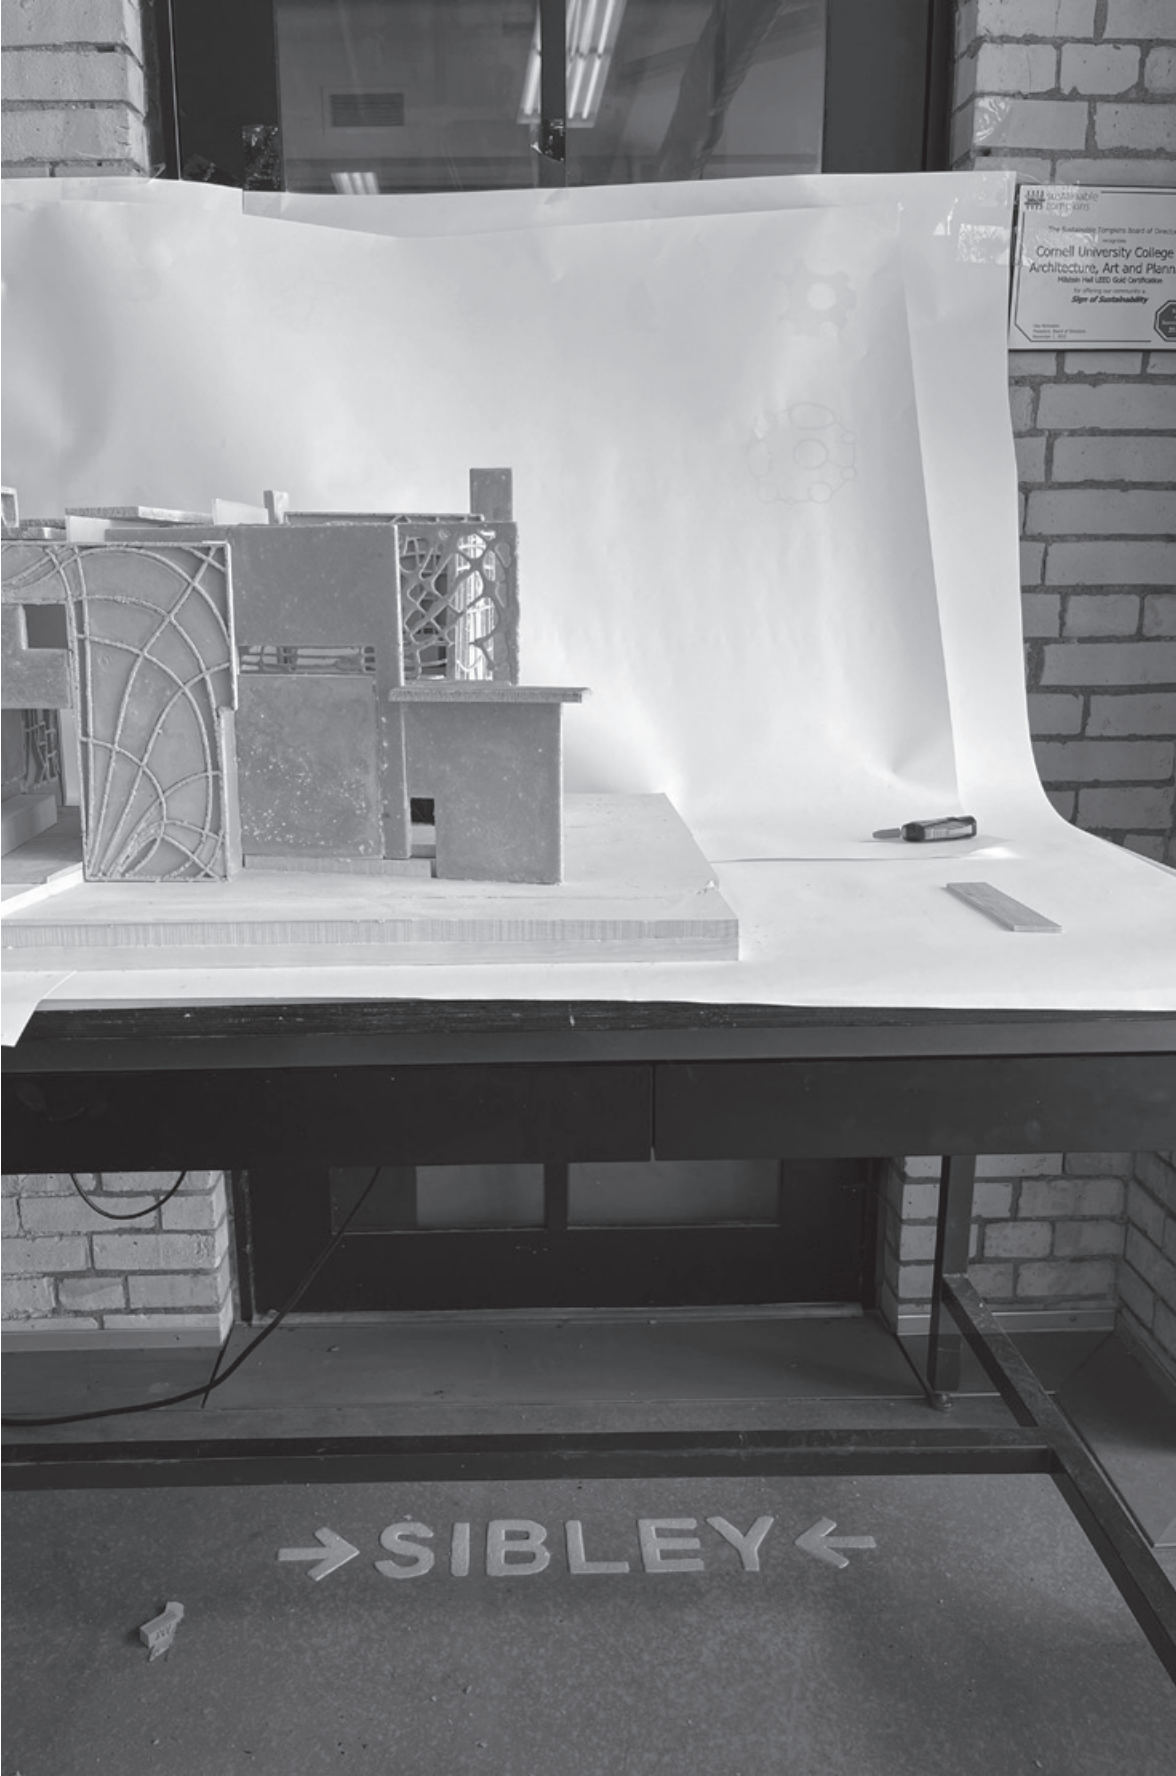
LEED Accredited
Sustainable
Cornell University
The Sustainable Campus Board of Directors
Cornell University College
Architecture, Art and Planning
Hudson Hall LEED Gold Certification
An Official Accreditor of
Sign of Sustainability

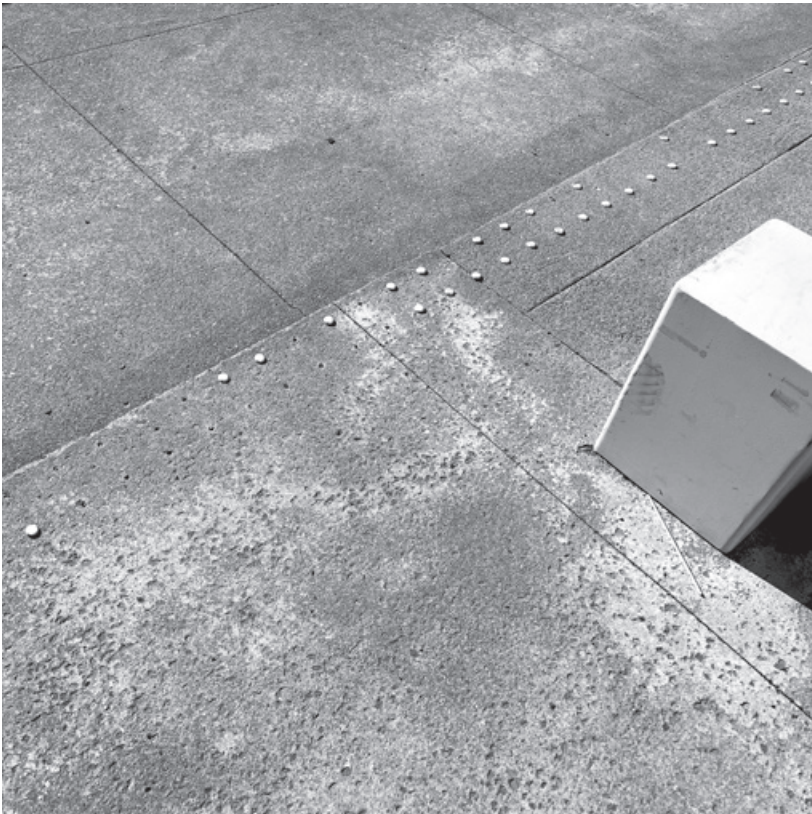
Figure 6.16. The discontinuity of Milstein Hall's plaza and the loading area, even with the addition of tactile circular discs, is extremely hard to pick up, especially in the late afternoon or early evening when there are no shadows cast by the western sun.

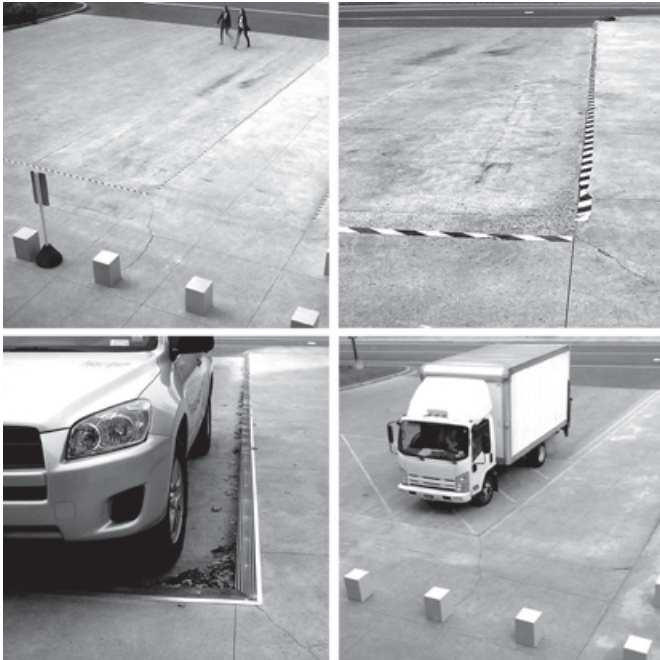
Figure 6.17. After a curb with no articulation was constructed at the loading dock for Milstein Hall, temporary yellow warning tape (*top left and top right*) was placed over the “invisible” edge; later a textured metal curb cover (*bottom left*) was installed, but later removed, so that the current condition as of this writing (*bottom right*) has the same lack of articulation as the original.

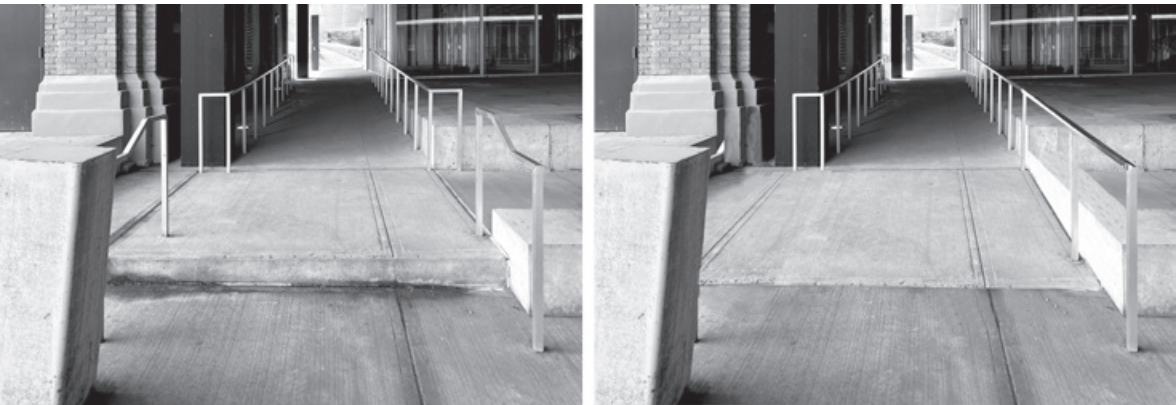
Figure 6.18. The single step at the end of a ramp leading from the Main entrance (exit) from Milstein Hall to University Avenue represents a noncompliant elevation change (*left*, as-built image); simply extending the ramp to the University Avenue sidewalk would have eliminated that problem (*right*, photoshopped image).

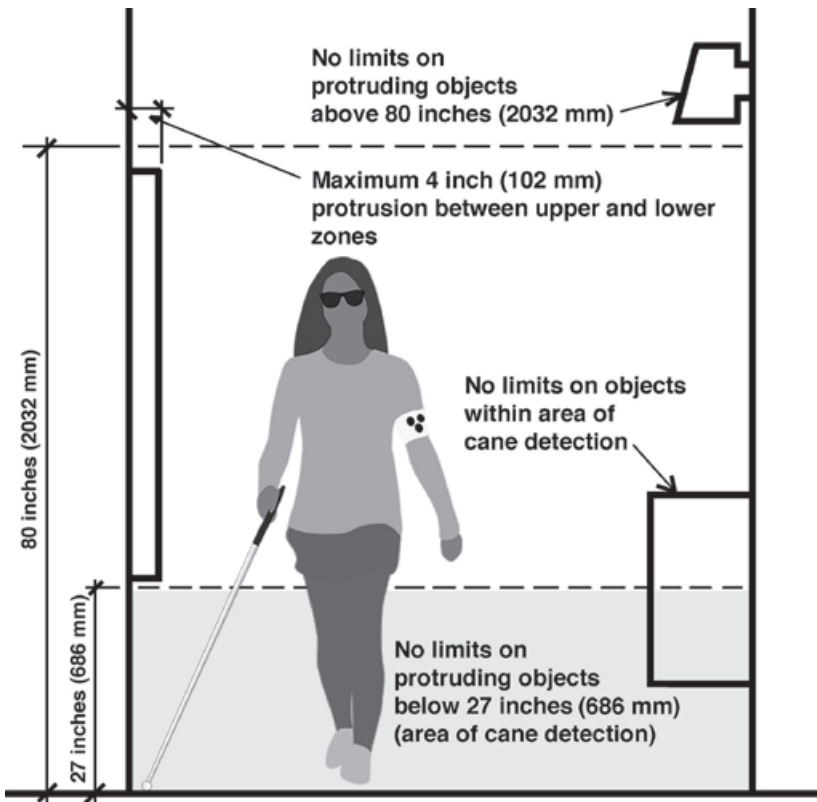
Figure 6.19. Graphic illustration showing limits of protruding objects.
