OMA'S MILSTEIN HALL

A CASE STUDY OF ARCHITECTURAL FAILURE

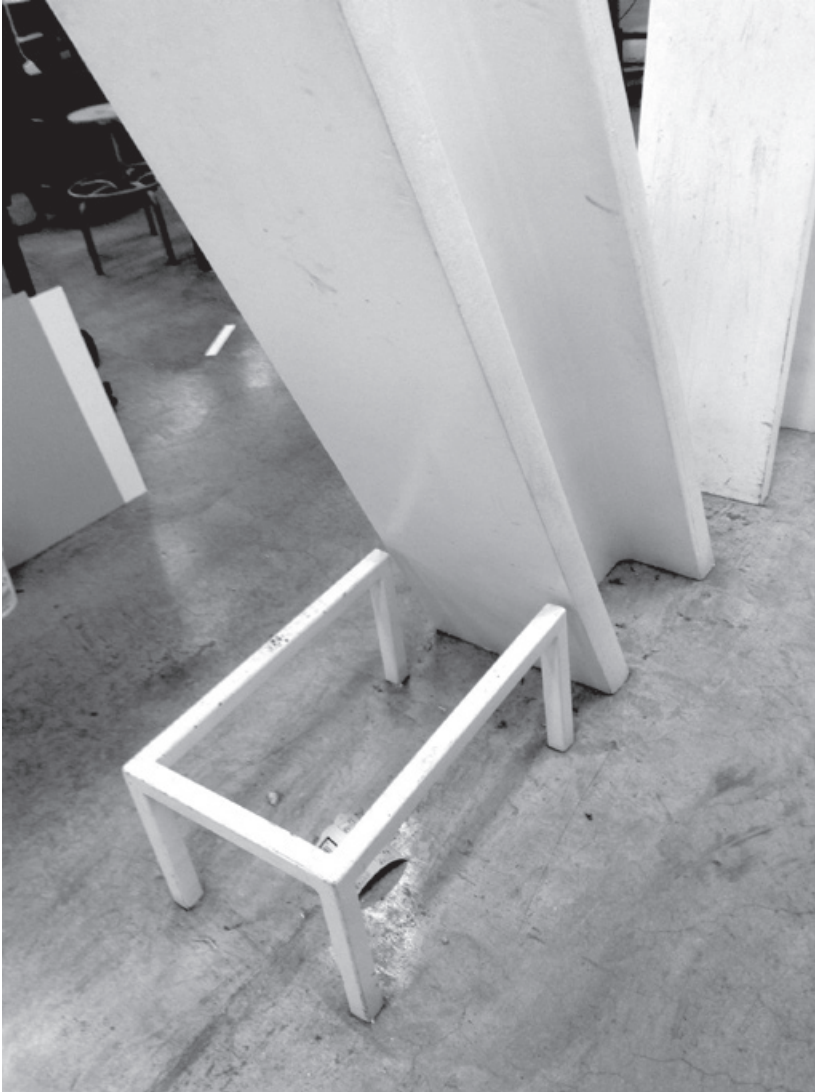
Figure 6.20. Typical cane-detection guard at inclined (protruding) structural element in Milstein Hall.

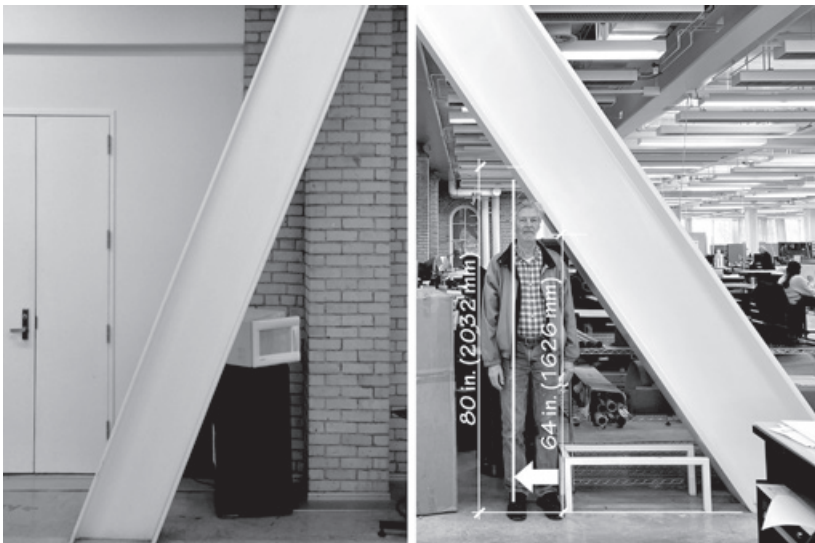
Figure 6.21. Cane protection guards are consistently missing at inclined elements of the hybrid trusses on the second floor of Milstein Hall that are adjacent to curtain walls or, as illustrated here, are close to the brick walls of Rand and Sibley Halls (*left*); other inclined elements have inadequate cane-detection guards, as illustrated in this image (*right*) where the guard only protects people to a height of 64 inches (1626 mm) instead of the required 80 inches (2032 mm).

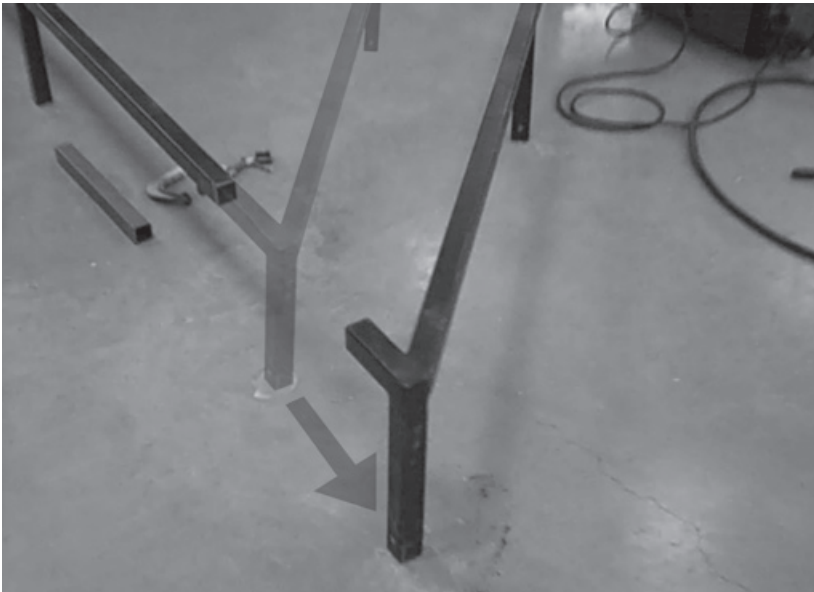
Figure 6.22. This photo, edited with Photoshop, shows how a cane-detection guard in the Crit Room needed to be cut and extended after the building was occupied.

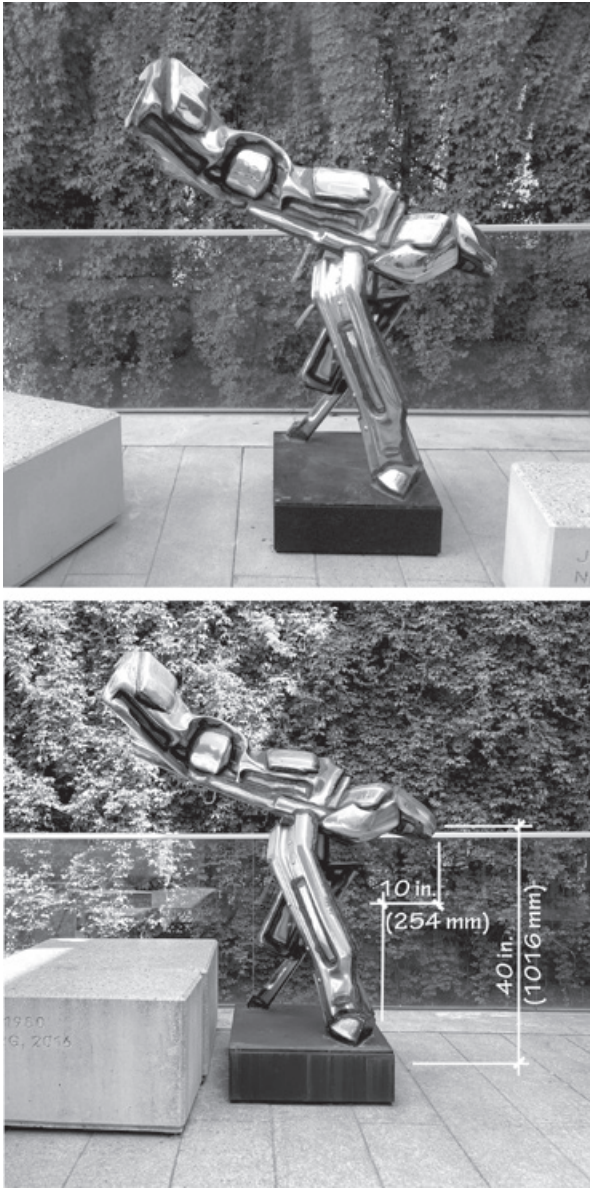
Figure 6.25. Sculpture as protruding object. A sculpture by Jason Seley was placed on Milstein Hall's concrete deck, creating a protruding object hazard (*top*); eventually, the issue was "resolved" by moving two of the plaza's concrete benches below the protruding part of the artwork, which created a cane-detection guard on one side of the sculpture, but not on the other side (*bottom*), where the welded car bumpers still protrude 10 in. (254 mm) into the circulation zone.

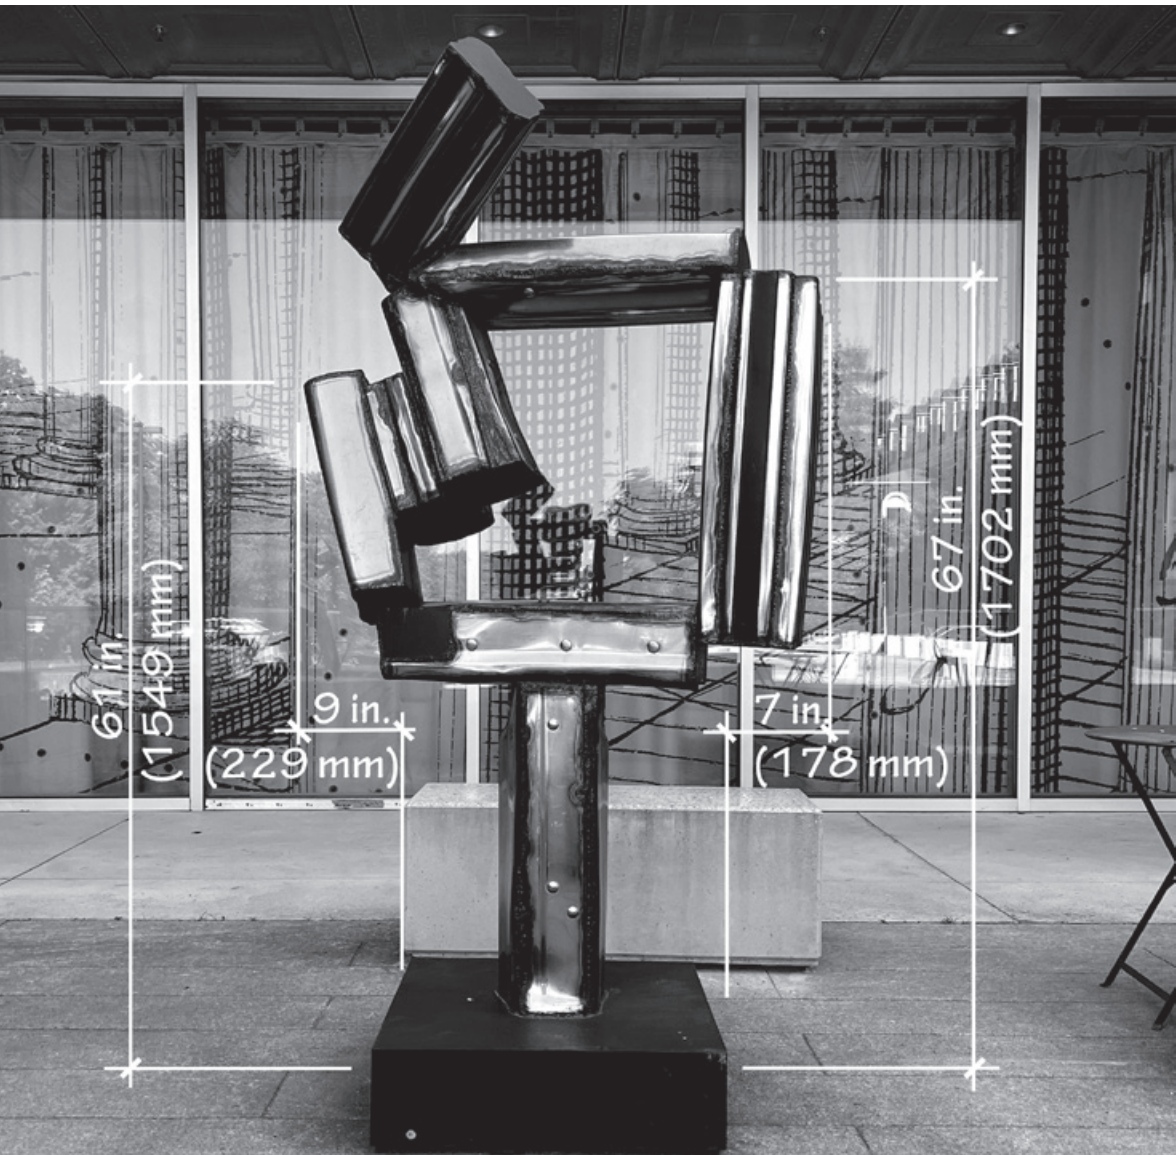
In the same outdoor space, a food truck with dangerous and illegal protruding canopies was designed and installed after Milstein Hall was completed and occupied and, like the Jason Seley sculptures, was not part of the design brief given to OMA (fig. 6.27). Two and a half years after I complained about its ADA/code violation, Cornell finally modified the protruding canopy supports so that they would not extend beyond the 4-in. (100 mm) limit.

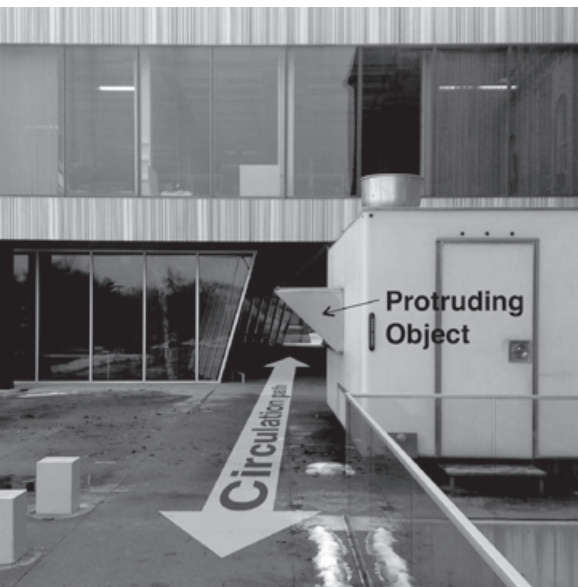
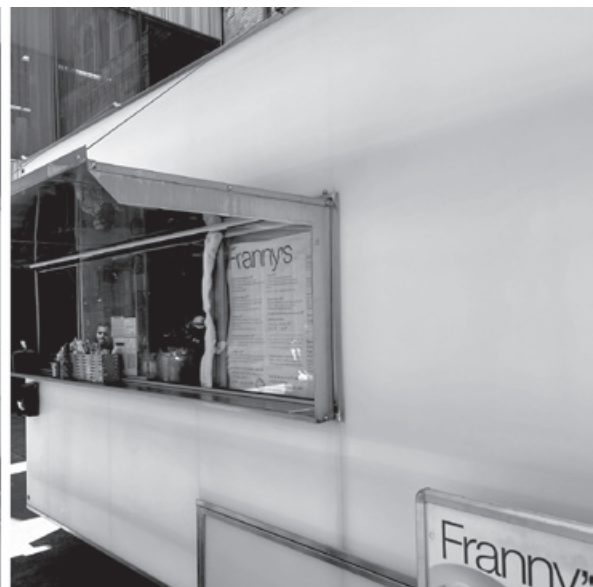
7 BUILDING GOOD: STRATEGIES, OBSTACLES, FICTIONS

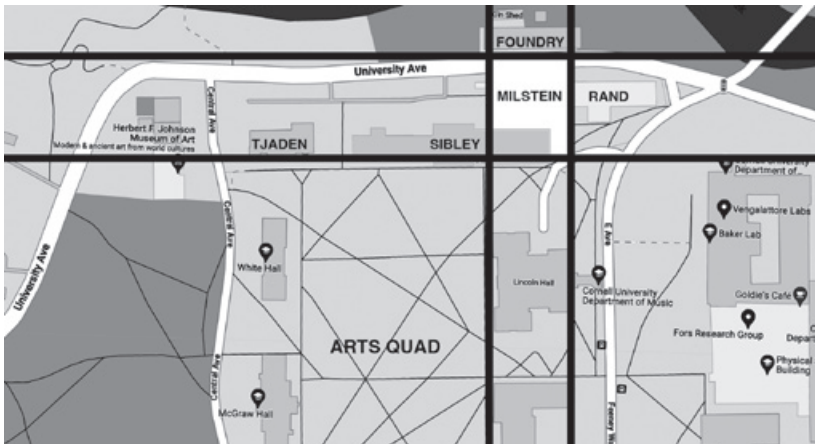
Figure 7.1. I've interpreted the diagrammatic basis for Milstein Hall's siting on this campus plan: an east-west zone brackets the primary buildings of the college (Tjaden, Sibley, and Rand Halls as well as the art museum to the west); while a north-south zone conceptually ties the college's Foundry structure to the eastern buildings of the Arts Quad. Milstein Hall occupies the intersection of these two zones.

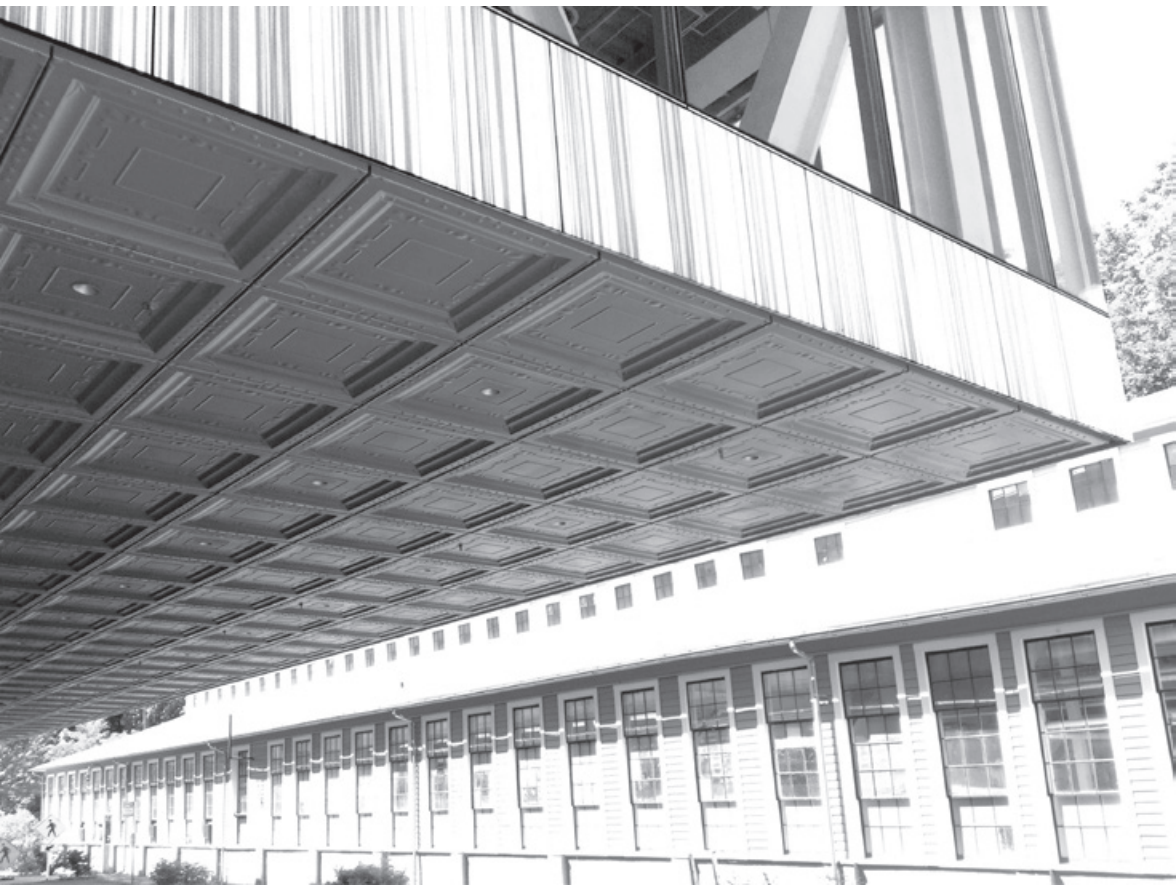
that have embraced their Victorian-era tin ceilings, the spaces under Milstein Hall's stamped aluminum panels remain largely empty and dysfunctional (fig. 7.8).

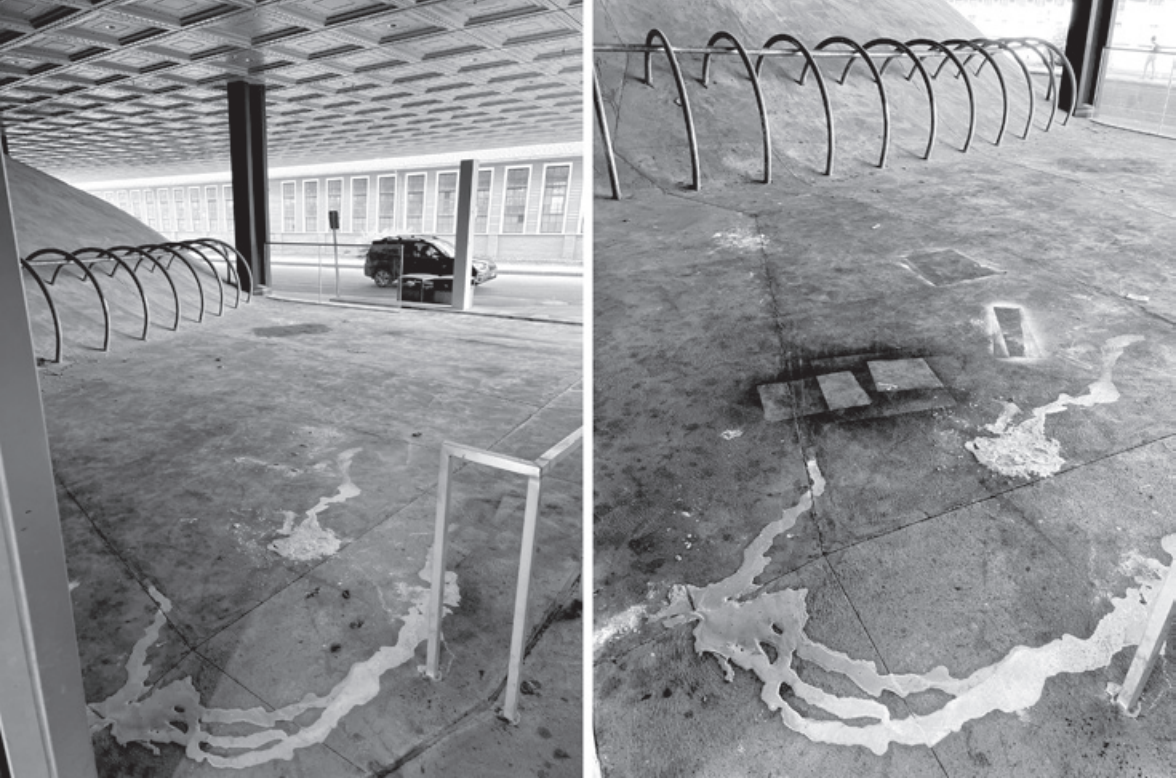
Figure 7.10. These Milstein Hall images of the covered outdoor space across from the Foundry were taken about a month apart in April (*left*) and May (*right*) 2023; one can see the addition of spray paint to the illicit composition that was already in place on the concrete surface: a work in progress!

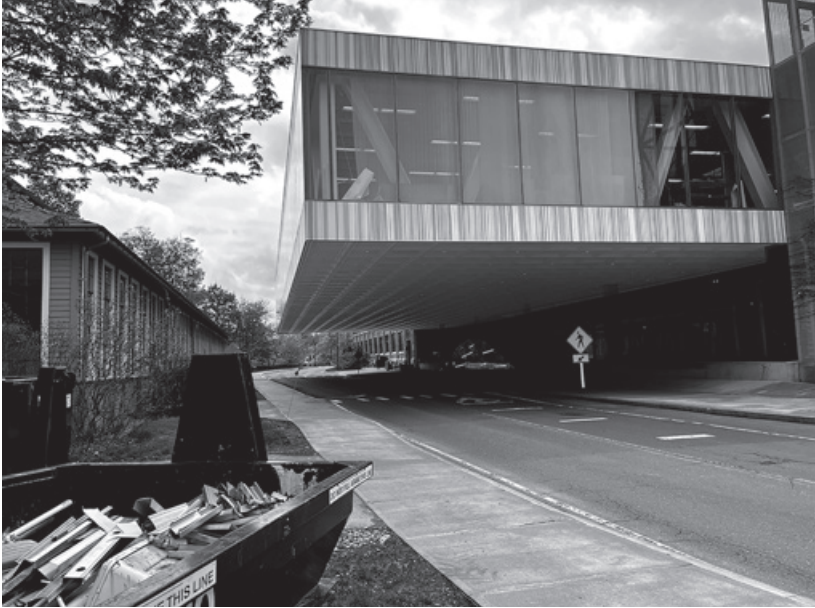
Figure 7.11. The outdoor covered space below Milstein Hall’s primary cantilever functions as a road and sidewalk—nothing else.

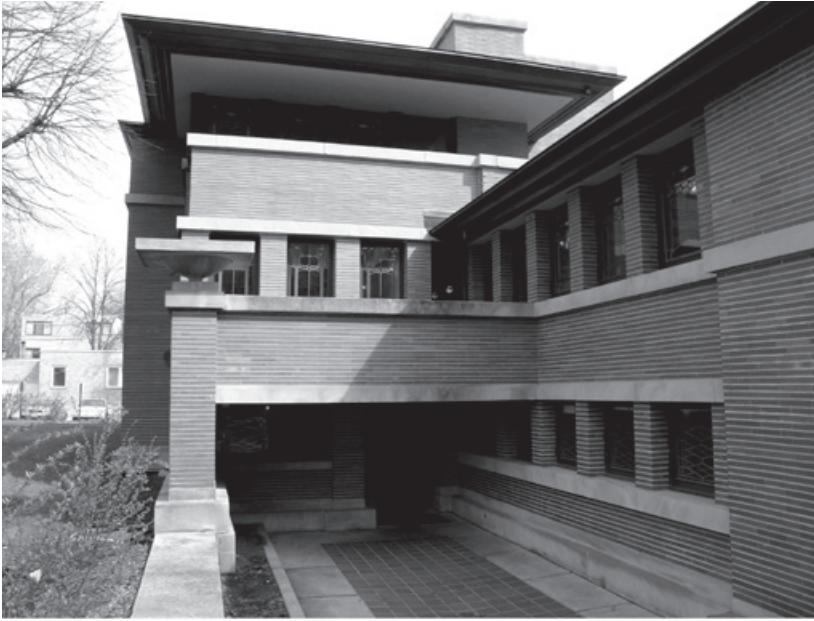
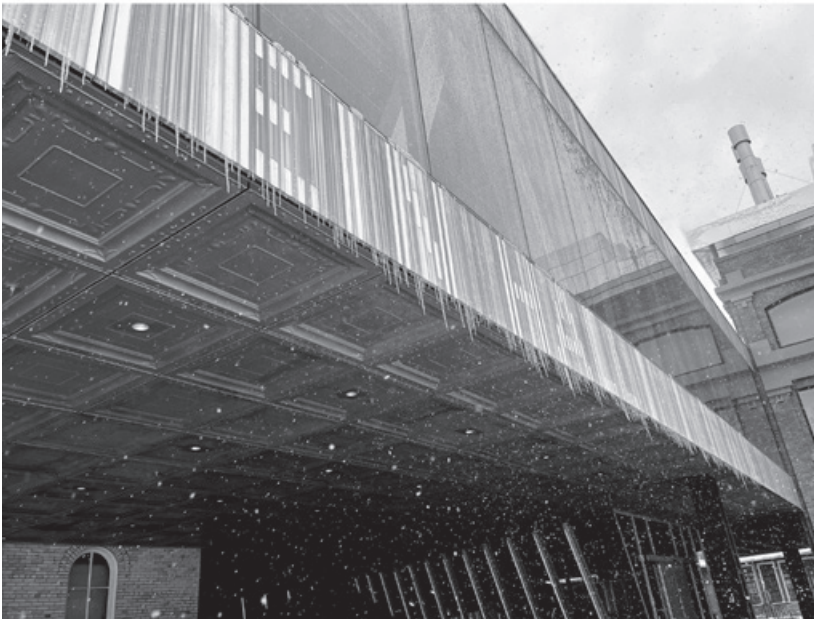
Figure 8.1. While leaking roofs are not unknown within Frank Lloyd Wright's oeuvre, the likelihood of water issues on exterior walls or windows of his Robie House is dramatically reduced by the use of roof overhangs (*top*); the exterior facade of Milstein Hall, on the other hand, forms icicles as snow striking the surface melts and then freezes (*bottom*).

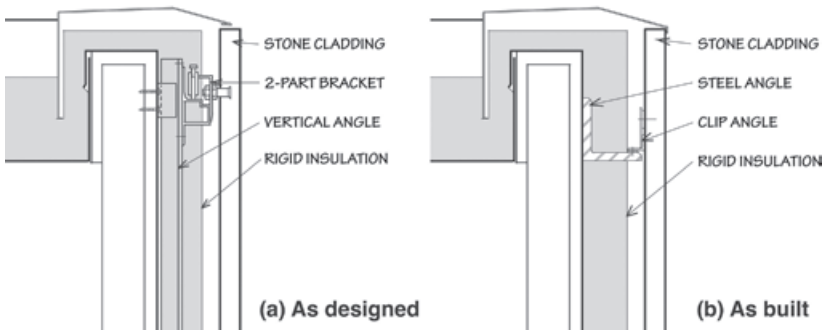
Figure 9.1. The original design (a) shows an adjustable 2-part bracket system which minimizes thermal bridging; the detail as built (b) replaces this “hi-tech” system with a “low-tech” assemblage of angles and clip angles which interrupt the continuity of the rigid insulation, creating a significant thermal bridge.

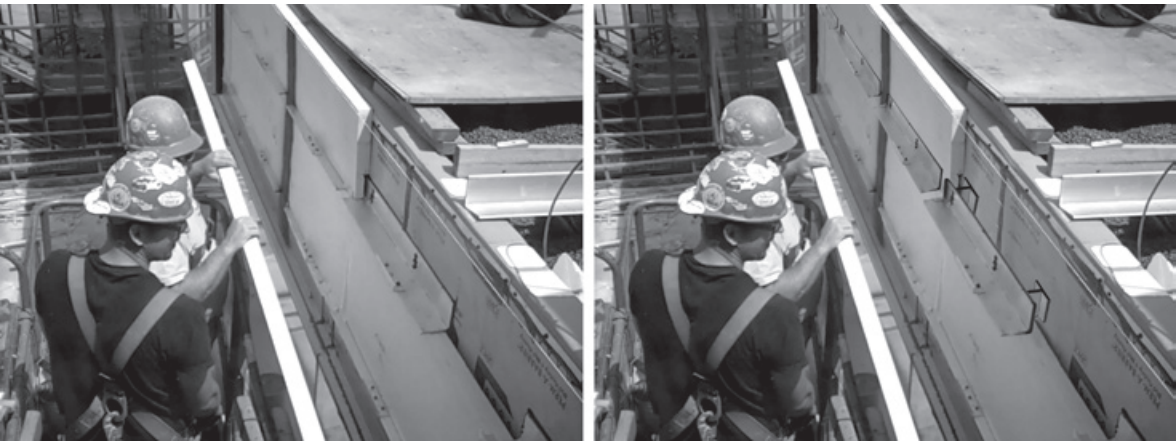
Figure 9.2 A significant thermal bridge can be seen in this construction photo of Milstein Hall (*left*), with horizontal steel angles, to support stone cladding panels, interrupting the thermal control layer, i.e., the rigid insulation. I’ve revised this screen-captured image to illustrate how a “stand-off” works (*right*): the horizontal angle would need to be moved 2 inches (50 mm) away from the sheathing and air barrier so that rigid insulation can be placed behind the steel angle, minimizing the thermal bridging.

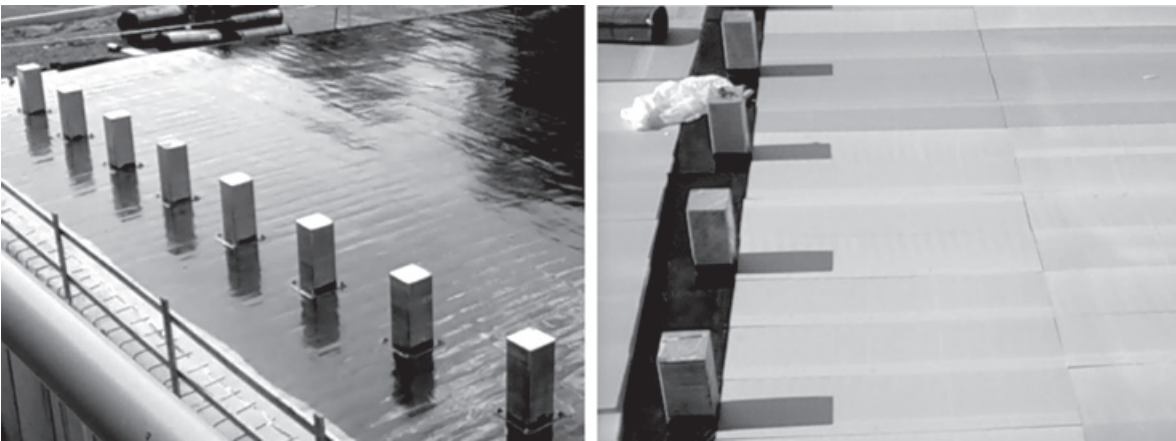
Figure 9.3. Bollards are installed directly on the structural concrete slab above occupied and heated space (*left*); insulation boards are then placed around the bollards (*right*).

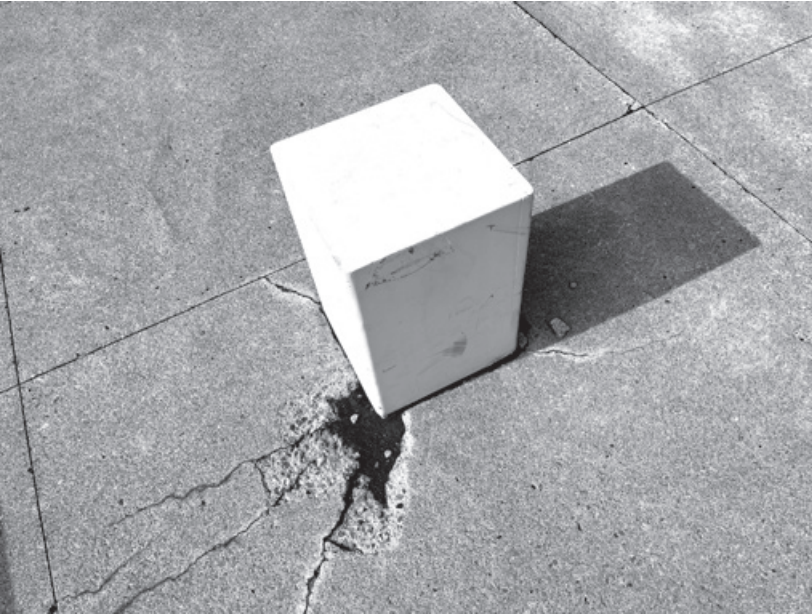
Figure 9.4. Concrete cracking and slight displacement of the bollard suggests a vehicle-bollard collision that may have compromised the waterproofing hidden below grade.

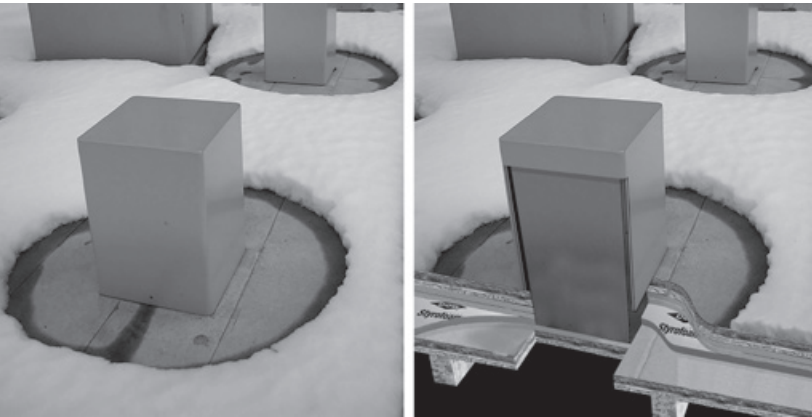
Figure 9.5. Bollards placed over Milstein Hall's below-grade heated space penetrate all three layers of below-grade rigid insulation, causing unimpeded heat loss from those below-grade spaces (*right*, photoshopped cut-away image—waterproofing and drainage layers not shown); the circular areas of melted snow around each bollard (*left*, original photo) attest to the heat loss through the bollards from the occupied space below.

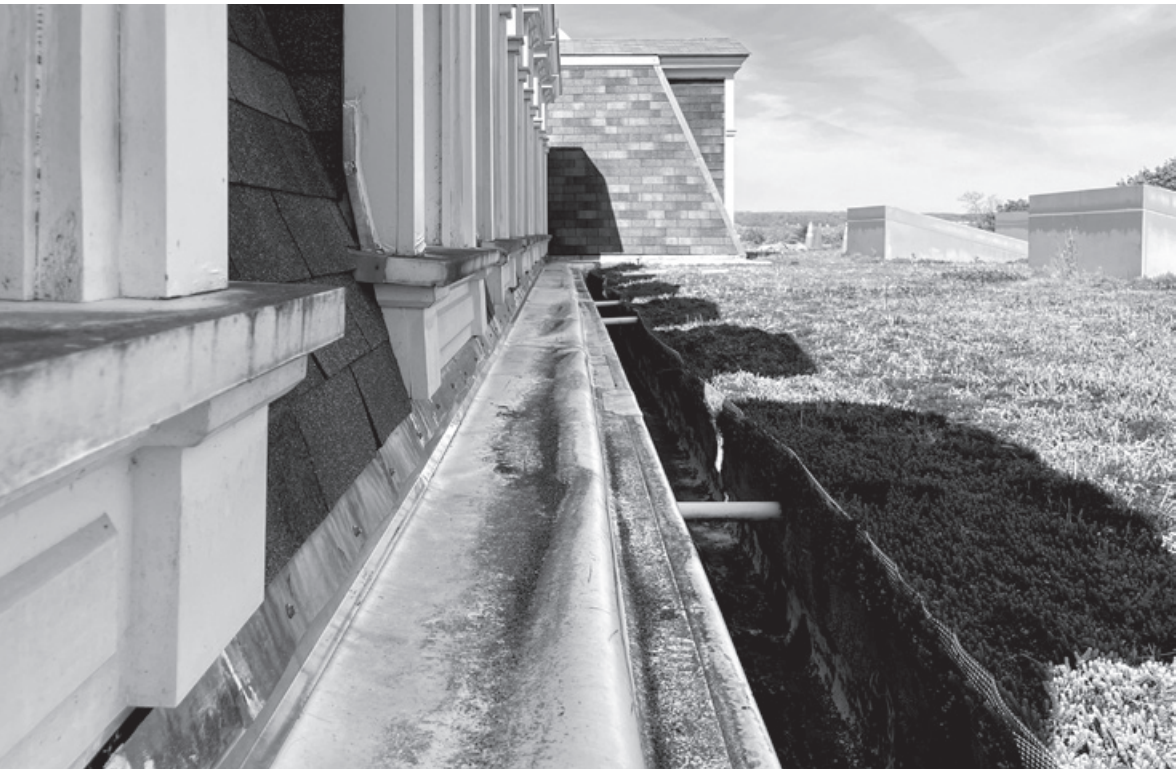
Figure 9.6. The 5-inch-wide seismic joint as detailed between Milstein and Sibley Halls (similar for Rand Hall).

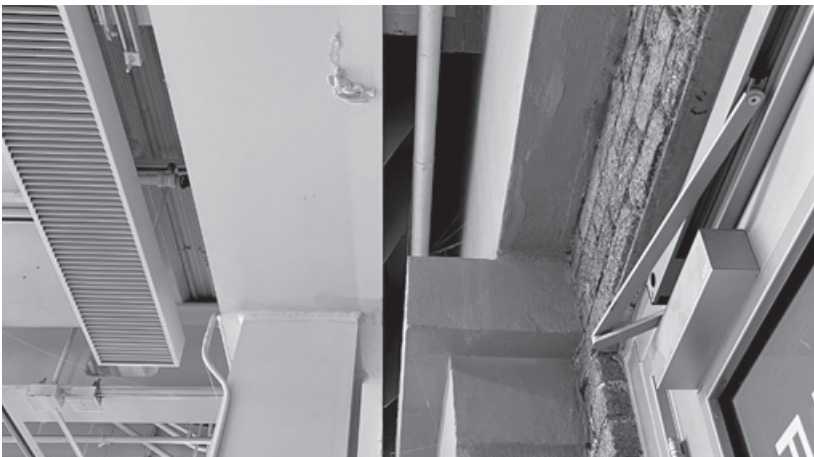
Figure 9.8. Seismic joints between Milstein Hall and Rand Hall create a 5-inch (127 mm) uninsulated gap where the buildings come together.

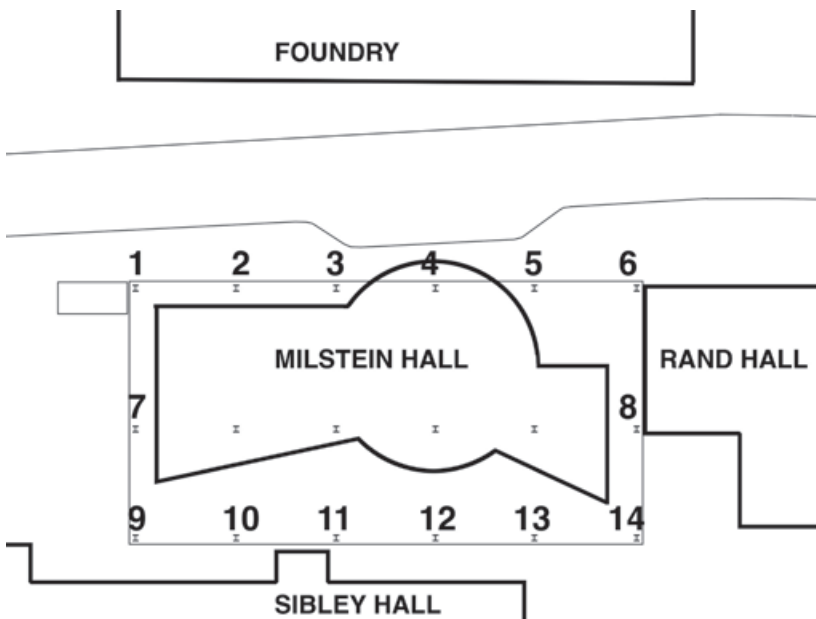
Figure 9.11. This schematic first-floor plan shows all 18 first-floor columns that support the large second-floor plate. Of these 18 columns, only four are within the building enclosure at the first-floor level; 14 are outside and contribute to thermal bridging.

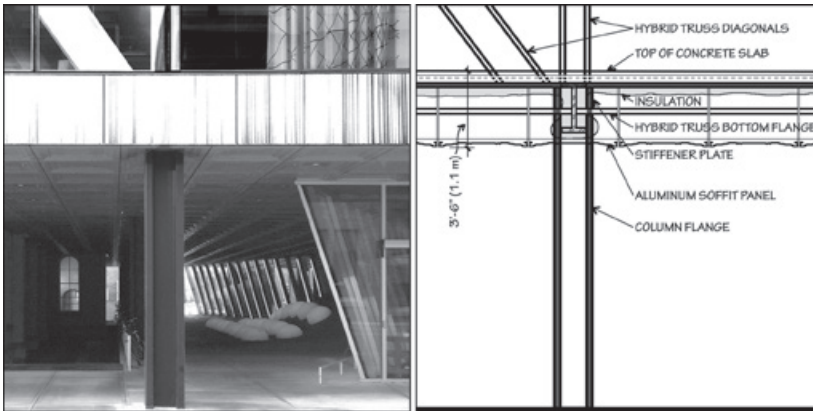
Figure 9.13. Milstein Hall's exterior columns, painted black as if to make them disappear, are all uninsulated (*left*). A schematic section (*right*) shows how the columns, and matching stiffener plates in the bottom chord of the hybrid truss, penetrate the insulation under the second-floor composite steel-concrete deck. Steel flanges that penetrate the insulation, creating a thermal bridge, are shown with a dark tone.

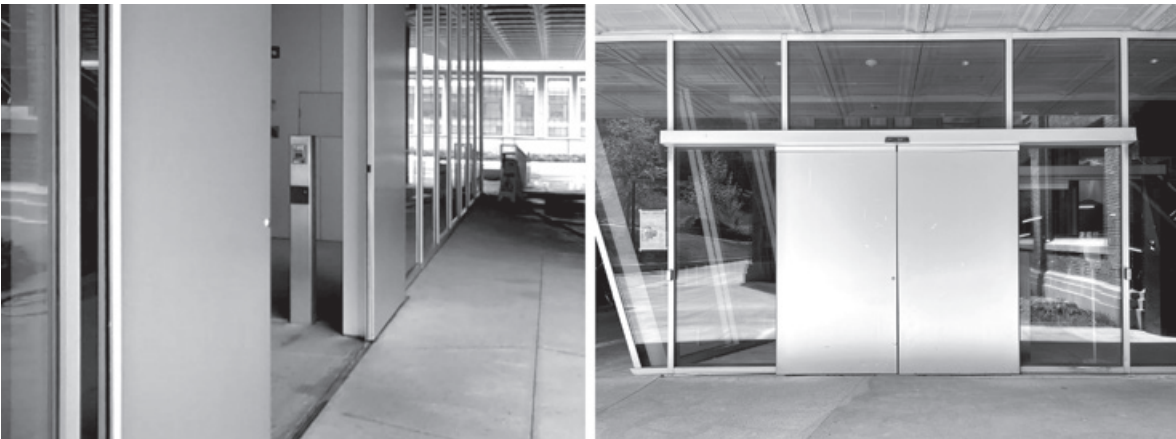
10 RAINWATER CONTROL

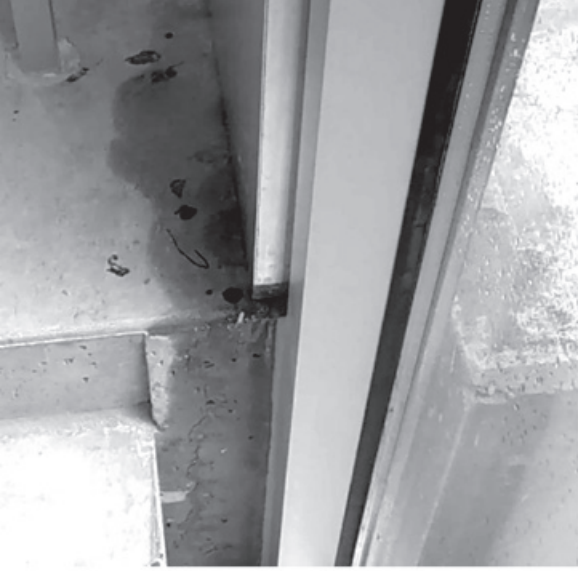
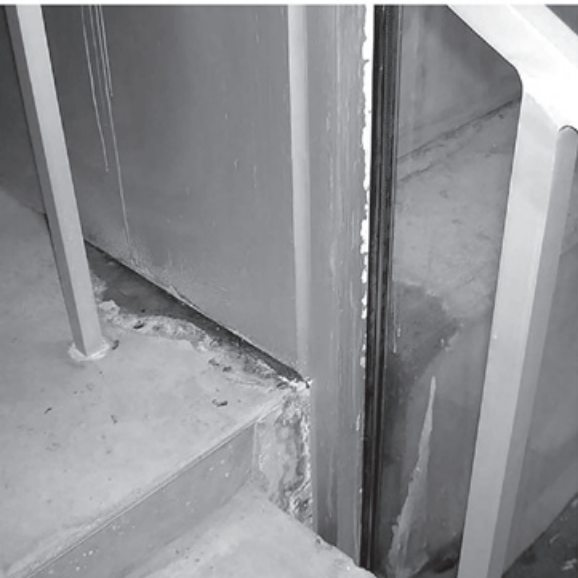
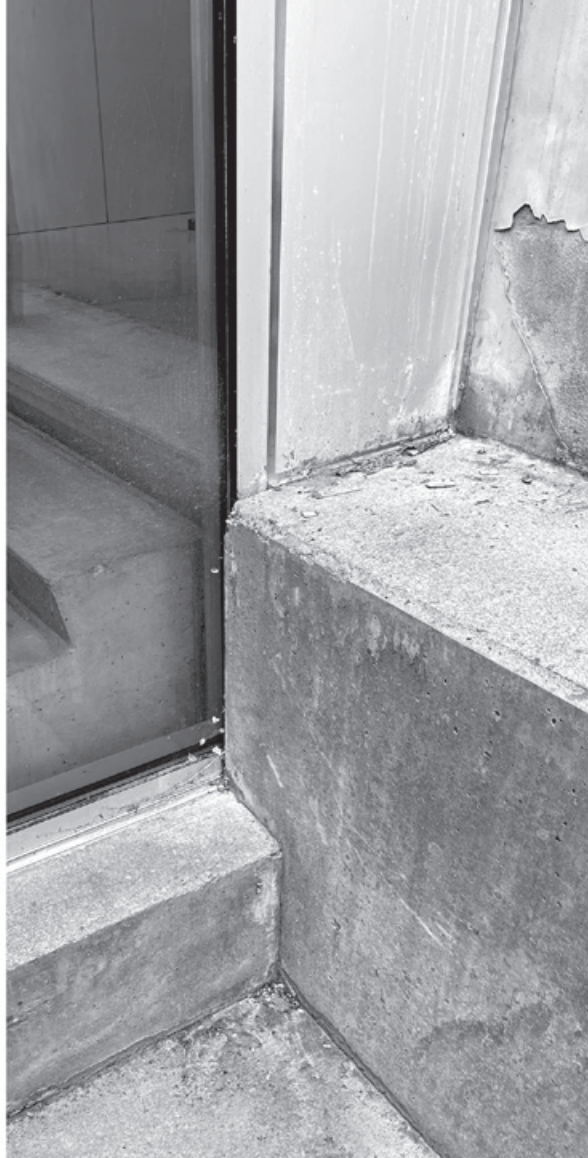
Figure 10.2. The joint between Milstein Hall's stair landing at the basement level, leading into Sibley Hall, leaked initially in September 2011 (*top left*), just before the building was occupied. It leaked again in March 2015 (*bottom left*) at the same location. The complexity of this condition (*right*) is evident in this exterior view, from May 2023: Milstein Hall's concrete stair and landing can be seen through the glazed curtain wall; the landing aligns with a concrete ledge ("seat") covering the foundation of Sibley Hall.

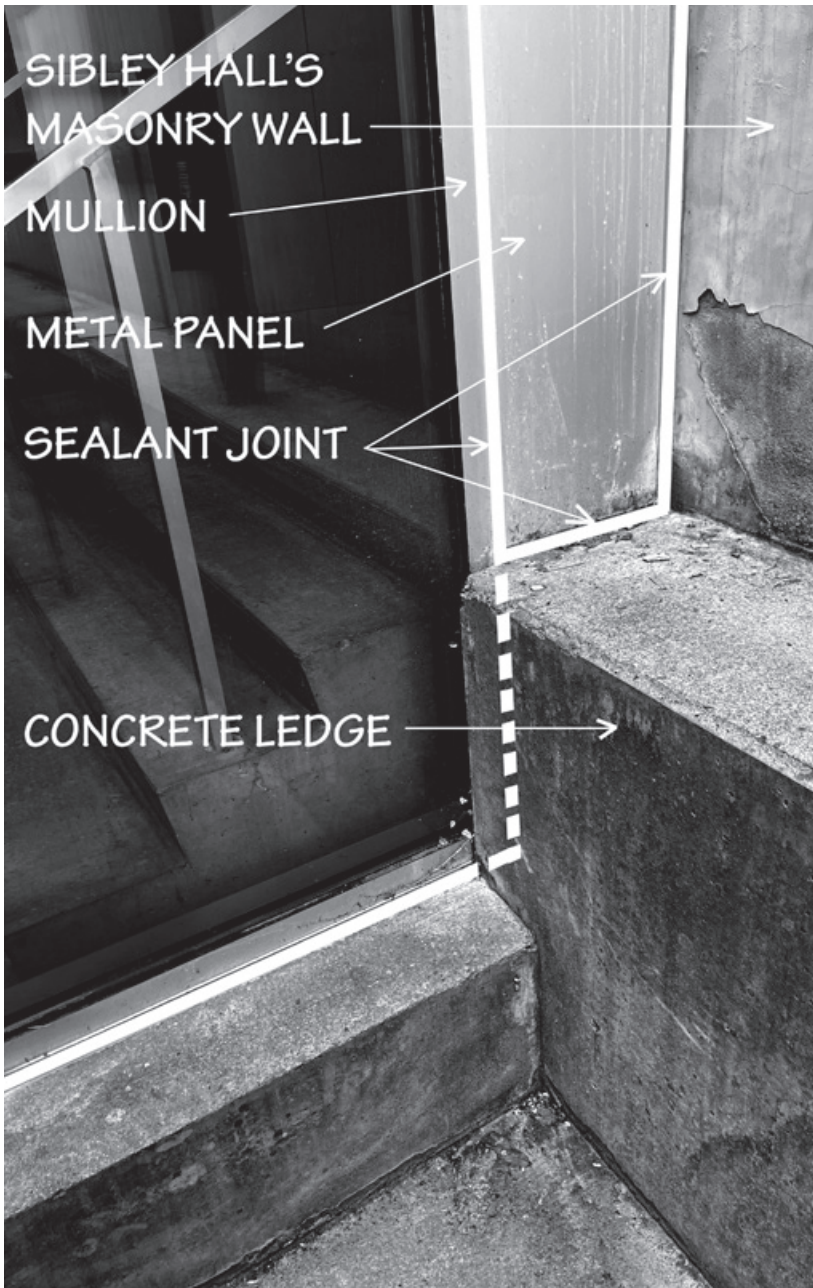
Figure 10.3. Intersection of Milstein and Sibley Halls at basement stair landing, May 2023: trying to create a water control layer by relying on sealant joints, especially at the intersection of concrete or masonry surfaces, is likely to fail.

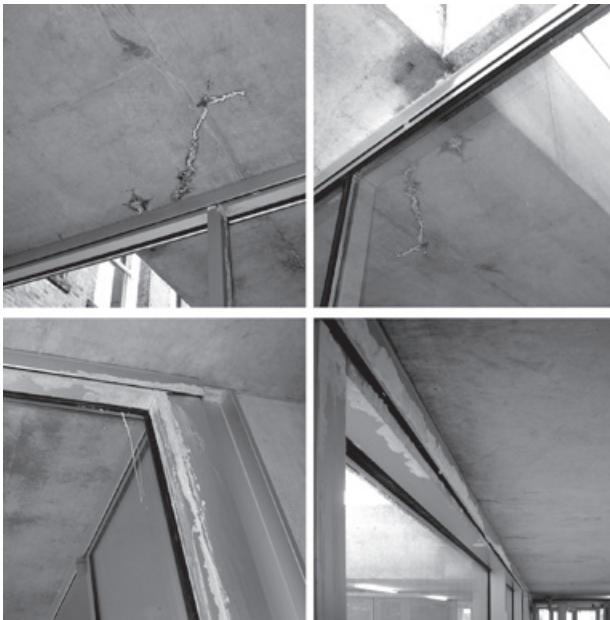
Figure 10.4. Efflorescence in Milstein Hall (July 2013) has occurred where water enters the concrete roof deck, e.g., above the gallery near the loading area, and migrates to interior surfaces, carrying soluble salts.

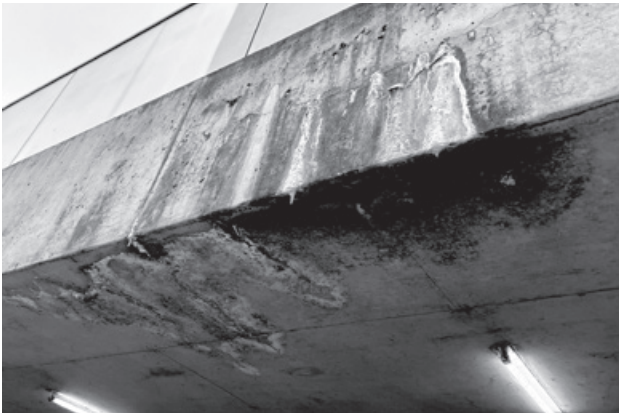
Figure 10.5. Efflorescence can still be seen on the soffit and fascia of the concrete deck supporting the loading area at Milstein Hall, more than a decade after its construction (image taken May 2023). Stalactites, possibly caused by dissolved cement stone, are an indication of a potential structural problem.

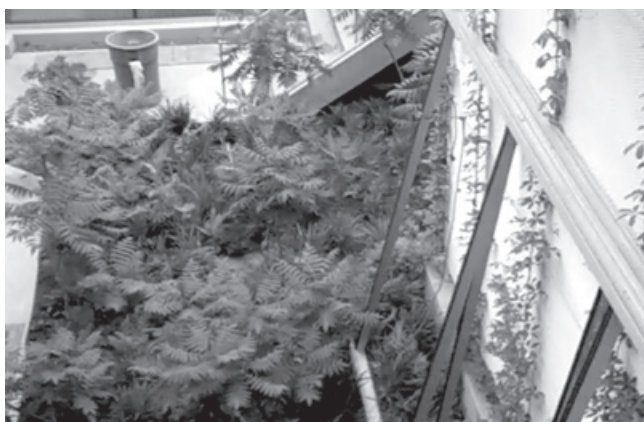
Figure 10.6. Windows and window frames were removed from the Bibliowicz Gallery in Milstein Hall during the summer 2012; aluminum window frames were temporarily stored against the exterior stair tower in the sunken garden; glazing panels were also stored in the garden.

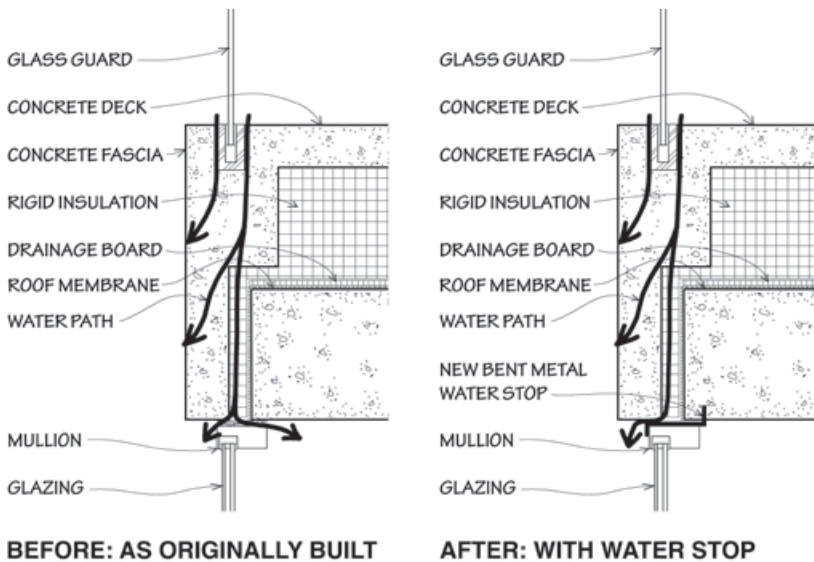
Figure 10.7. Water appears in the gallery in Milstein Hall and causes efflorescence to appear on the fascia and exterior glazing, presumably entering through cracks in the concrete deck, and working its way down to the top of the mullion (*left*); a bent metal water stop was inserted above the mullion, in 2012, to direct water reaching the mullion to the exterior (*right*). In these schematic sections, based on Milstein Hall working drawings, a second drainage board, that seems to have been installed above the insulation, is not shown.

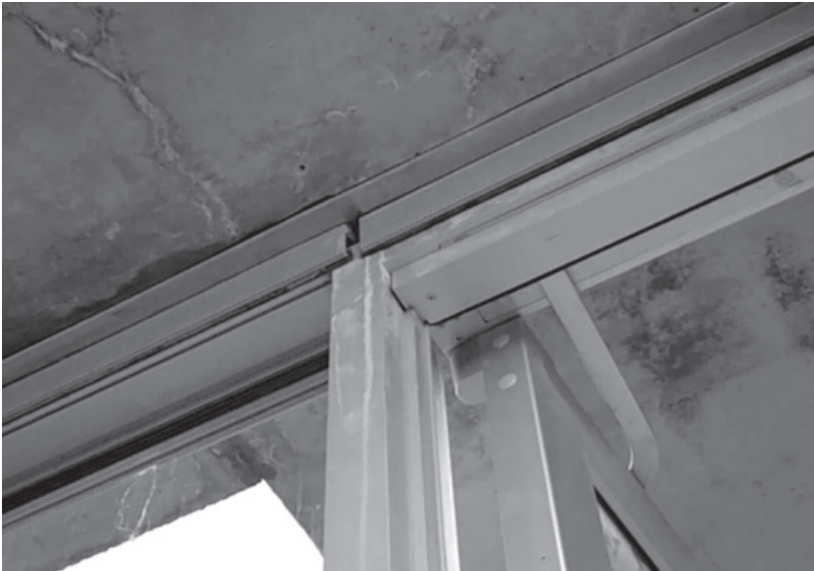
Figure 10.8. Water stains and efflorescence are still visible after a bent metal water stop was inserted into a kerf cut into the concrete ceiling of the Bibliowicz Gallery at Milstein Hall in 2012.

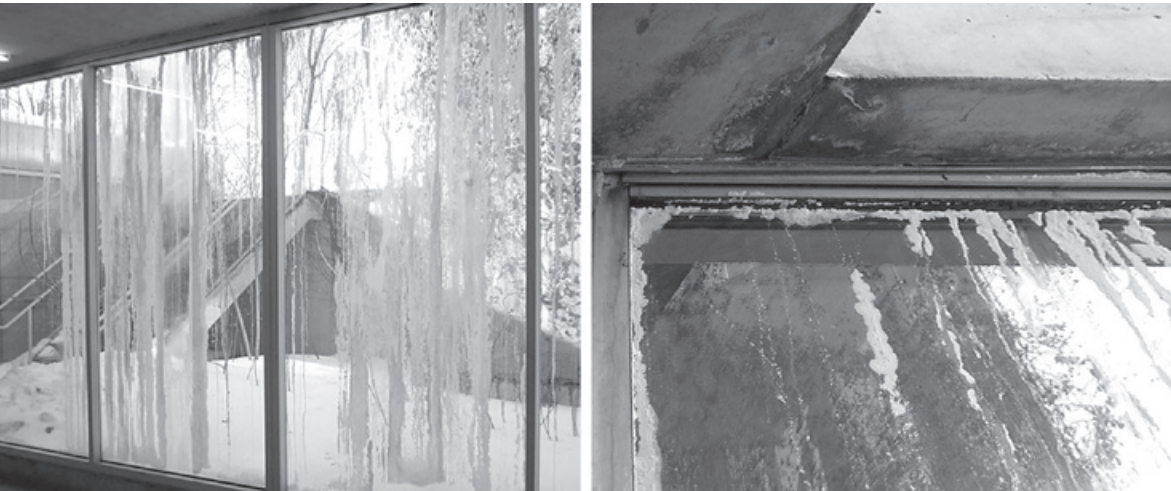
Of these six guidelines, only one was correctly implemented in Milstein Hall—the fourth one requiring insulation above the roof membrane with drainage mats above and below the insulation.⁸ A series of images screen-captured from my low-resolution video clips, part of my online critique of Milstein Hall,⁹ shows a roof membrane, drainage mats, and insulation being placed above a perfectly flat structural slab; after that, a topping slab—also perfectly flat—is placed above the insulation and drainage mat (fig. 10.10).

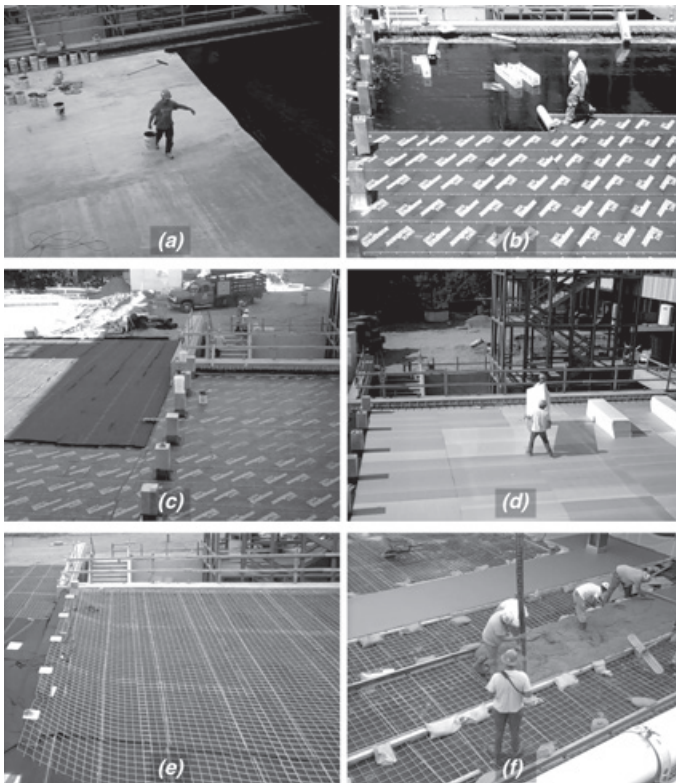
Figure 10.10. The plaza roof deck at Milstein Hall was constructed over a perfectly flat structural slab. All subsequent layers were also perfectly flat: (a) initially, some sort of mastic or primer was applied to the structural concrete slab; (b) next, a waterproof membrane was rolled out over the primer/mastic; (c) a drainage mat came next; (d) then three layers of rigid insulation were placed over the drainage mat; (e) a second drainage mat was placed over the insulation, along with welded wire mesh reinforcement for (f) the final perfectly flat layer, a concrete topping slab.

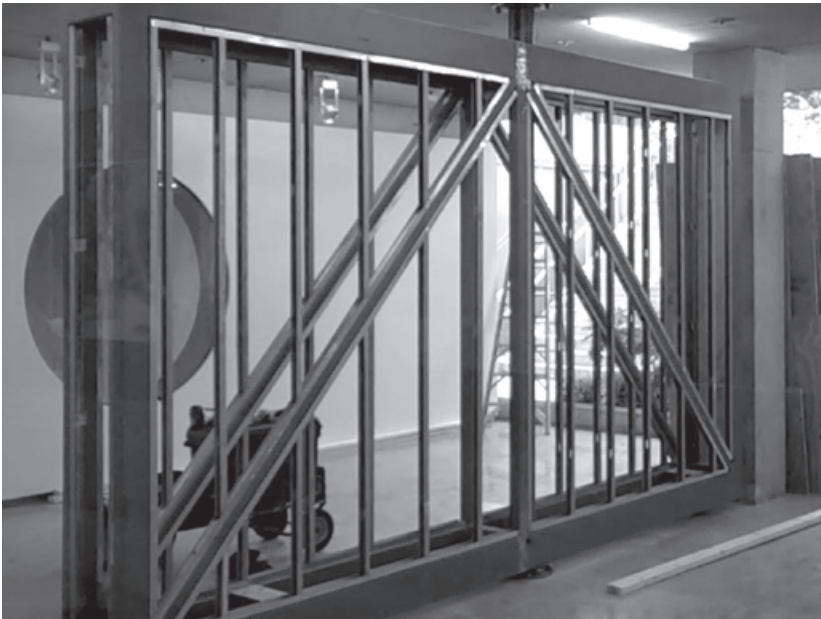
Figure 10.11. The rotating wall in Milstein Hall's Bibliowicz Gallery was taken apart and reconstructed, shown here with the wall finishes removed in the summer of 2012, possibly because of damage caused by excessive deflections in the concrete slab above.

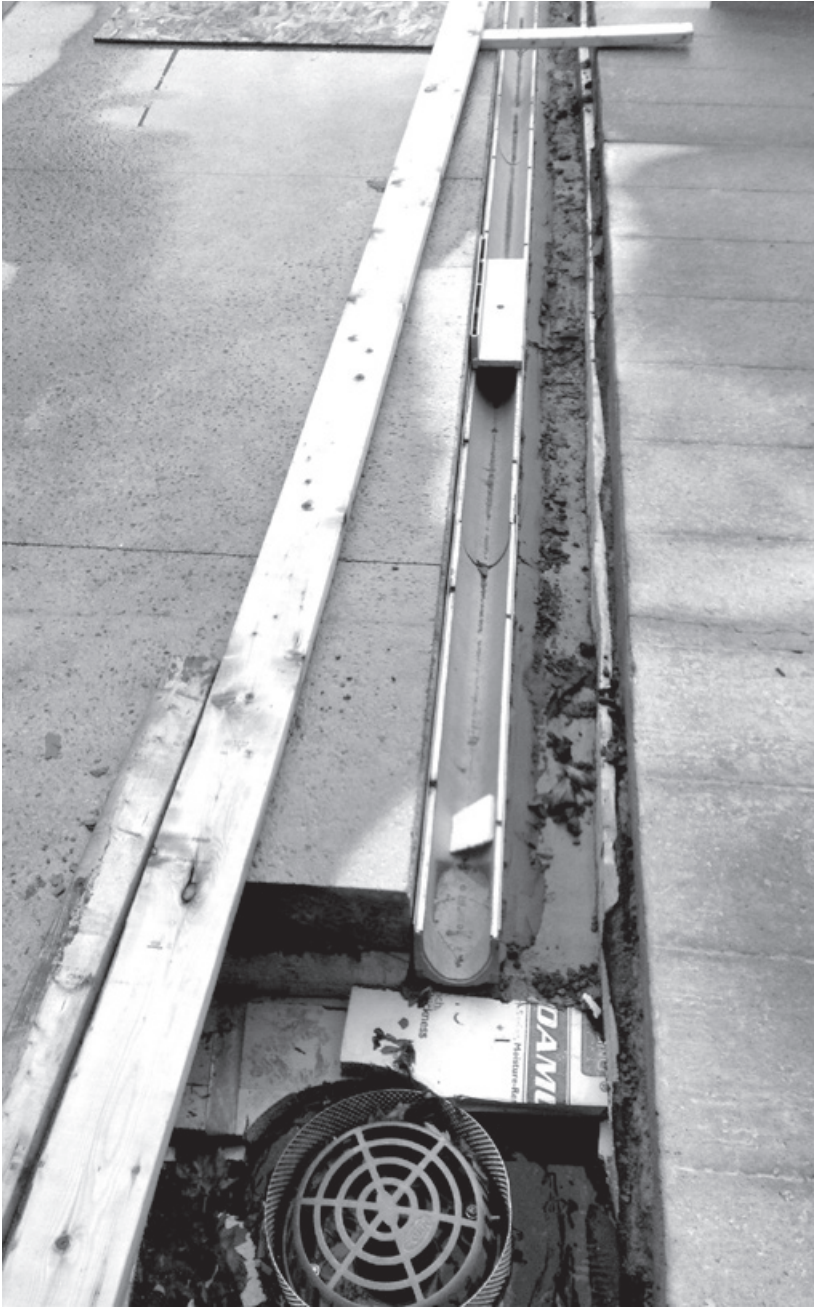
Figure 10.13. The topping slab of Milstein Hall's plaza deck was cut at the approximate low point and most of the rigid insulation was removed to accommodate a linear channel, sloping to a new drain.
