OMA'S MILSTEIN HALL

A CASE STUDY OF ARCHITECTURAL FAILURE

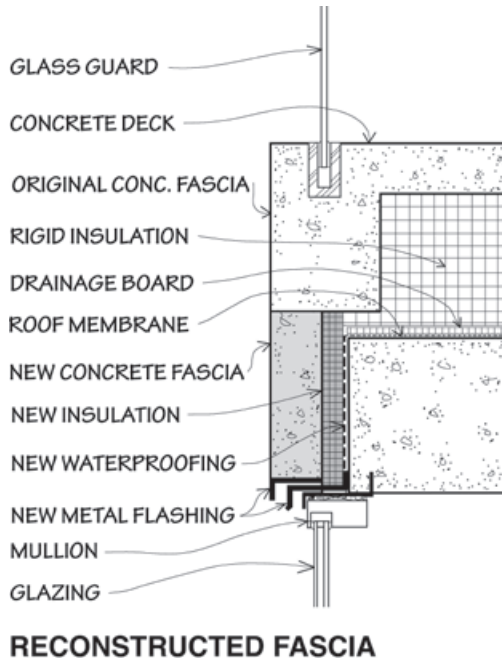
Figure 10.16. The second gallery reconstruction, in 2015, removed and replaced much of the concrete fascia, installed new waterproofing and insulation behind the new fascia panel, and placed two pieces of metal flashing above the bent metal water stop that had been inserted into the concrete ceiling above the mullion in 2012. Water entering the slab from the deck above and working its way down to the mullion will now be directed between the two pieces of flashing to the exterior. This is a speculative and schematic section based on my observations of the reconstruction that occurred in 2015.

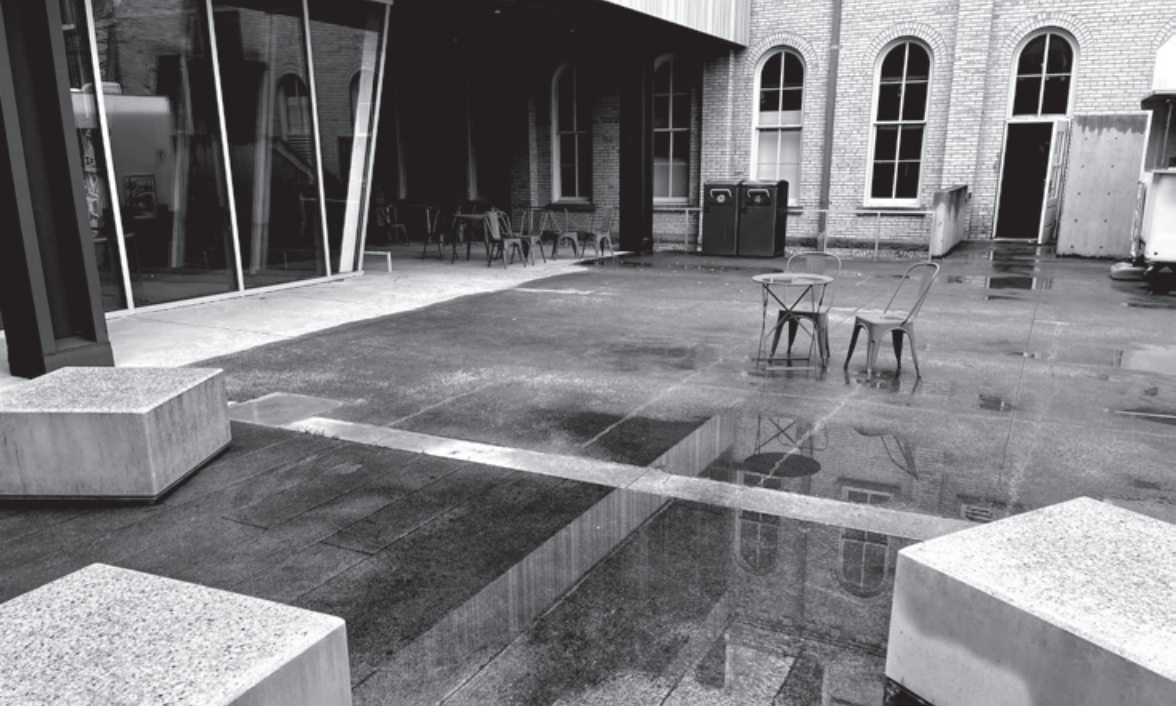
Figure 10.17. Puddles still form, and remain, on the Milstein Hall plaza because the slope caused by the slab's unintended deflection does not create a consistent low point that aligns with the position of the linear drain that was added later, visible in the middle of the image.

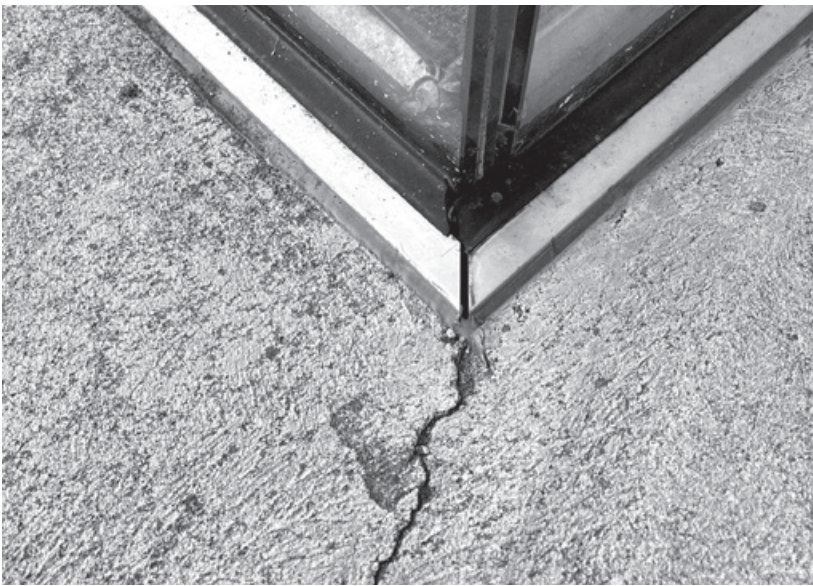
Figure 10.18. Water can enter the concrete slab of the plaza deck through cracks in the concrete and openings in the glass guard inserts around the sunken garden, above the below-grade gallery. (Image taken May 2023.)

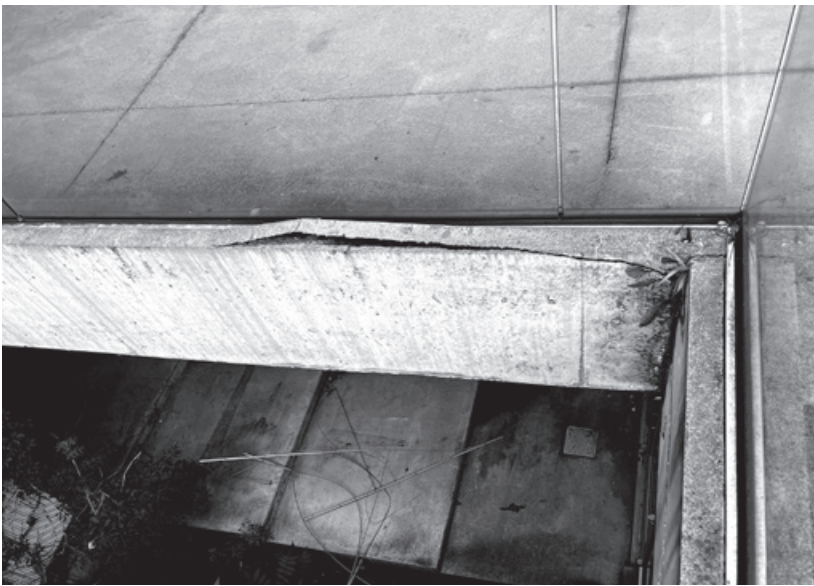
Figure 10.19. Even after substantial renovation of the gallery fascia and plaza deck in 2015, major spalling of concrete is occurring at the fascia-deck intersection. (Image taken July 2023.)

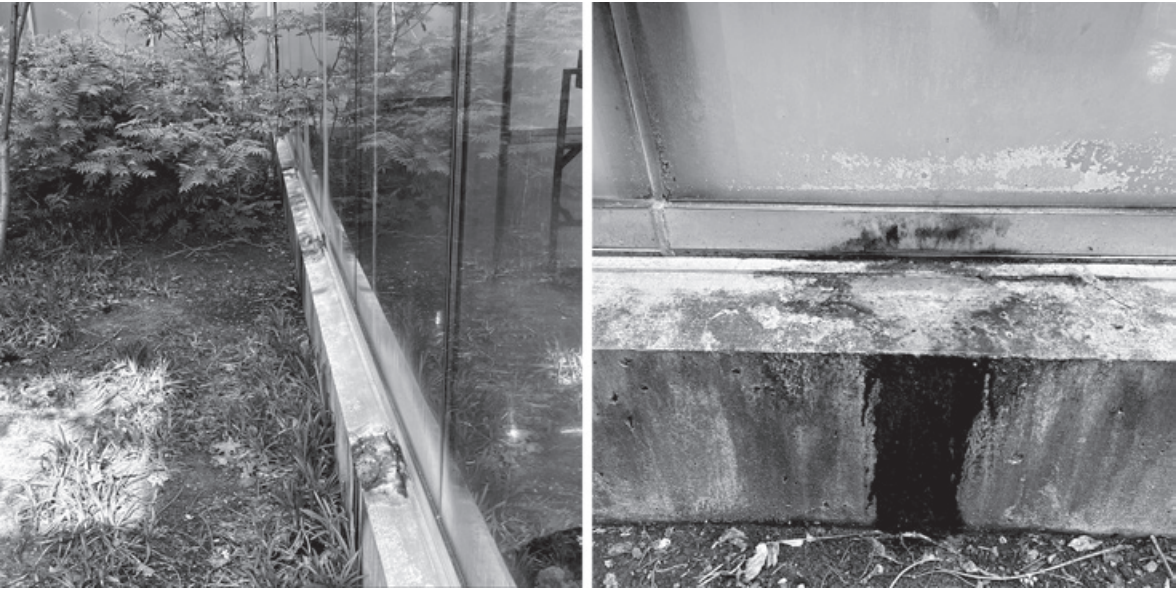
Figure 10.20. Water also picks up some rather nasty artifacts as it enters the concrete, passes through both intended and unintended channels, and drips down to the gallery sill below. (Image taken May 2023.)

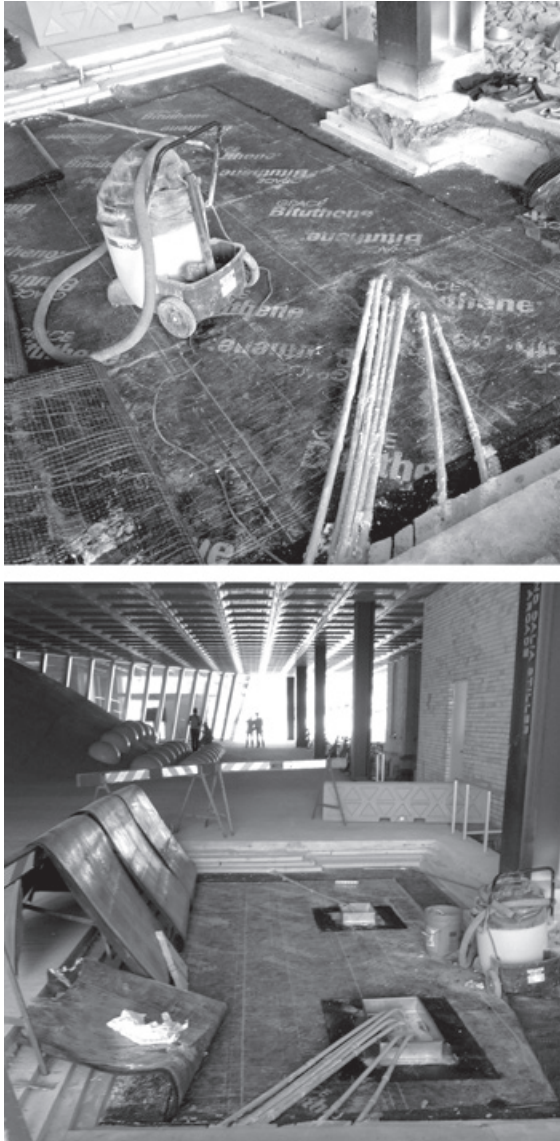
Figure 10.21. Electrical conduits are cast into the roof deck concrete slab under Milstein Hall's arcade; once over the basement electrical room, they penetrate through the structural concrete slab below the topping slab with only nominal attention to waterproofing, providing a pathway for rainwater to enter the electrical room (*top*). To repair this condition, the concrete topping slab, insulation, and drainage mats were removed so that metal "dams" could be placed around the areas where conduit penetrations occur (*bottom*). The drainage mats and insulation were then re-installed, and new concrete was cast to repair the topping slab.

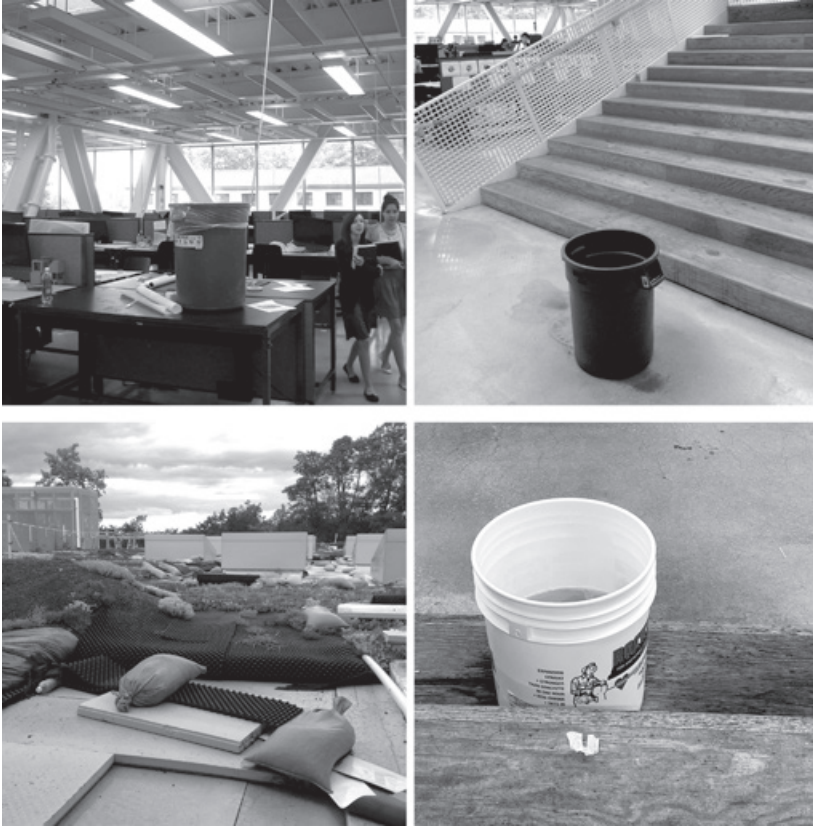
Figure 10.22. Trash cans appeared in Milstein Hall's cantilevered second floor design studios soon after the building was occupied in 2011, placed strategically to catch rainwater leaks from the vegetated roof above (*top left*), both through skylights and at the intersection of Rand Hall and Milstein Hall. Leaks continued in 2015 (*top right*), triggering a major roof repair that lasted for at least two years (*bottom left*), during which time sedums, engineered soil medium, insulation, drainage mats, and protection layers were removed and stockpiled elsewhere on the roof. This major repair also proved unsuccessful, as leaks continued in some of the same places during the fall of 2022—at the stepped auditorium (*bottom right*) and at the intersection of Rand Hall and Milstein Hall (not shown).

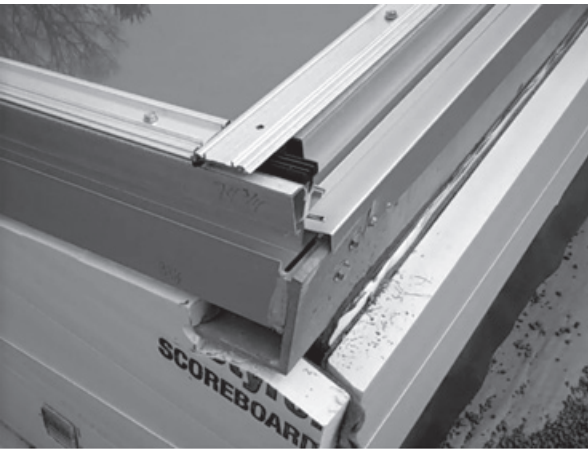
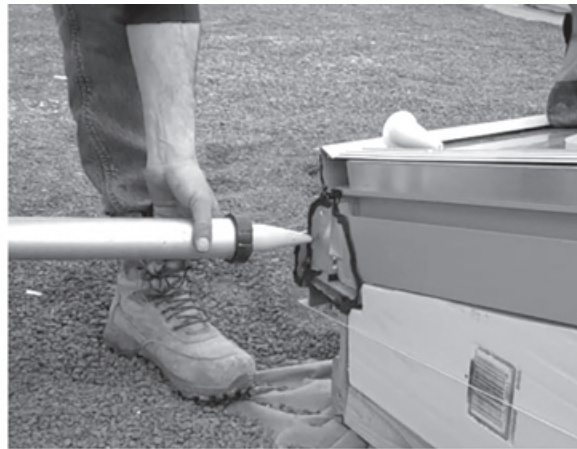
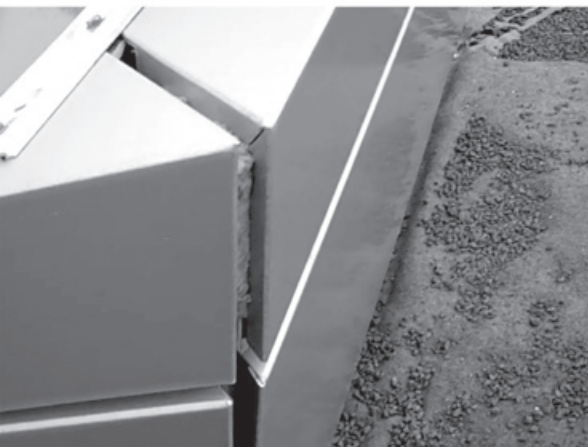
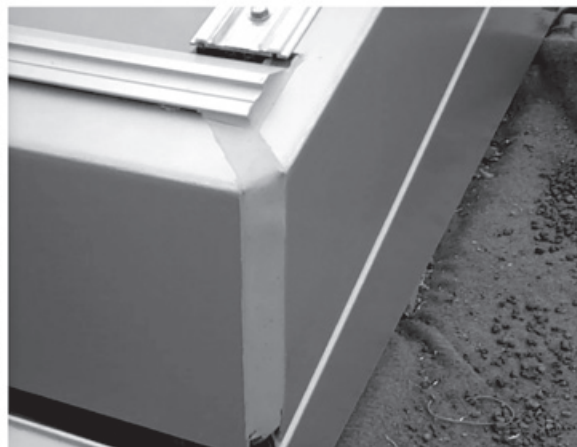
At the intersection of Rand Hall and Milstein Hall, the seismic joint between the two buildings relies on reglets—minimal saw-cut openings in the horizontal brick mortar joints of Rand Hall—that not only are unreliable because water can penetrate around such flashing through cracks between mortar and brick (fig. 10.24), but especially because, in this case, the reglet and flashing need to negotiate tricky geometries where brick protrudes to cover Rand Hall's steel columns (fig. 10.25). This is a complex three-dimensional condition that is represented in the Milstein Hall working drawings as a simple two-dimensional section, as if the reglet flashing—even if it *were* effective in its two-dimensional incarnation, something far from certain—could somehow be fashioned into this more complex three-dimensional form based solely on the goodwill and expertise of the installers.

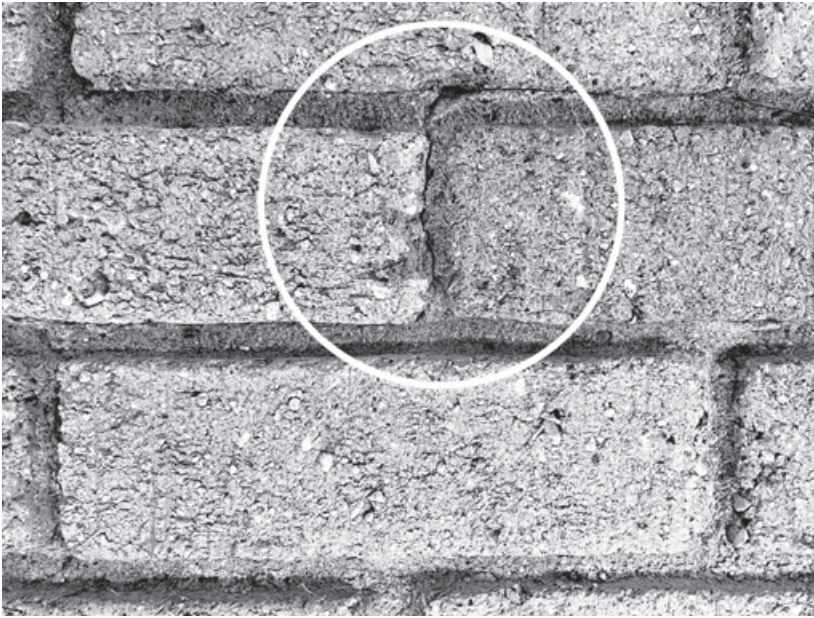
Figure 10.24. This detail of Rand Hall's facade shows a typical crack between brick and mortar through which water can enter the wall, bypassing flashing in saw-cut reglets.

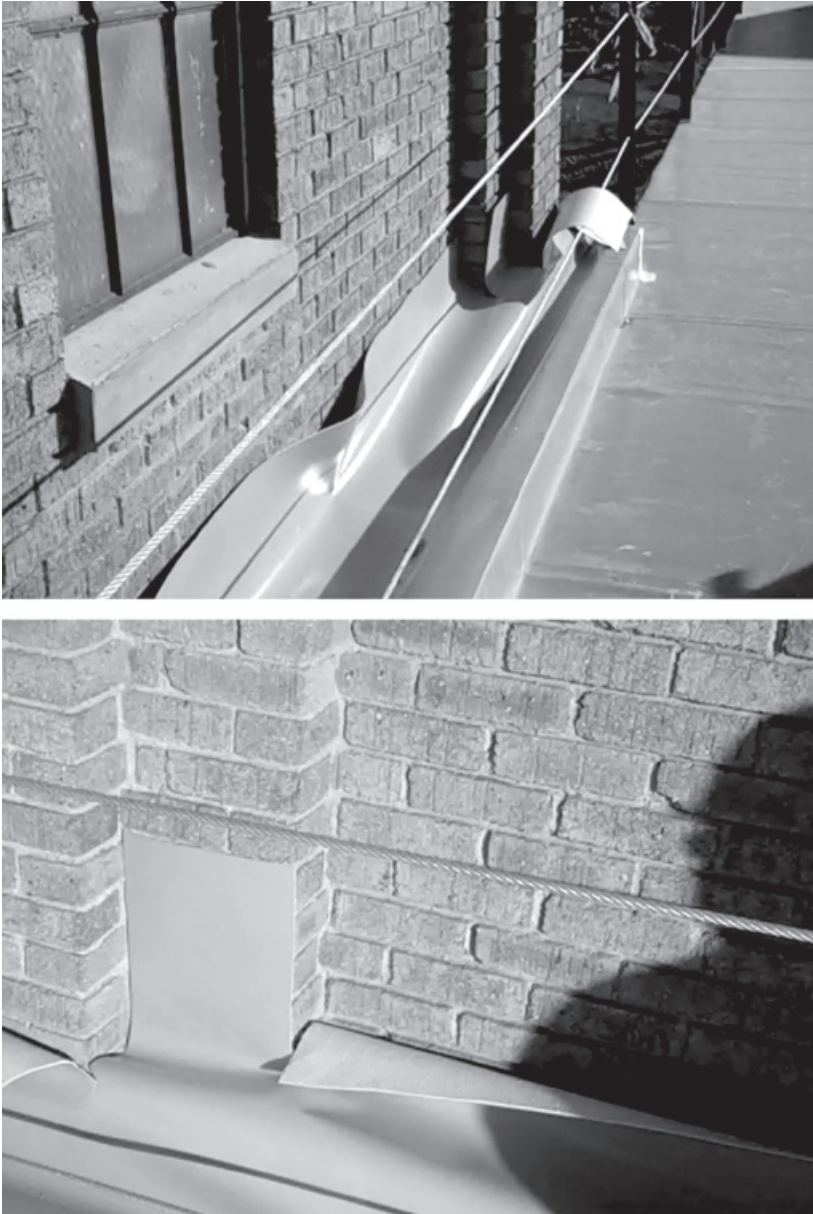
Figure 10.25. The intersection of Milstein Hall's roof with the brick cladding of Rand Hall was sealed with a seismic joint, similar to the joint at Sibley Hall illustrated schematically in Figure 9.6. Here, Milstein Hall's PVC roof membrane is shown prior to the creation of a reglet in the brick wall and the completion of a seismic joint (*top*) and at the challenging geometry where brick protrudes to cover Rand Hall's steel columns (*bottom*).

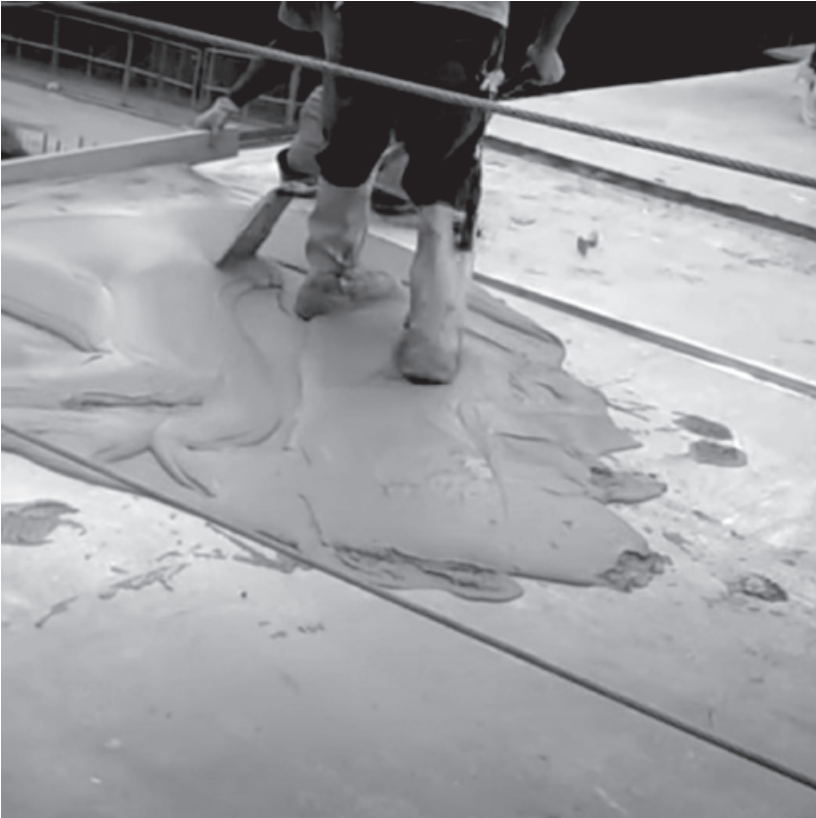
Figure 10.27. Milstein Hall's topping slab is shown being poured over the flat structural slab. The wooden guide for the screed has almost no inclination and certainly not a two-percent slope.

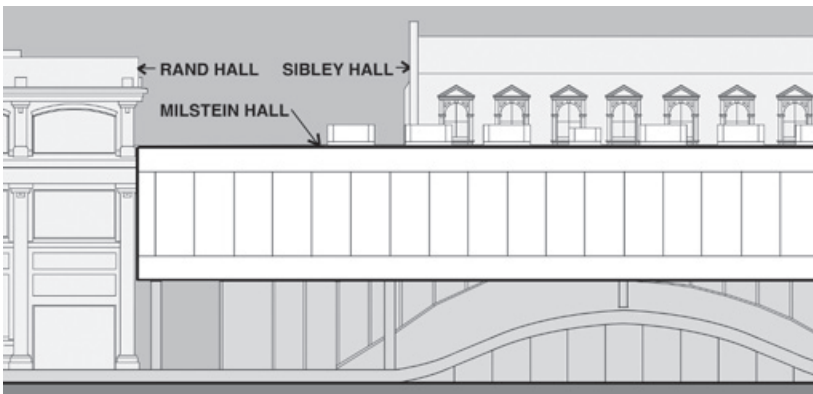
Figure 10.28. The second floor of Milstein Hall needed to be high enough to align with (and connect to) the second floors of Sibley Hall and Rand Hall, while the roof of Milstein Hall needed to be low enough so that it would fit under the existing third-floor windows of Sibley Hall.

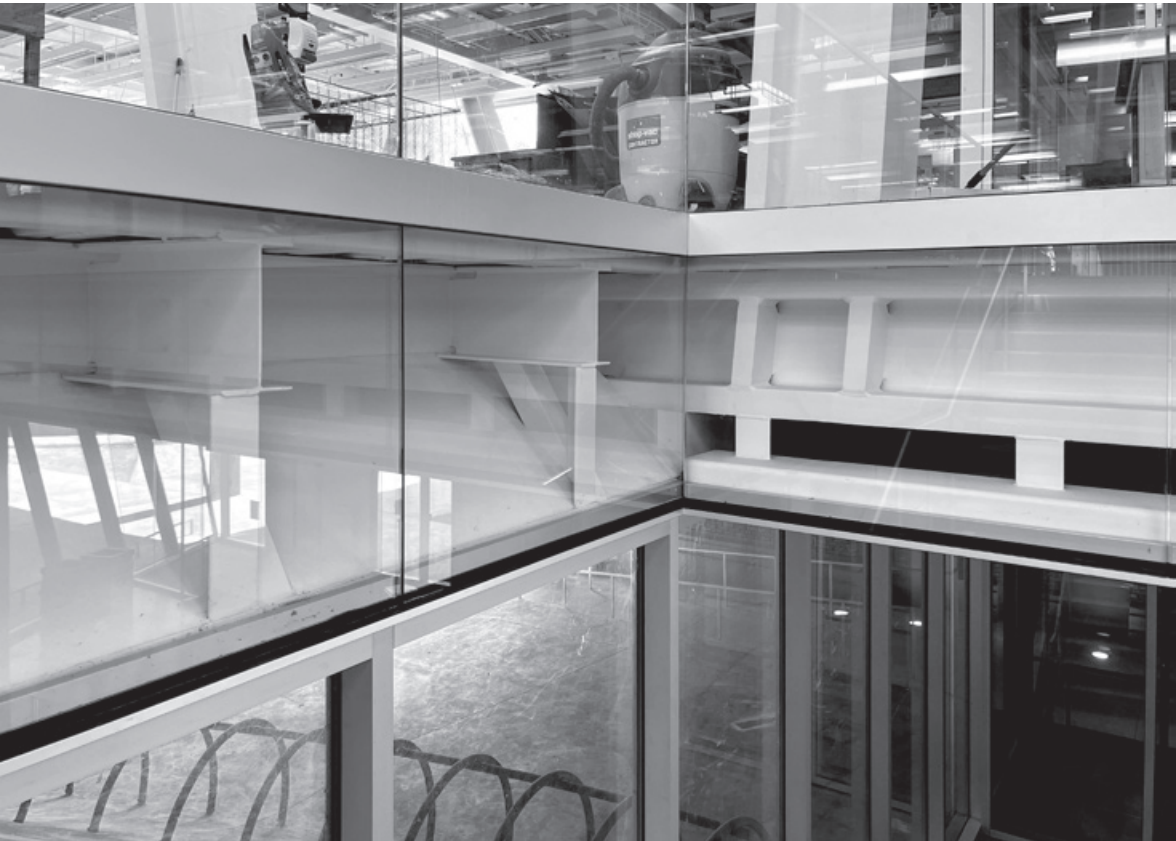
Figure 11.1. Glass panels at the second-floor stair opening create what amounts to a structural display case.

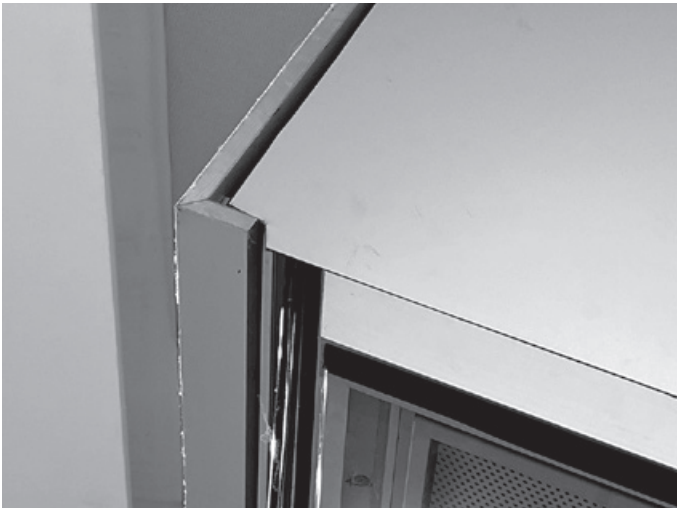
Figure 11.3. Metal panels come together awkwardly at the angled enclosure providing an entrance from second-floor studios to the auditorium below.

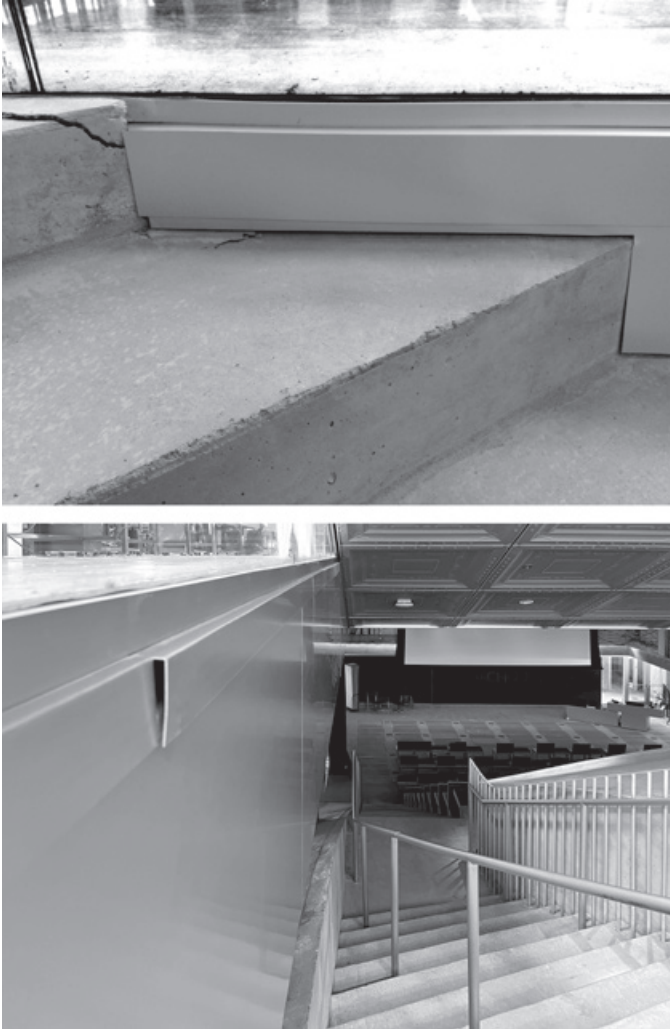
Figure 11.4. Metal trim creates an awkward transition between the Miesian “box” of the second floor and the concrete “blob” that includes auditorium stairs.

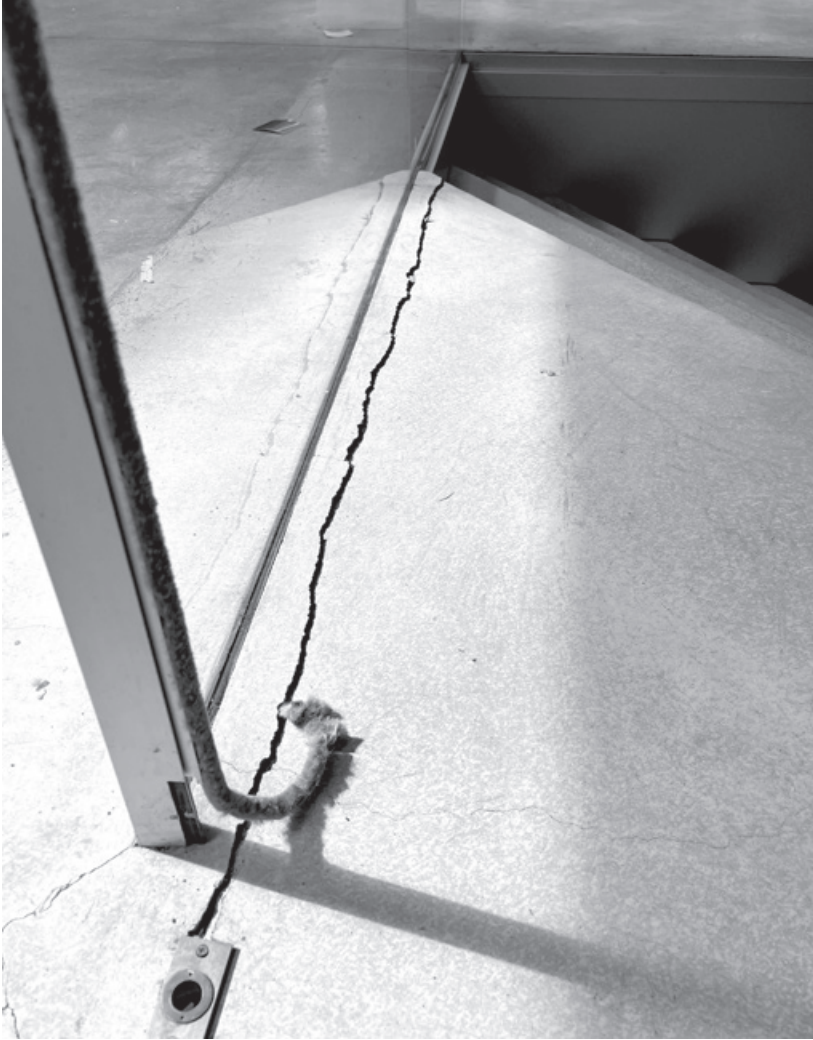
Figure 11.5. Major concrete slab cracking has occurred at the second-floor entrance to the Milstein Hall auditorium; the acoustic seal for the sliding door is also falling apart.

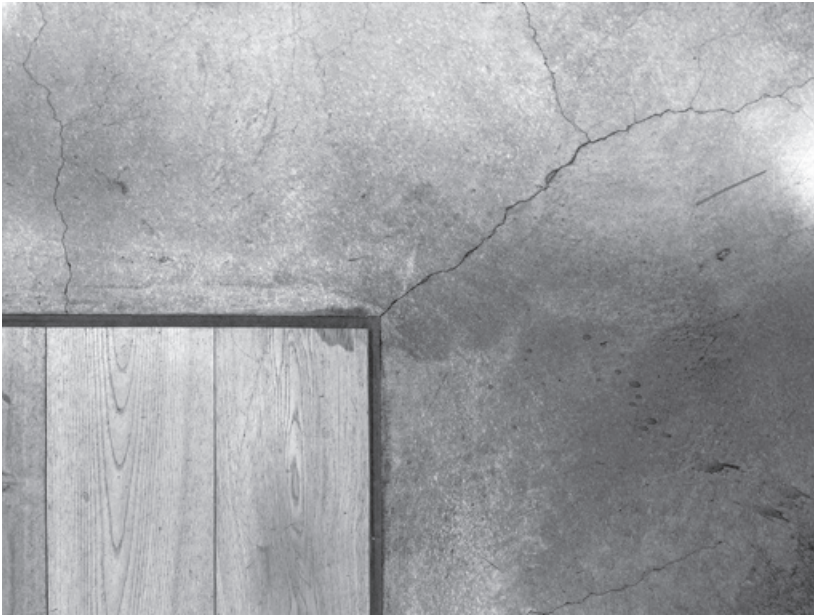
Figure 11.10. Cracks have proliferated throughout the topping slab on the second floor of Milstein Hall; especially at corners—here, where the wood floor area meets the concrete.

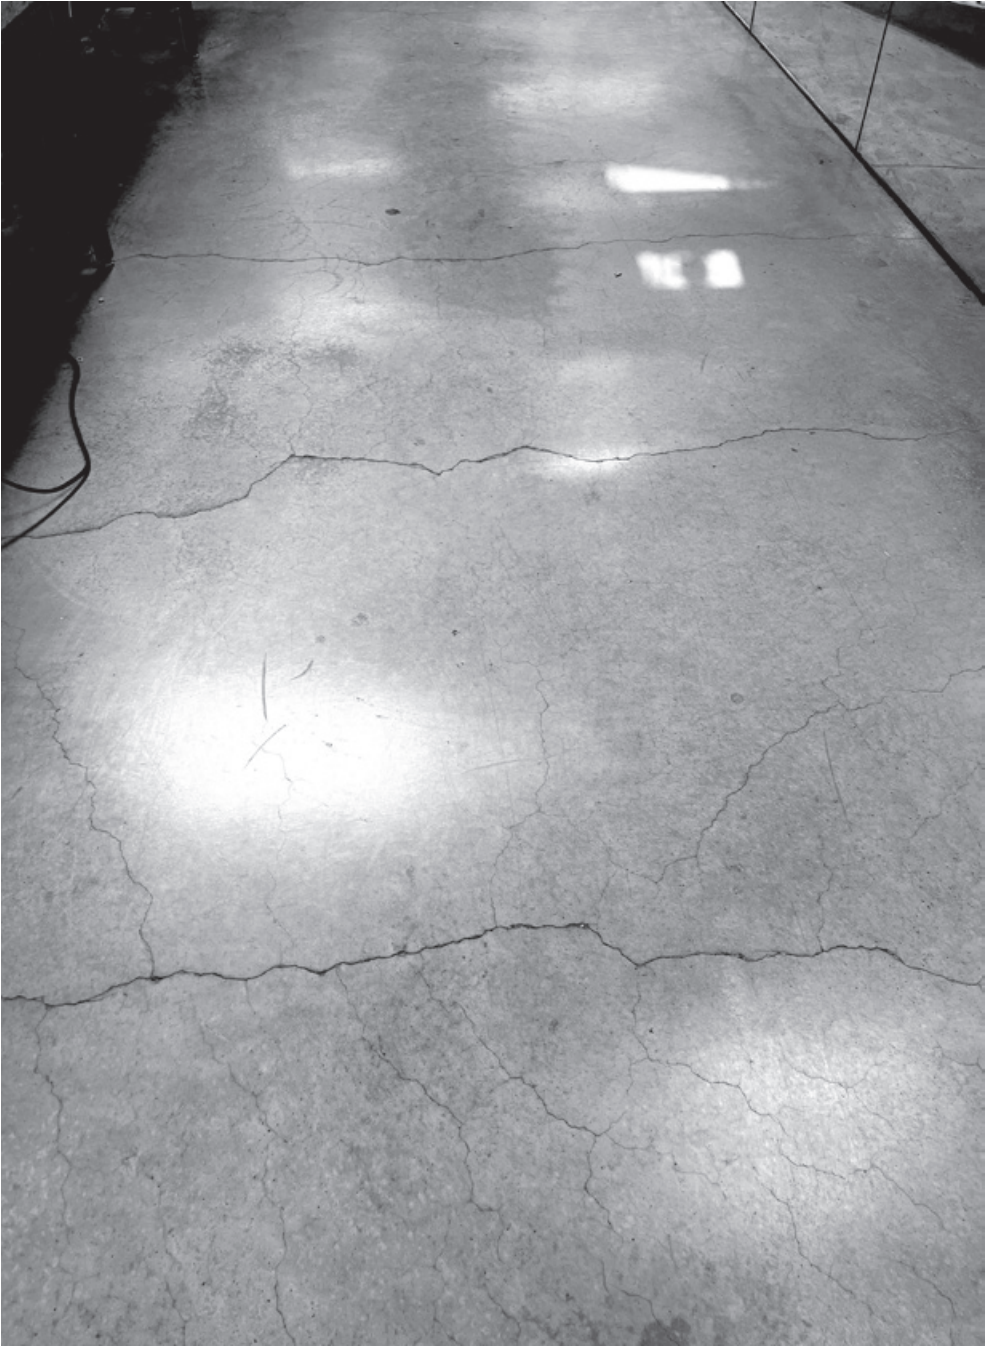
Figure 11.11. Cracks appear not only at re-entrant corners of Milstein Hall's second-floor slab, but also throughout the general field.

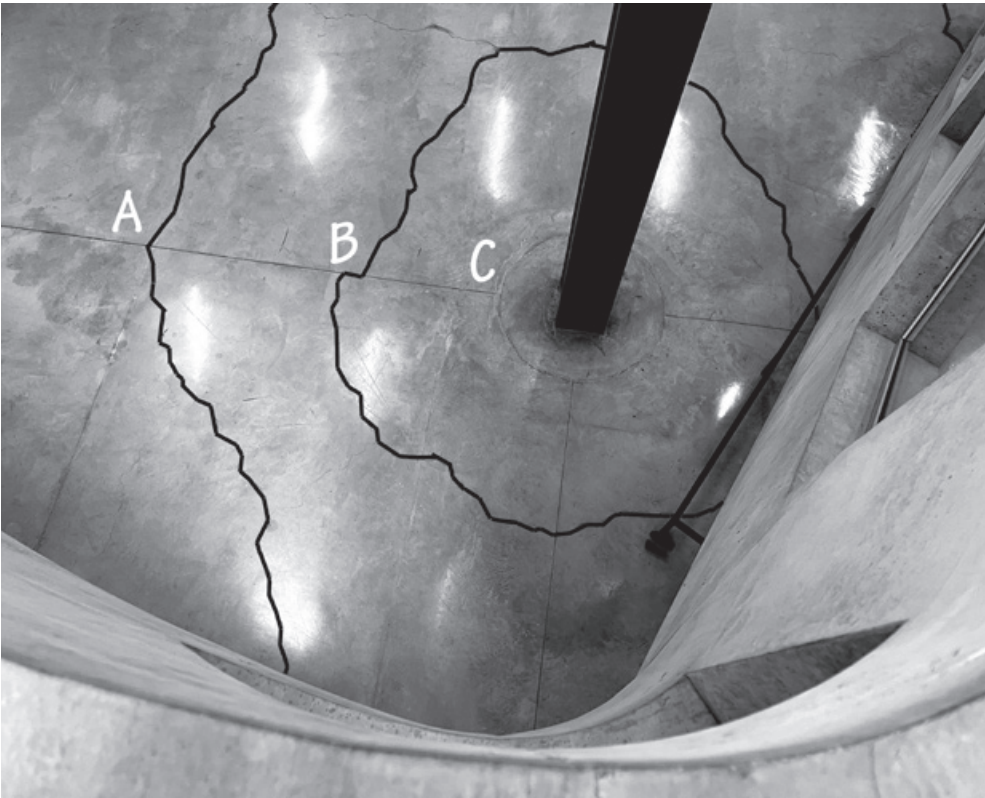
Figure 11.12. Concrete slab-on-ground cracks have occurred, not only in the general field, but especially around columns where control joints were not correctly detailed or constructed. Concentric cracks around a column in the Crit Room have been highlighted at *A* and *B*, while neither the “aesthetic” circular control joint around the column at *C*, nor the orthogonal grid of saw-cut control joints aligning with the centerline of the columns, proved effective at controlling cracks.

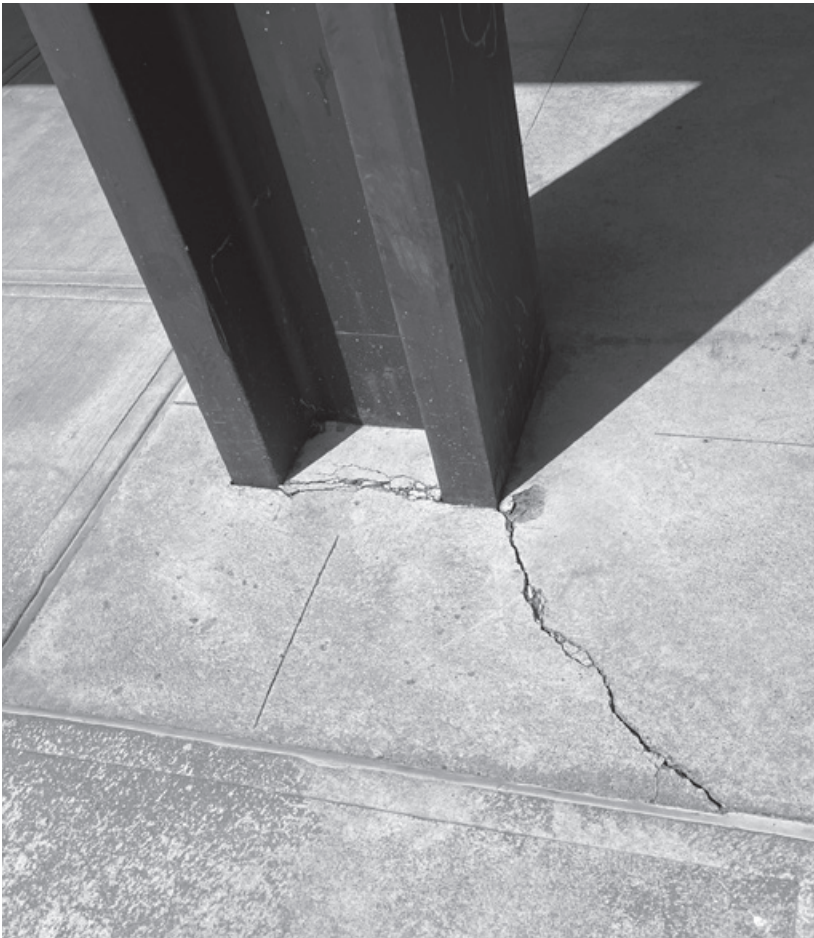
Figure 11.13. With no isolation joints at exterior columns, slab cracking is fairly predictable.

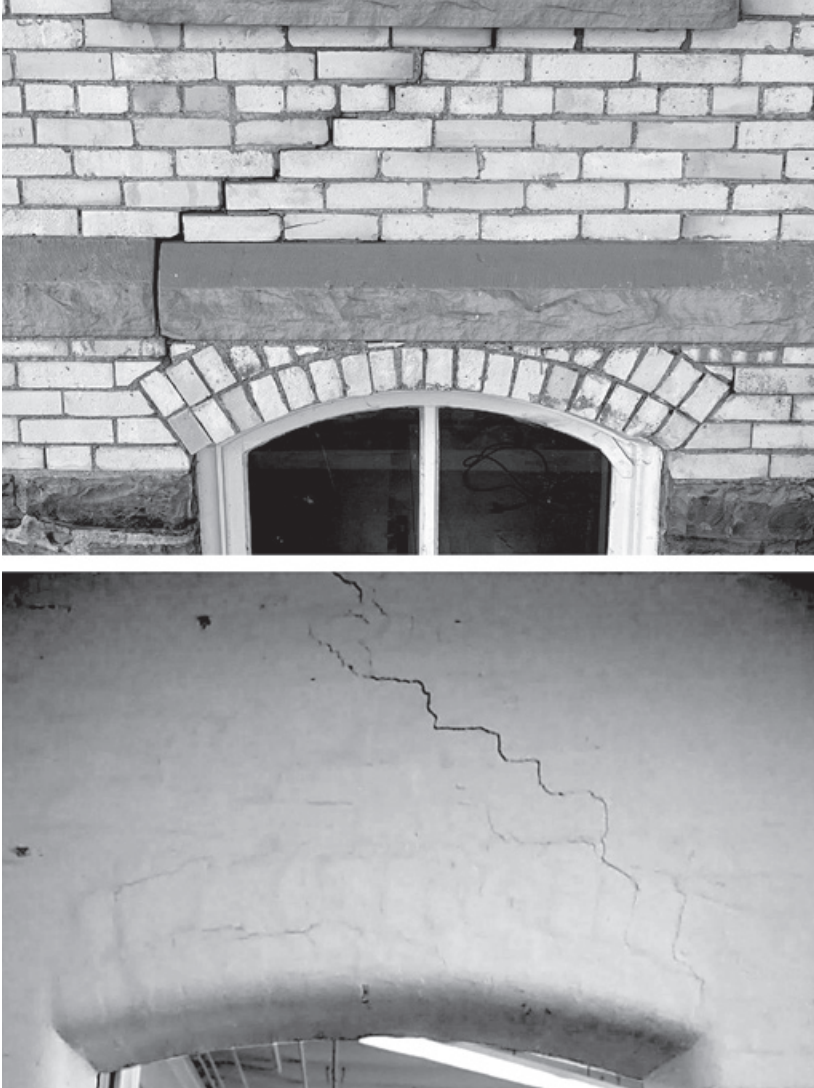
Figure 11.14. Cracking in the brick walls of Sibley Hall occurred after the foundations of Sibley Hall were underpinned and the Milstein Hall site was excavated.

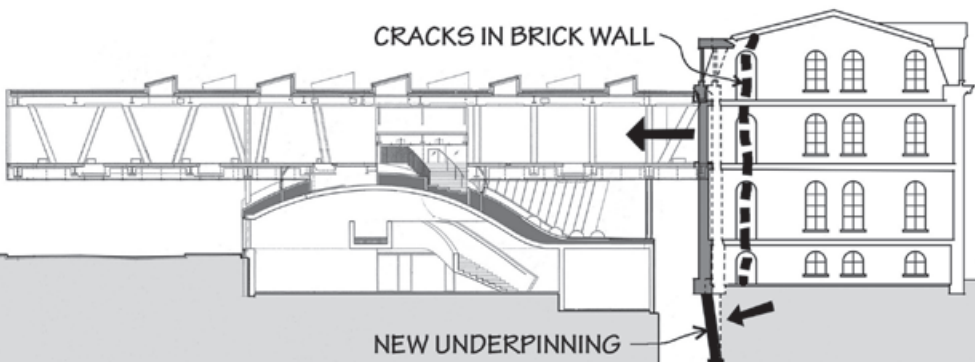
Retaining wall displacement

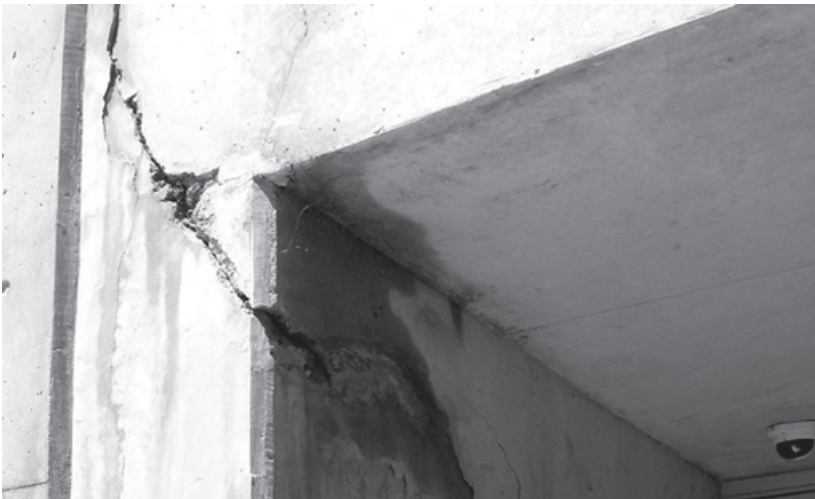
Figure 11.17. A large crack appeared in Milstein Hall’s basement-foundation wall immediately adjacent to the concrete retaining wall to its left, shown here in 2013.

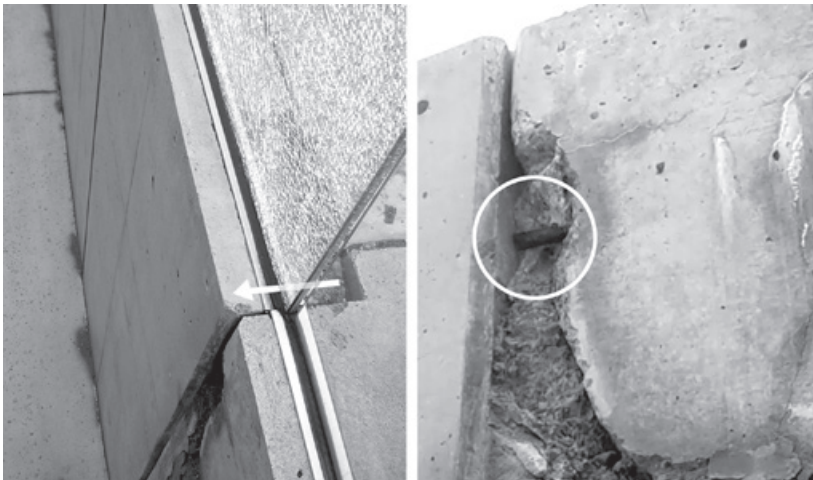
Figure 11.18. The glass guard panel between Milstein Hall's loading area and the accessible ramp from the parking lot (*left*), shown here in 2015, can be seen spanning over the joint between the displaced retaining wall and the building; spalling of the concrete could also have been triggered by corrosion of reinforcement, visible in the highlighted circle, placed between the retaining wall and the building (*right*).

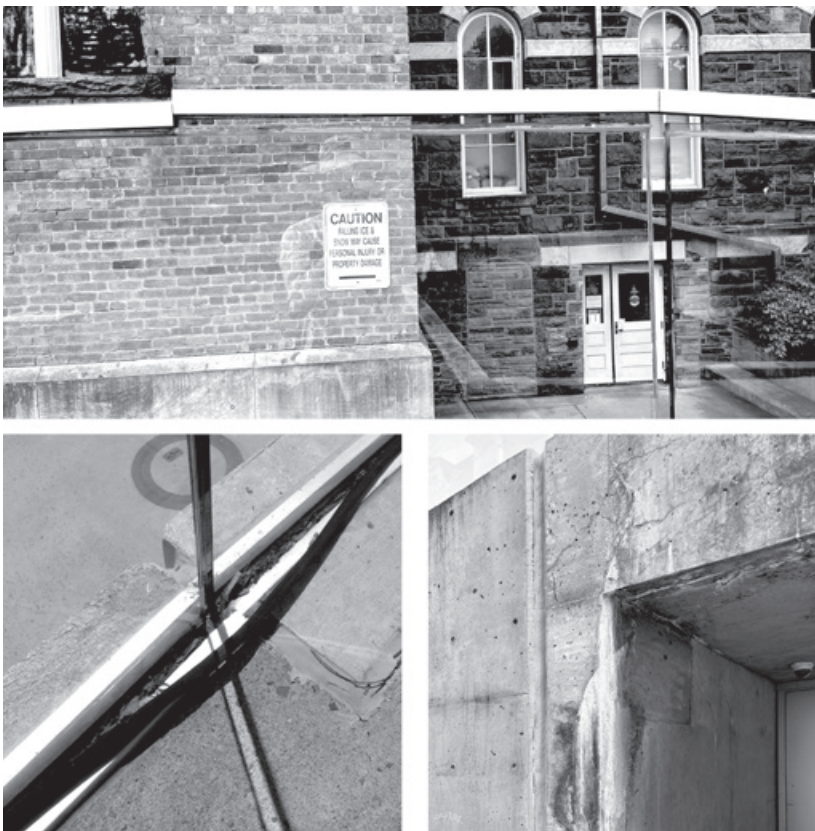
Figure 11.19. The glass guard panel between Milstein Hall's loading area and the accessible ramp from the parking lot, shown here with displaced trim in 2023 (*top*), a detached gasket in 2018 (*bottom left*), and continued efflorescence in 2023 (*bottom right*).

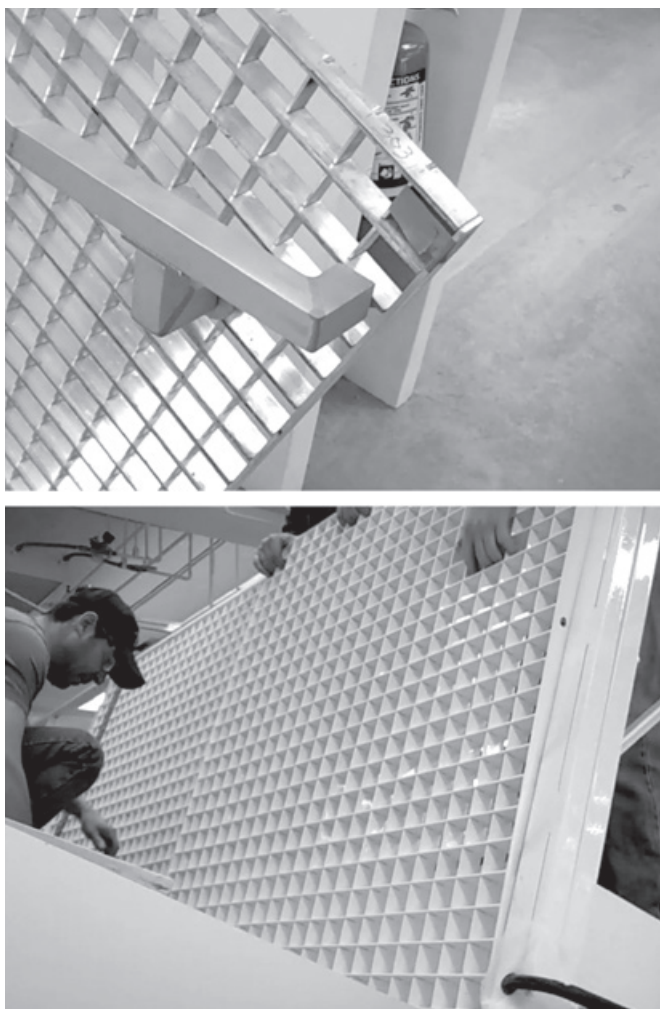
Figure 11.20. Milstein Hall's original aluminum guards were apparently too flexible (*top*) and were replaced with welded steel guards having a similar gridded design (*bottom*) just a few months after the building was occupied.

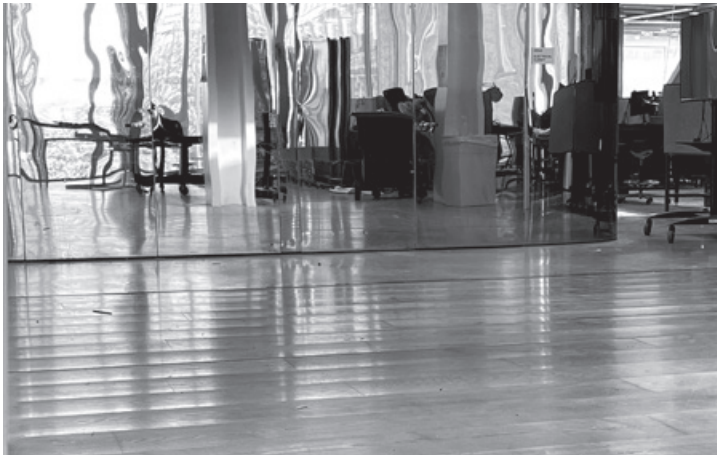
Figure 11.21. The wide ash planks in Milstein Hall’s wood floor have cupped, i.e., warped so that the center of each board is lower than its edges, due to differential moisture conditions above and below the wood surface. When light strikes the floor obliquely, the curved surface of the boards creates a repeating pattern of light and shadow. The stainless-steel-clad wall in the background is Milstein Hall’s second-floor electrical closet.

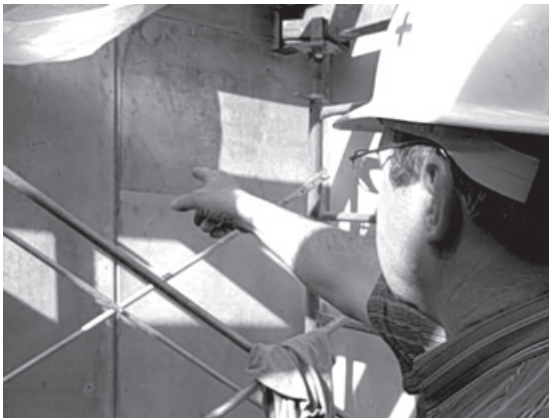
Figure 11.22. The contractor's field superintendent explains the mottling of concrete surfaces in Milstein Hall's Crit Room.

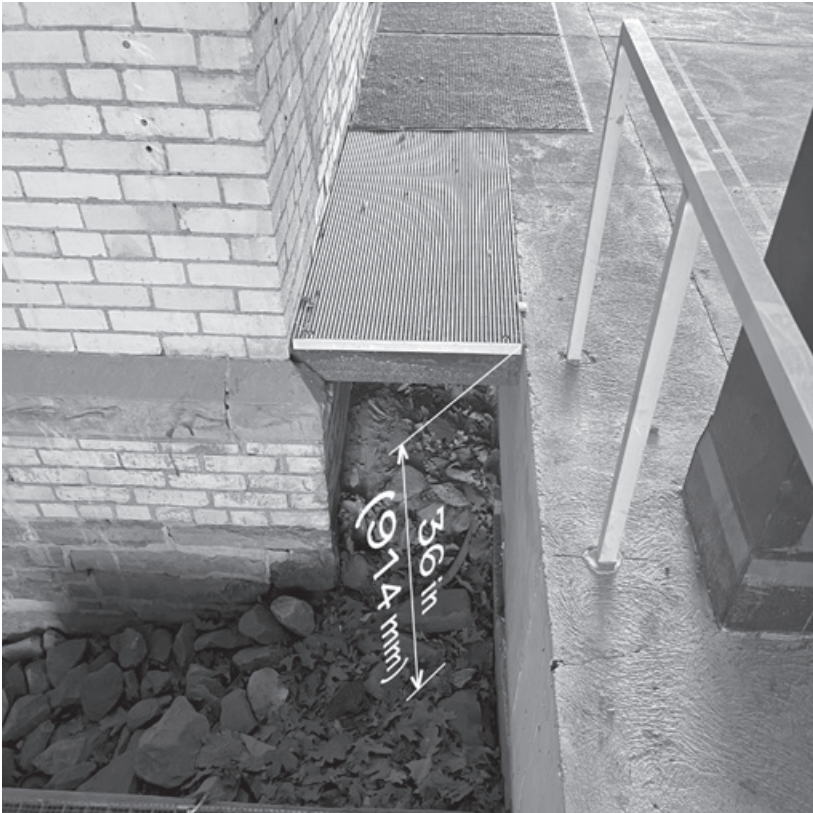
Figure 12.1. Guards are both missing and, where they appear, noncompliant at the grated bridge connecting Milstein Hall’s arcade to Sibley Hall.

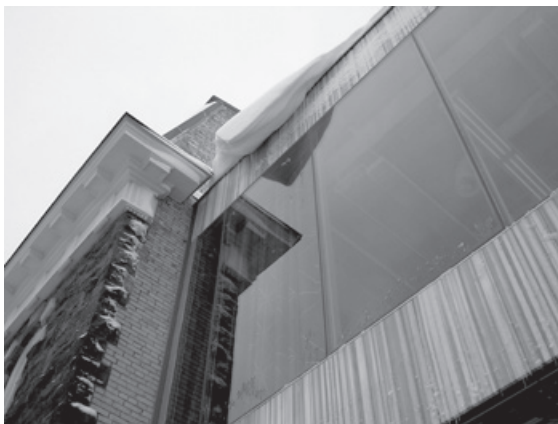
Figure 12.5. Hunks of snow often cantilever out over the roof edge of Milstein Hall, which has no protective parapet or railing.

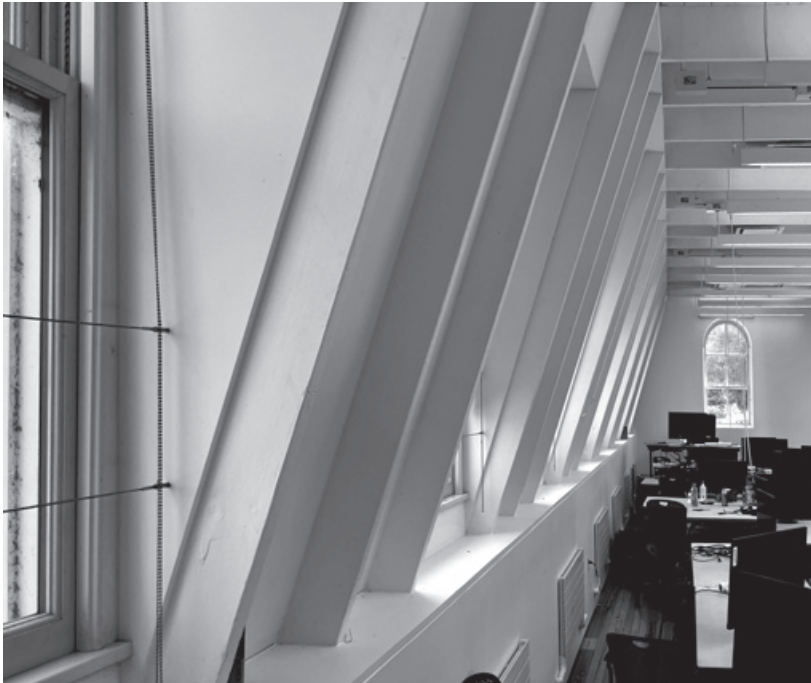
Figure 14.1. The inclined wooden structure of Sibley Hall’s Mansard roof downgrades its construction type from IIIB (fire-rated masonry exterior walls and wood-framed floors and roof) to VB (non-fireproofed wood frame).

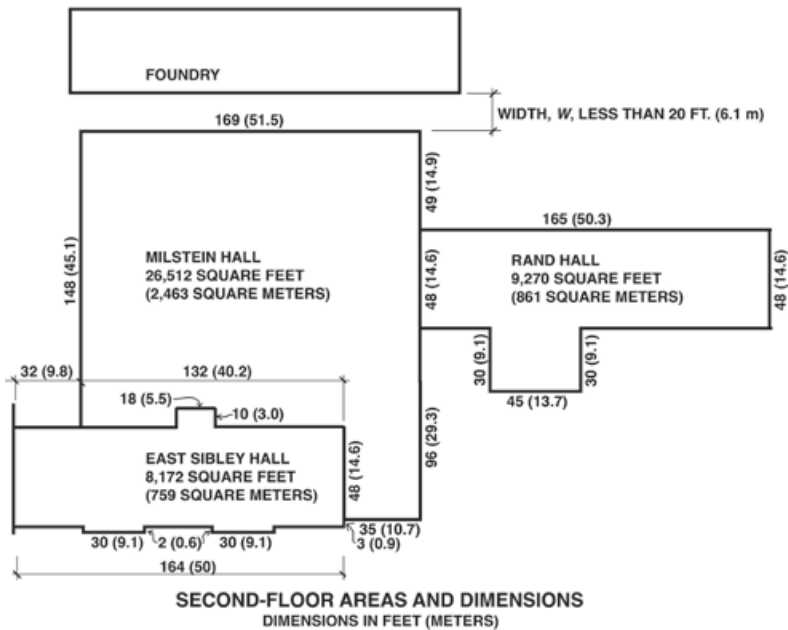
Figure 14.2. Schematic plan showing approximate dimensions and second-floor areas of Milstein, East Sibley, and Rand Halls.

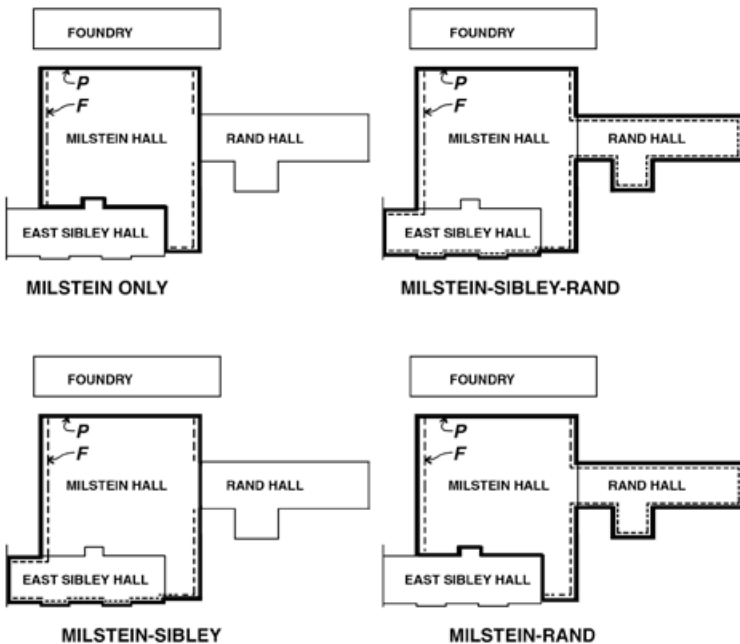
Figure 14.3. Milstein Hall’s perimeter (P) and partial perimeter (F)—taken alone or combined with adjacent buildings—are shown with a heavy solid line and a dotted line, respectively, for the four scenarios outlined in Table 1. Approximate dimensions for perimeter segments are shown in figure 14.2.
