OMA'S MILSTEIN HALL

A CASE STUDY OF ARCHITECTURAL FAILURE

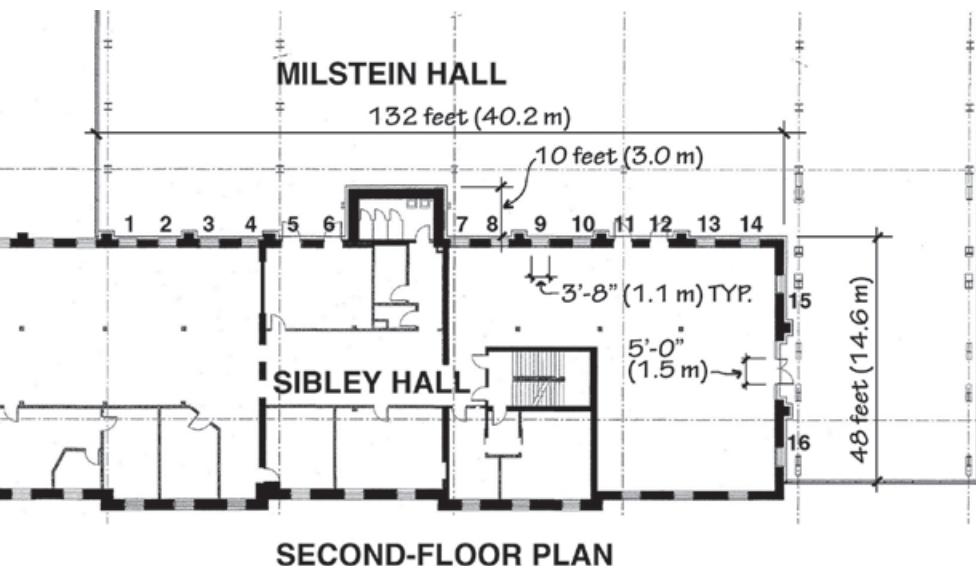
Figure 15.1. Fire barrier wall dimensions between Milstein and Sibley Hall are based on the dimensions shown in Figure 14.2. The aggregate opening width, consisting of 16 typical windows and doors, each 3'-8" (1.1 m) wide plus one special door 5'-0" (1.5 m) wide, exceeds 25% of the fire barrier width.

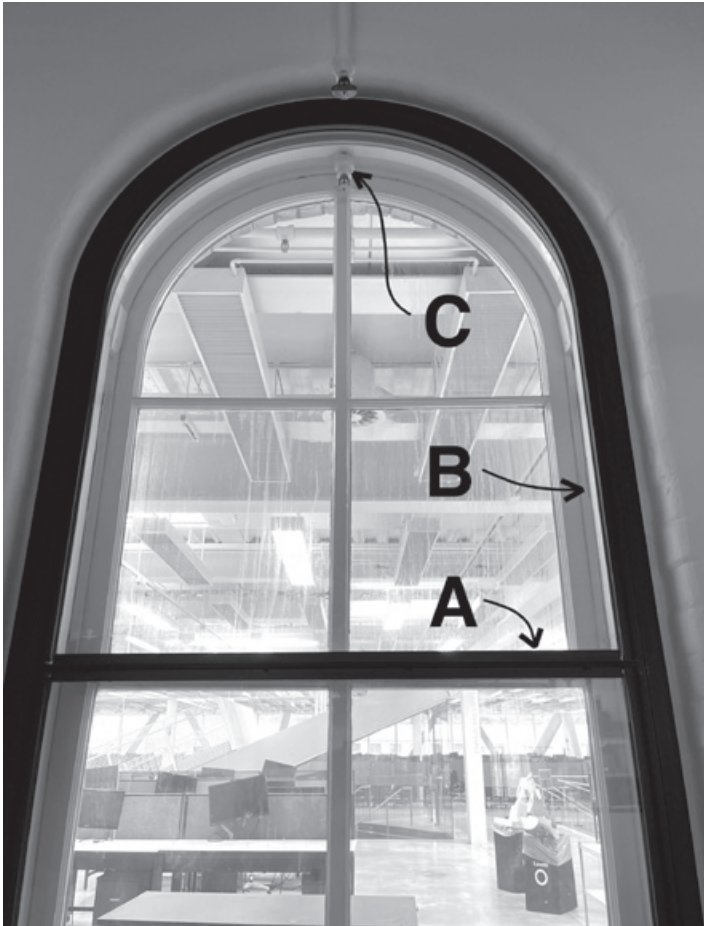
Figure 15.2. Installation of Tyco sprinklers violated the manufacturer's specifications in three ways: horizontal mullions are not permitted (A); combustible material is within 2 inches (51 mm) of fire-rated glazing (B); and sprinklers are sandwiched between fire-rated glazing and the existing window (C).

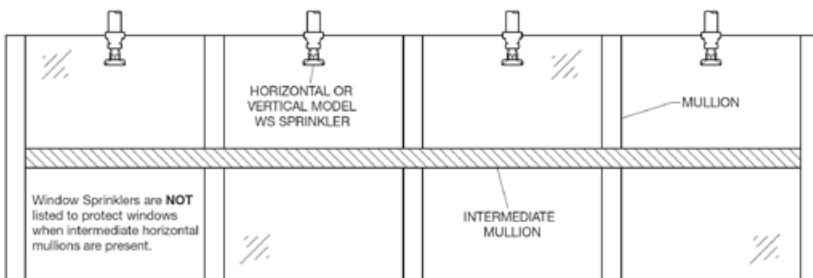
Figure 15.3. Reproduction of Tyco’s Figure 3B-3 prohibiting horizontal mullions (see notation in bottom left window pane).

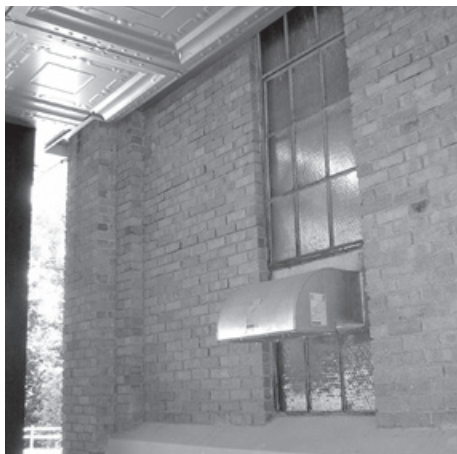
Figure 15.6. Openings in the fire barrier between Milstein and Rand Halls have neither opening protectives nor fire dampers.

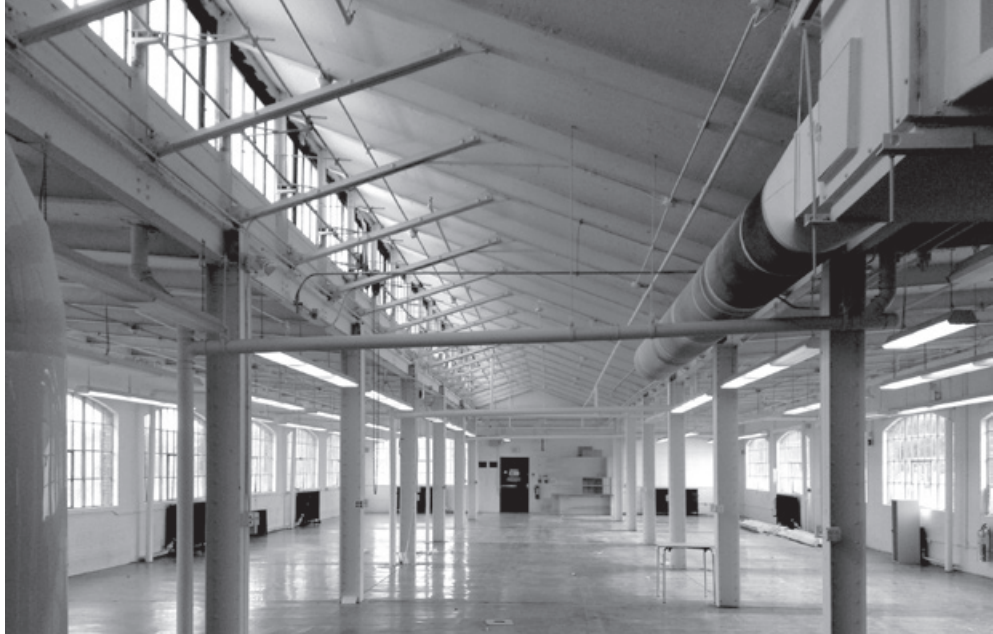
Figure 15.7. Rand Hall’s non-fireproofed steel frame in 2017, before it was converted into the Mui Ho Fine Arts Library.

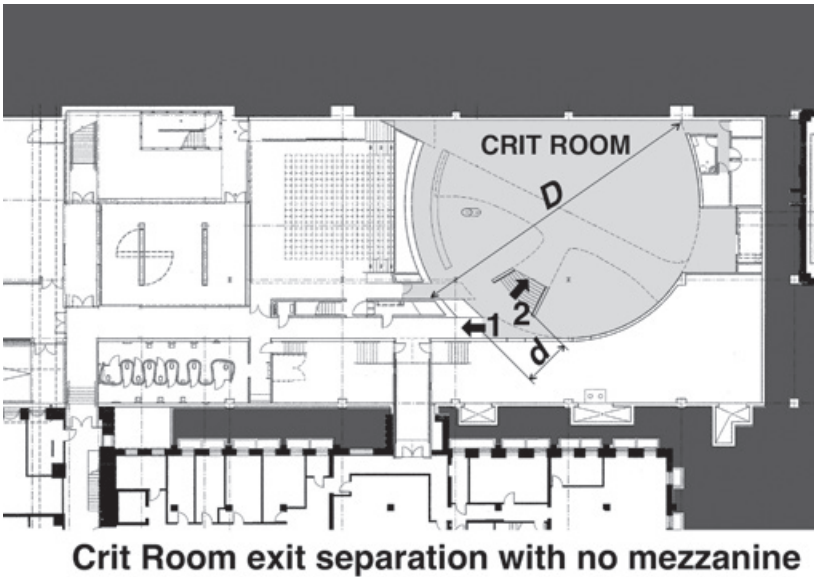
Figure 16.5. Without a mezzanine, the actual required separation between exits is found by taking the diagonal length of the room, $D = 90$ feet (27.4 m), and dividing it by three to find the minimum required separation distance of 30 feet (9.1 m). The actual separation distance between the two exits, $d = 15$ feet (4.6 m), is noncompliant because it is less than the required separation distance.

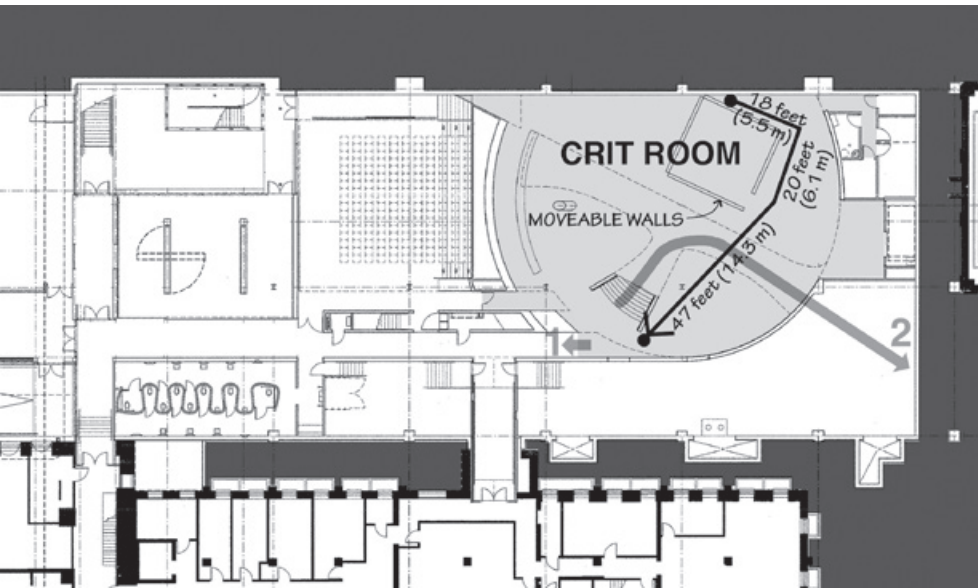
Figure 16.8. Milstein Hall’s Crit Room plan showing moveable walls and common path of egress travel, accounting for necessary movement around those partitions.

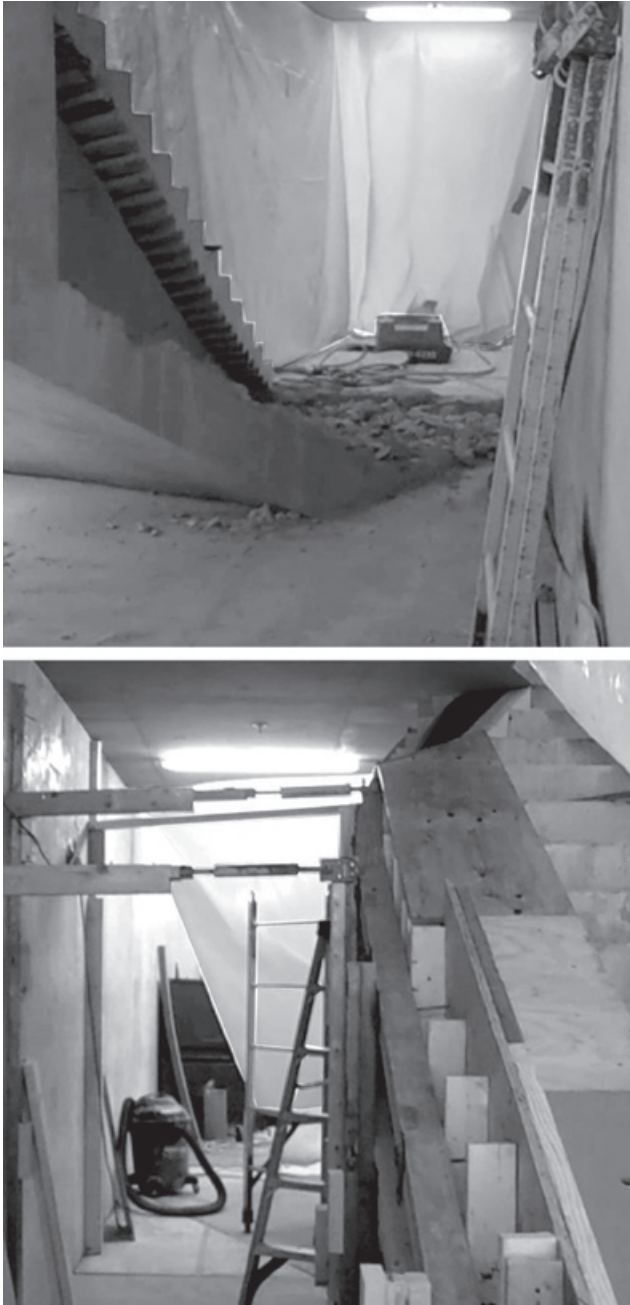
Figure 17.1. Extensive modifications were made to auditorium seating and to the wall separating the Crit Room from the auditorium in Milstein Hall in order to create a new exit from the Crit Room, through the auditorium.

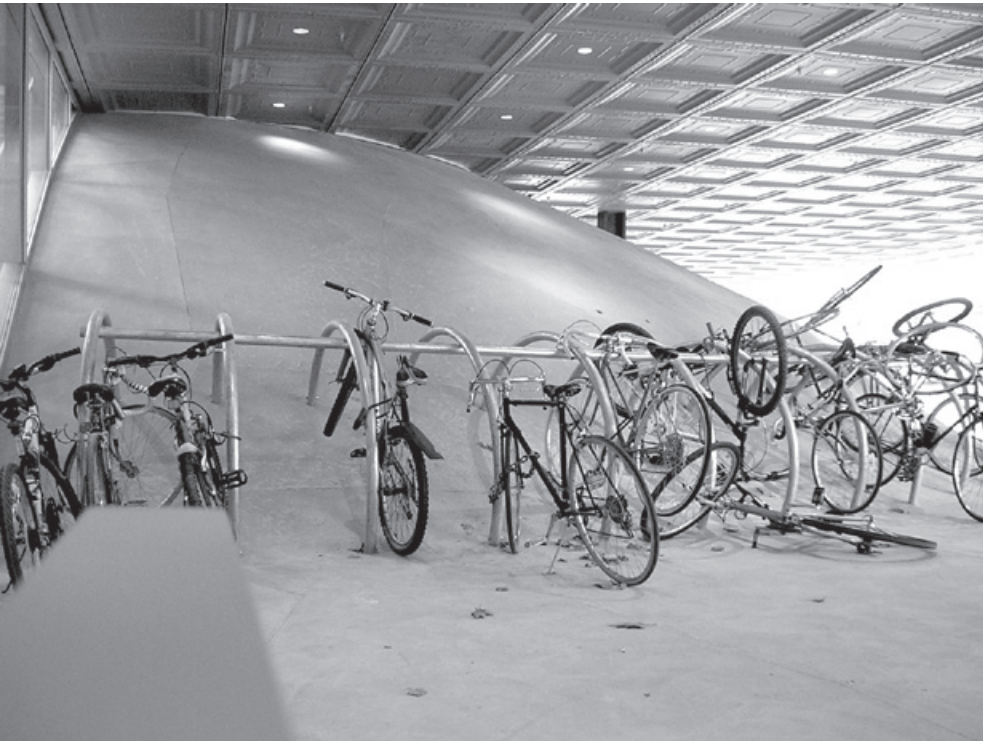
Figure 20.4. Milstein Hall bike racks contain 11 semi-circular supports, presumably to accommodate 22 bikes, less than the 26 bike storage spaces required for a LEED point.

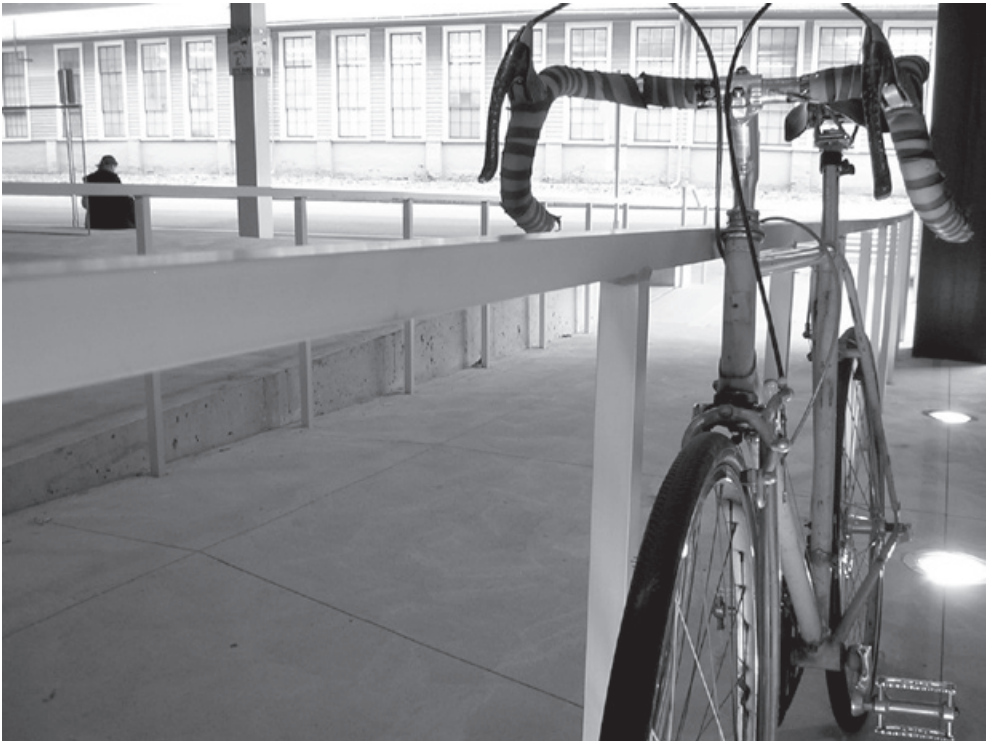
Figure 20.5. LEED-recommended storage for 26 bikes is clearly inadequate for 520 bike-friendly building users. Here, unsanctioned bike storage takes place along ADA-required handrails.

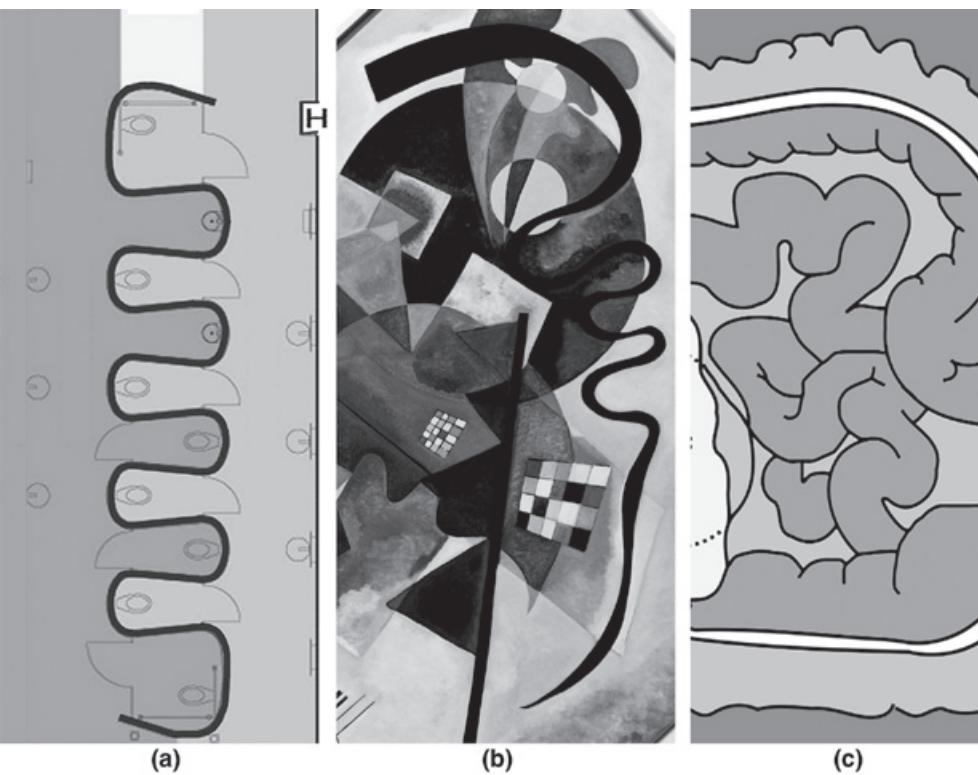
Figure 21.1. Toilets and urinals for Milstein Hall are defined by a curving stainless steel wall (a) reminiscent of the paintings of Wassily Kandinsky (b), or the interlocking geometry of the small intestine (c).

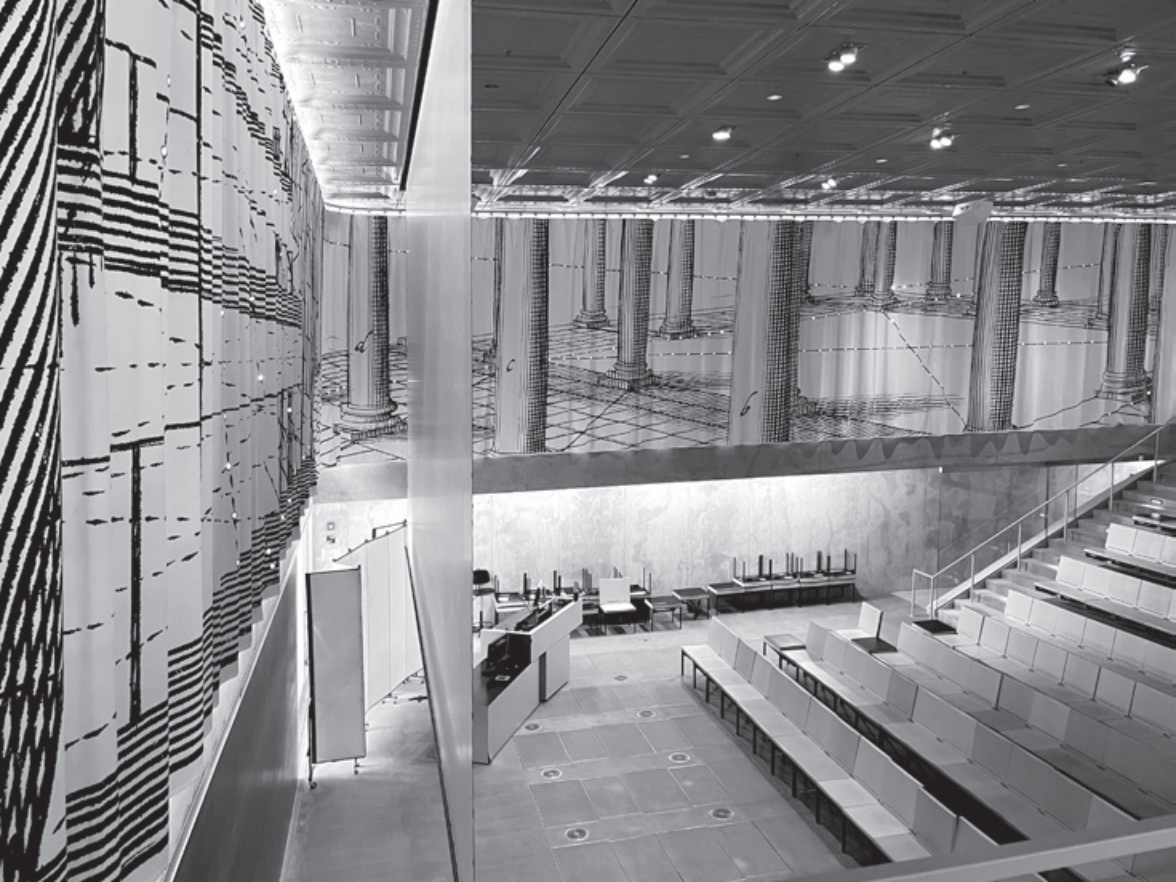
Figure 24.1. A small amount of “sustainable” carpet, used at the bottom level of the auditorium space, generates a LEED point.

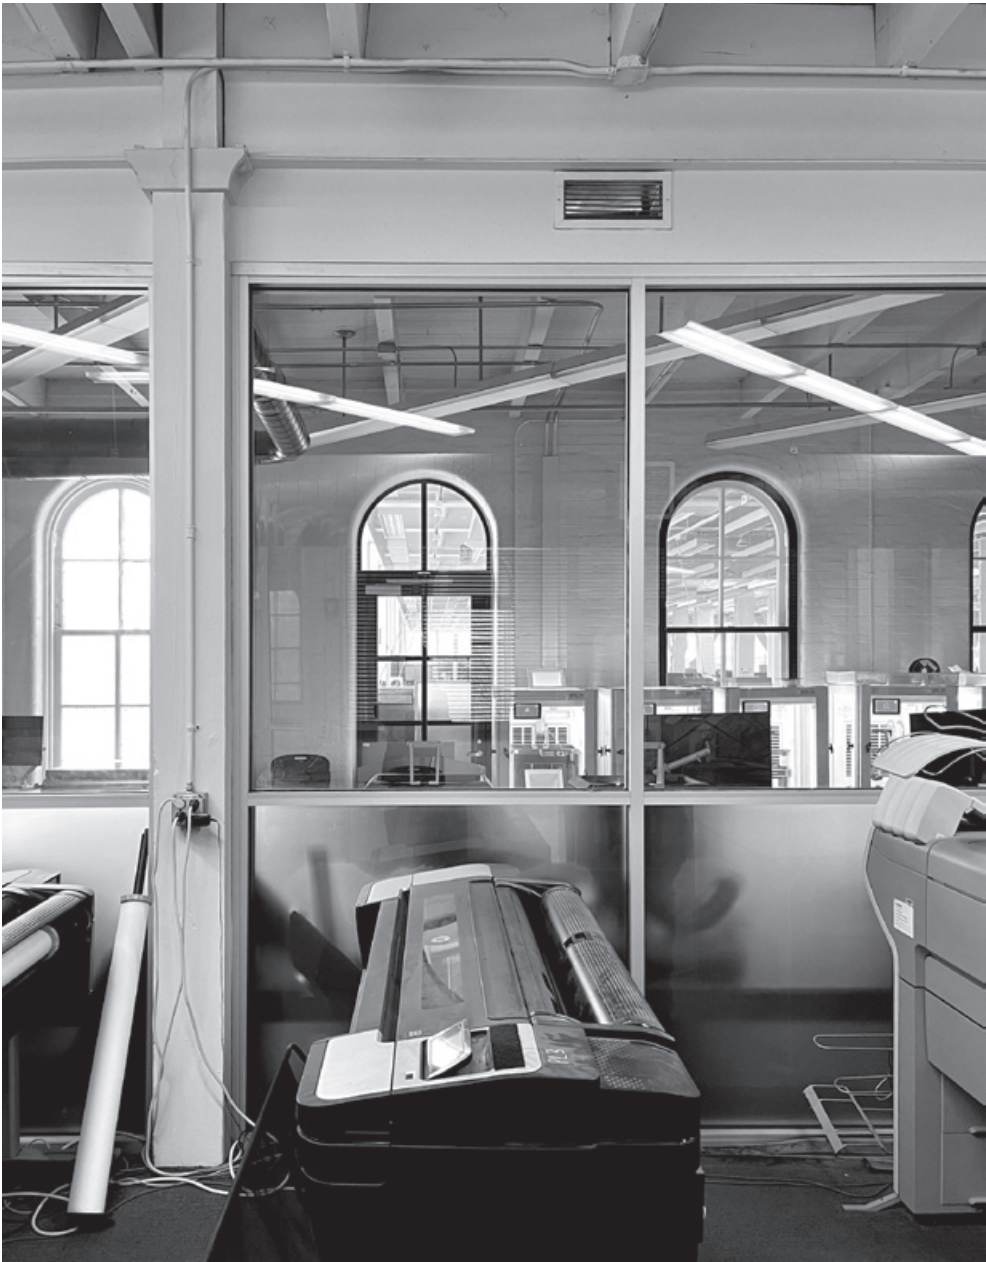
Figure 24.2. Sibley Hall's digital fabrication lab, immediately adjacent to Milstein Hall (visible through the fire barrier windows), has no fresh air supply—except for what gets in the room through transfer grilles visible above the glazed wall—in spite of containing 3-D printers, some of which use material that is both toxic and carcinogenic.
