Summary of false claims made by Cornell University in its variance request (No. 2016-0269) Prepared by Jonathan Ochshorn for the June 15, 2017 meeting of the New York State DCEA Syracuse Regional Board of Review.

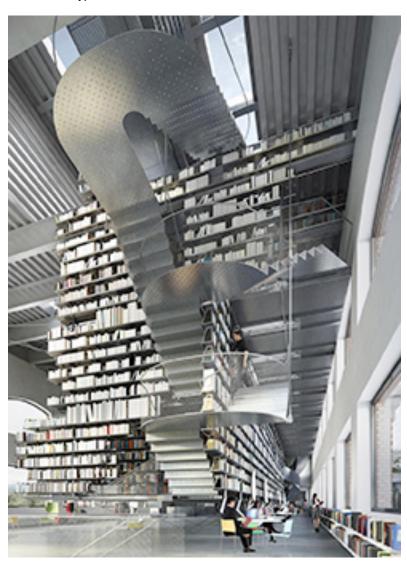
The entire floor construction for all the library stacks is made of, and supported by, non-fireproofed steel elements, including floor beams for the stacks, cables to suspend them, and transfer girders above them—none of which have any fire-resistive ratings. The proposal, if it were a separate building, is not even close to being Type IIA construction, and is correctly classified as Type IIB construction.

Figure 2. Architect's rendering of Rand Hall Fine Arts Library showing new construction and structure, none of which has any fireproofing (only the first floor columns on the level below and the 2nd-floor slab have any fireresistance rating).

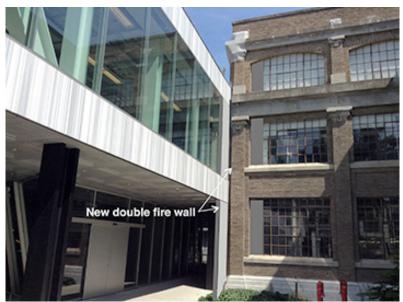
Figure 5. Schematic illustration of a double fire wall (by J. Ochshorn)

Cornell actually proposed building a bizarre and costly 2-hr fire wall in its schematic design submission. It was costly because it placed the proposed fire wall entirely within Rand Hall, thereby requiring extensive structural modifications to Rand Hall's steel frame. However, it would not have been disruptive, since the entire building would have been vacated in any case to build the library. Since Milstein and Rand are already structurally independent, it would be much easier, and far less costly, to build a **double-wall fire wall assembly, per NFPA 221**, with one part of the fire wall supported by Milstein Hall. Most of the other part of such a double fire wall already exists as the masonry exterior wall of Rand Hall. Furthermore, *only a 2-hr rating is needed* in each half of the double fire wall to satisfy the requirements for a 3-hr fire wall. Such a wall is easy to construct (Figure 3), entirely feasible, and would allow Rand Hall to be considered as a separate building with Type IIB construction.

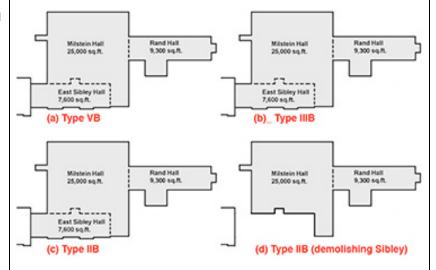
Figure 7. Four "upgrade" scenarios for the construction of Sibley Hall:

Scenario (a): No change to Sibley Hall's construction type.

NONCOMPLIANT

- 1. Actual floor area exceeds allowable floor area
- 2. A-3 occupancy (library) cannot be placed above 2nd story

Scenario (b): Sibley Hall's 3rd-floor exterior wooden walls replaced with noncombustible material.

1. Actual floor area exceeds allowable floor area

Scenario (c): Sibley Hall's entire structure replaced with noncombustible material.

Scenario (d): Sibley Hall demolished, leaving only Rand and Milstein Halls.
