Draft Environmental Impact Statement

Paul Milstein Hall and Central Avenue Parking Garage Projects

Cornell University

City of Ithaca
Ithaca, New York

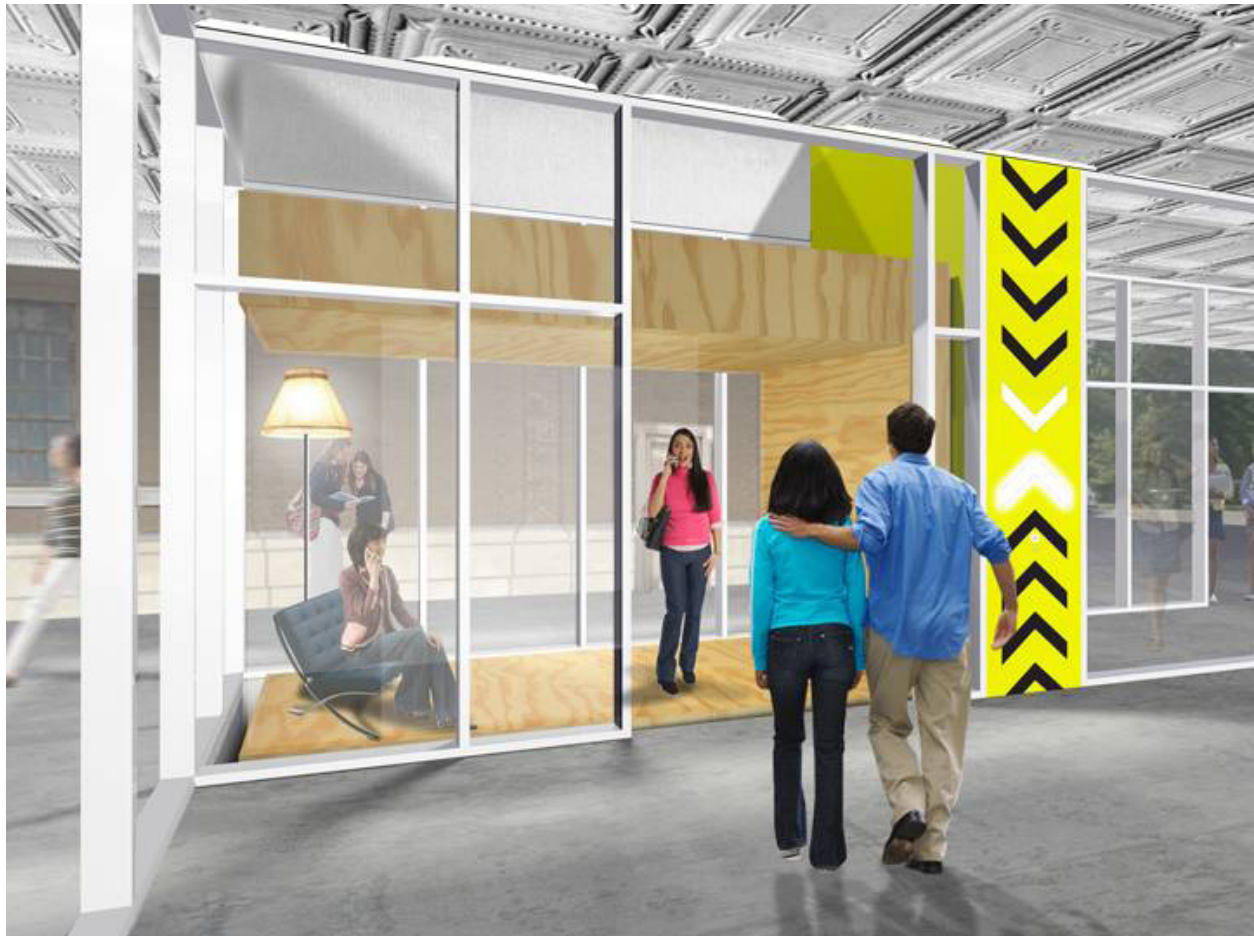
An elevator is typically an enclosed, functional box that becomes an invisible element within a building. The Milstein Hall elevator is a three-sided glass room within a glass-enclosed shaft. It will be visible and dynamic. The six foot by 12 foot cab is fitted with a chair and lamp to create a room-like condition, yet it is big enough to transport large models, drawings and equipment between the studios and the lower level dome and exhibition space.

Figure 1.4.18: View of the elevator.

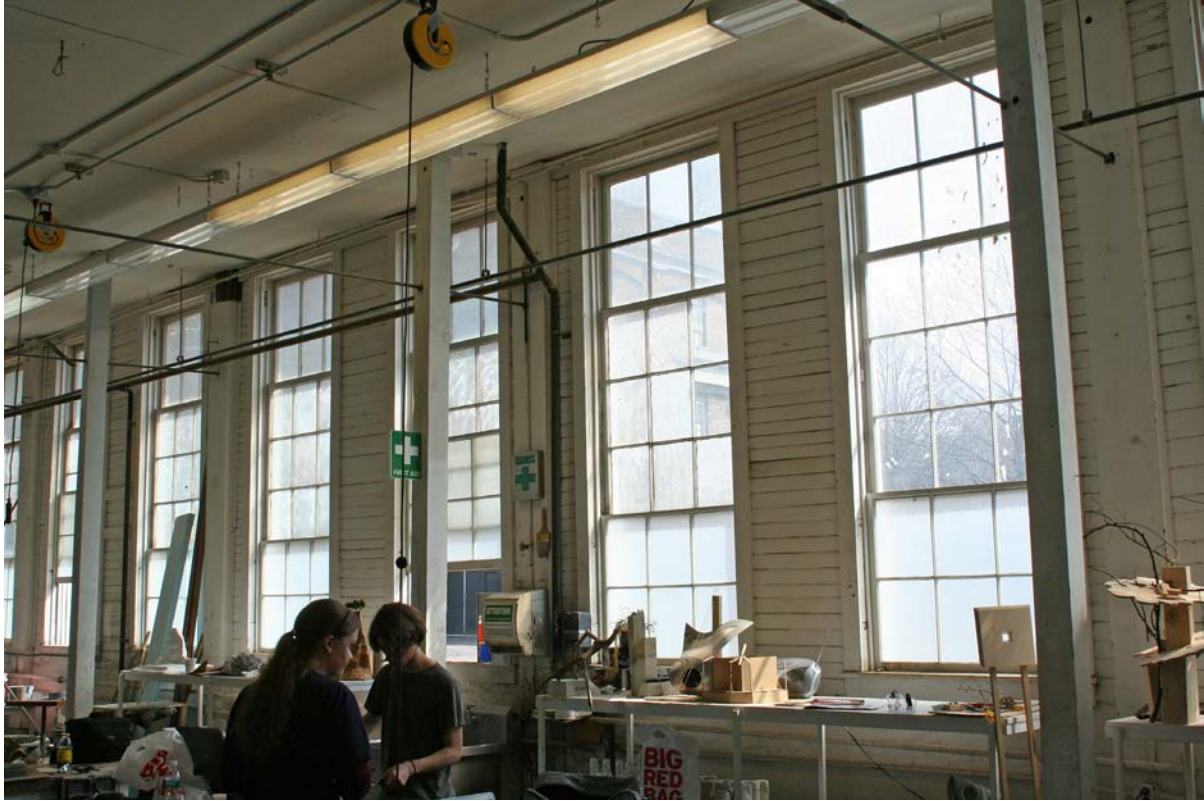
Figure 2.5.28: Existing view from inside the Foundry looking south.

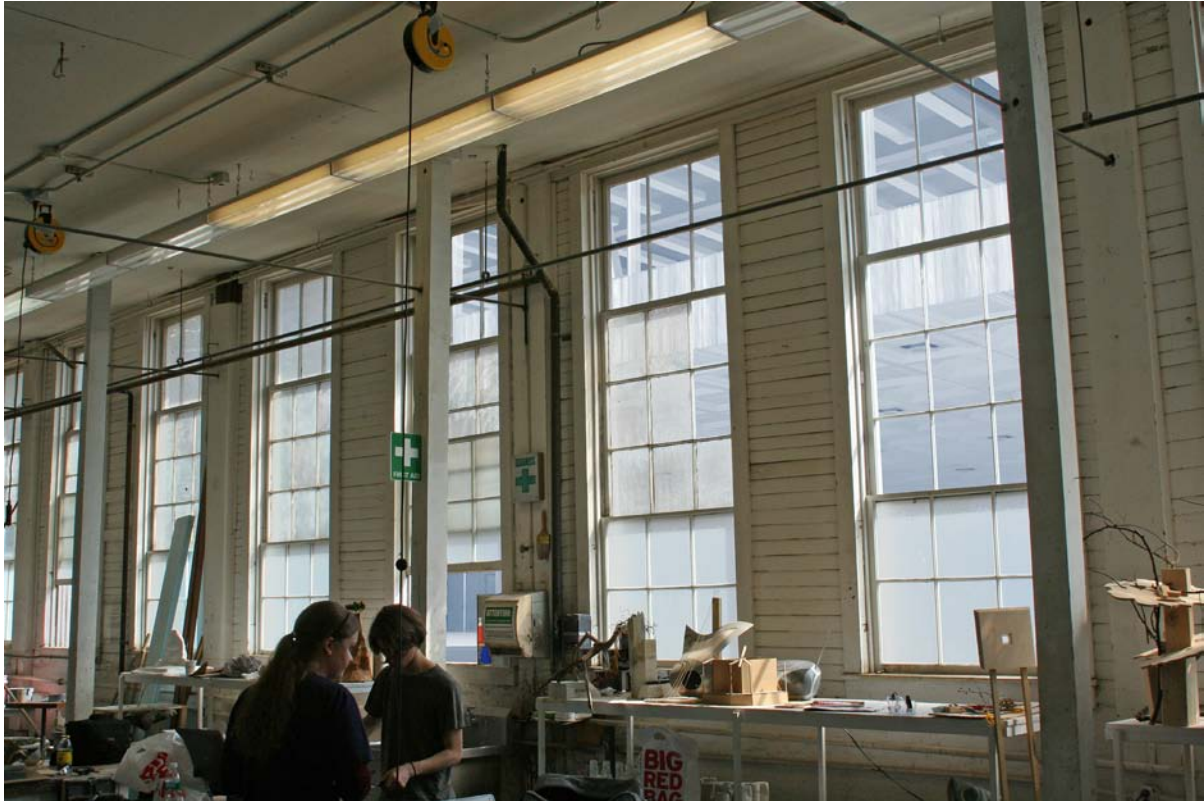
Views from this location will be altered as shown.

Figure 2.5.29: Proposed view from inside the Foundry looking south.

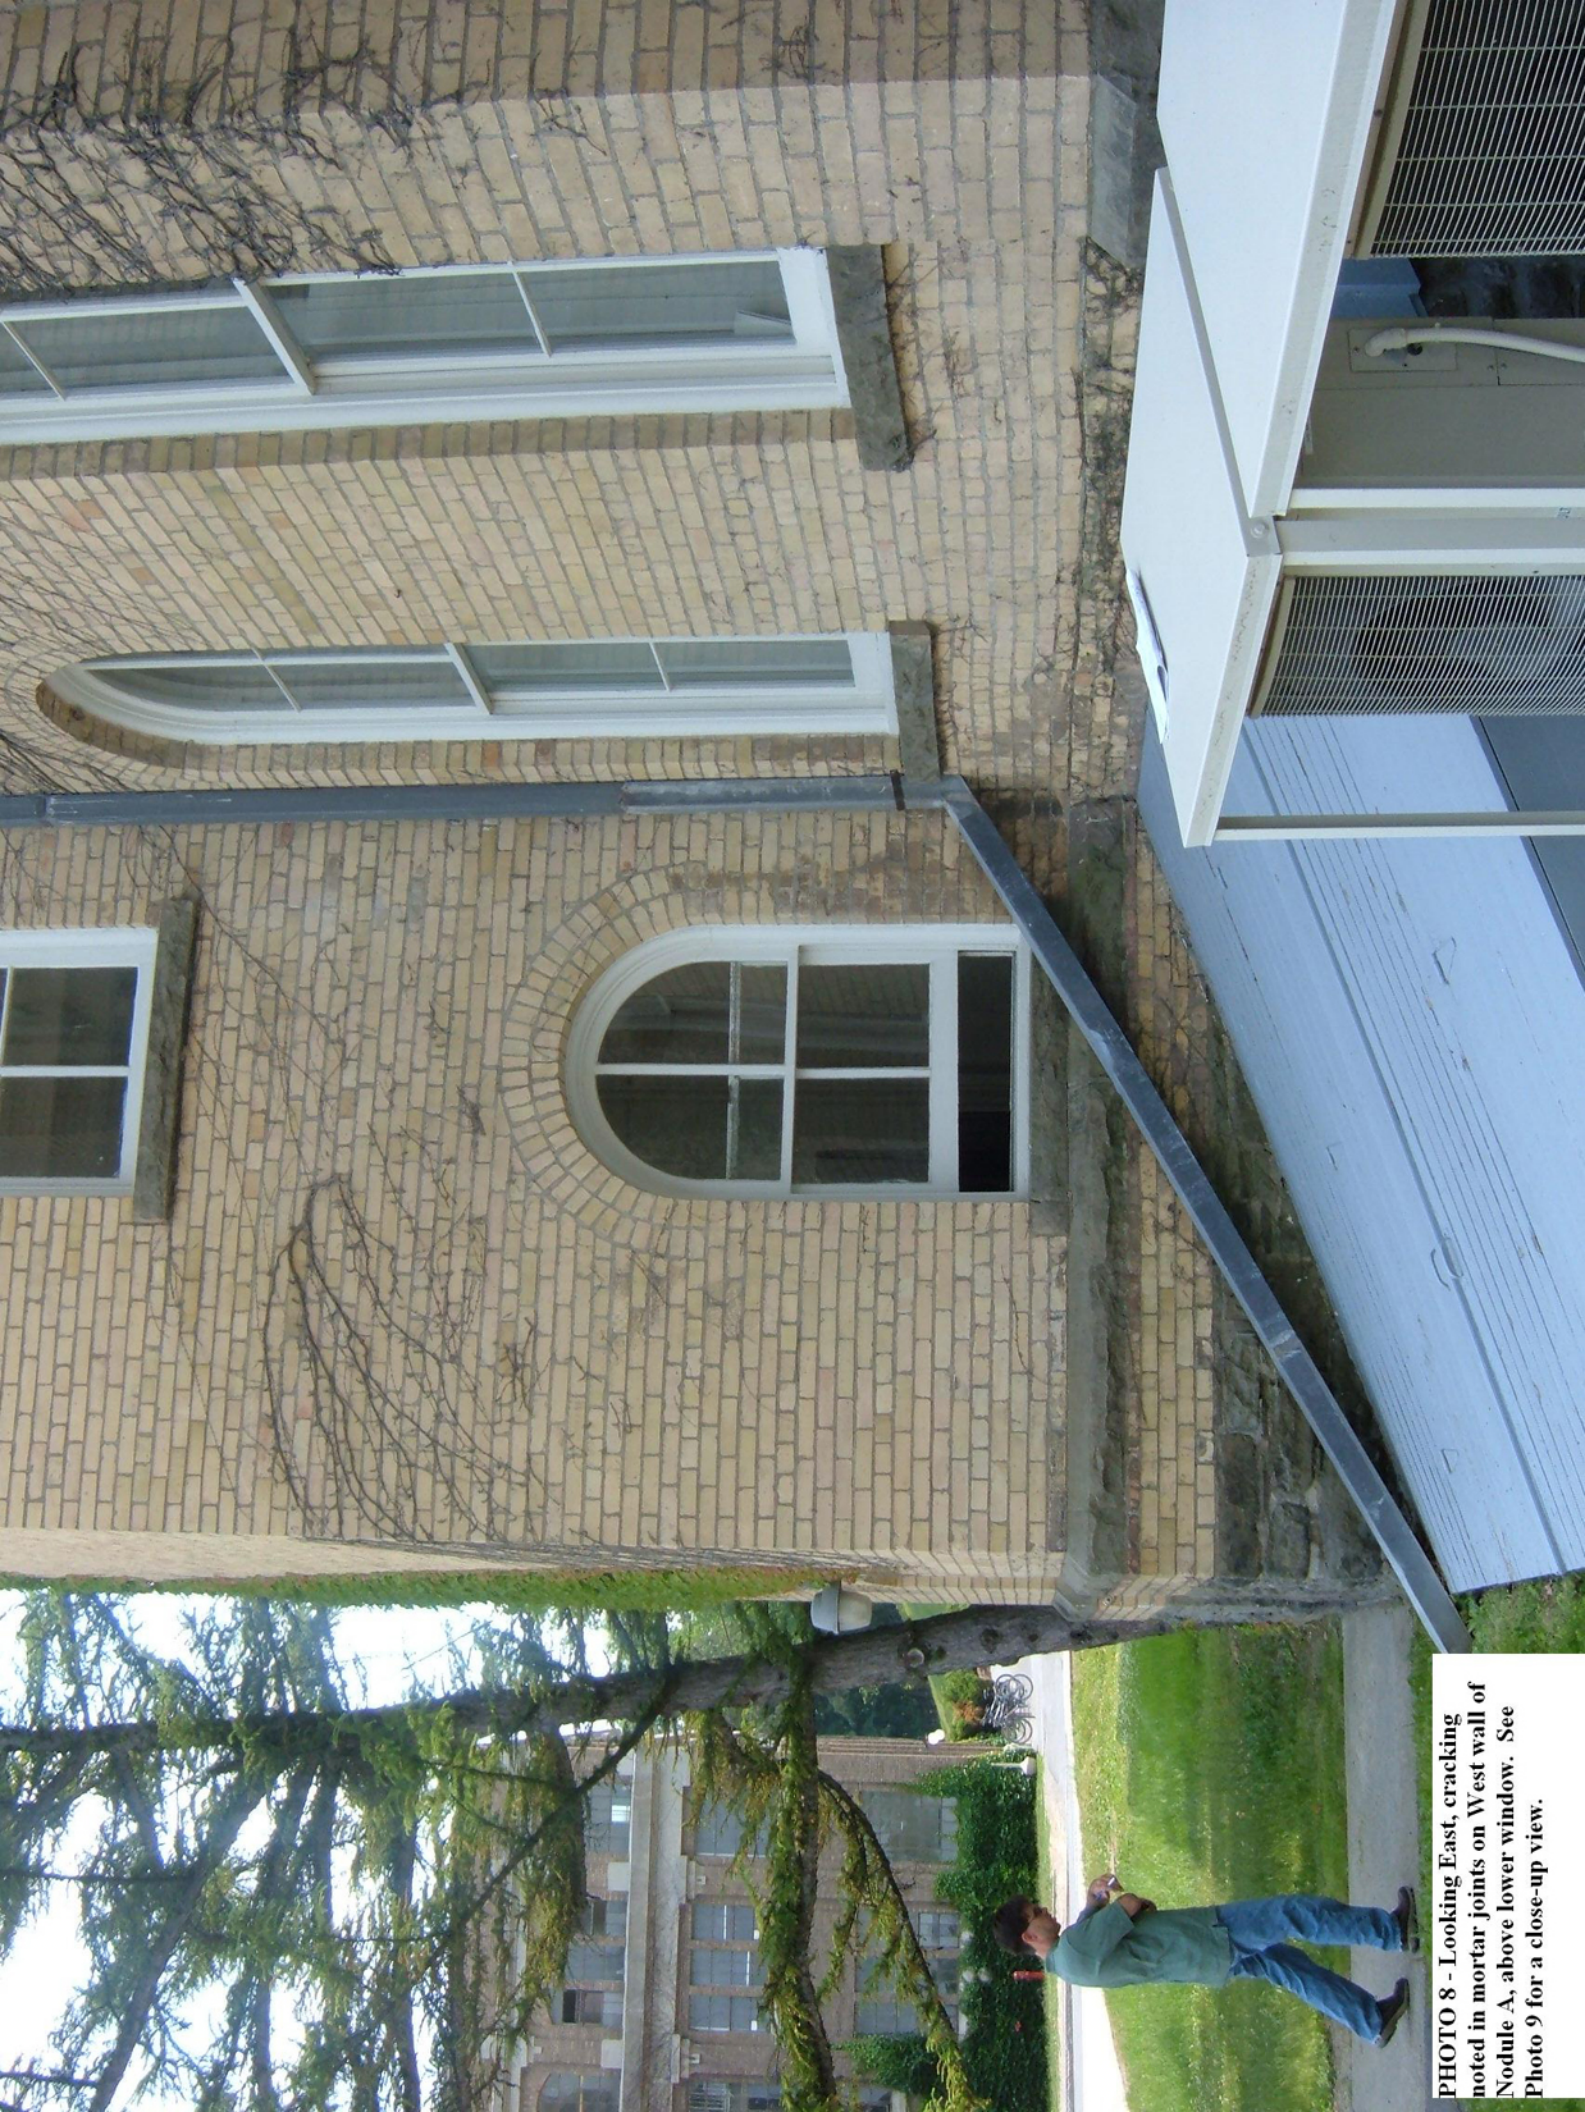
PHOTO 8 - Looking East, cracking noted in mortar joints on West wall of Nodule A, above lower window. See Photo 9 for a close-up view.

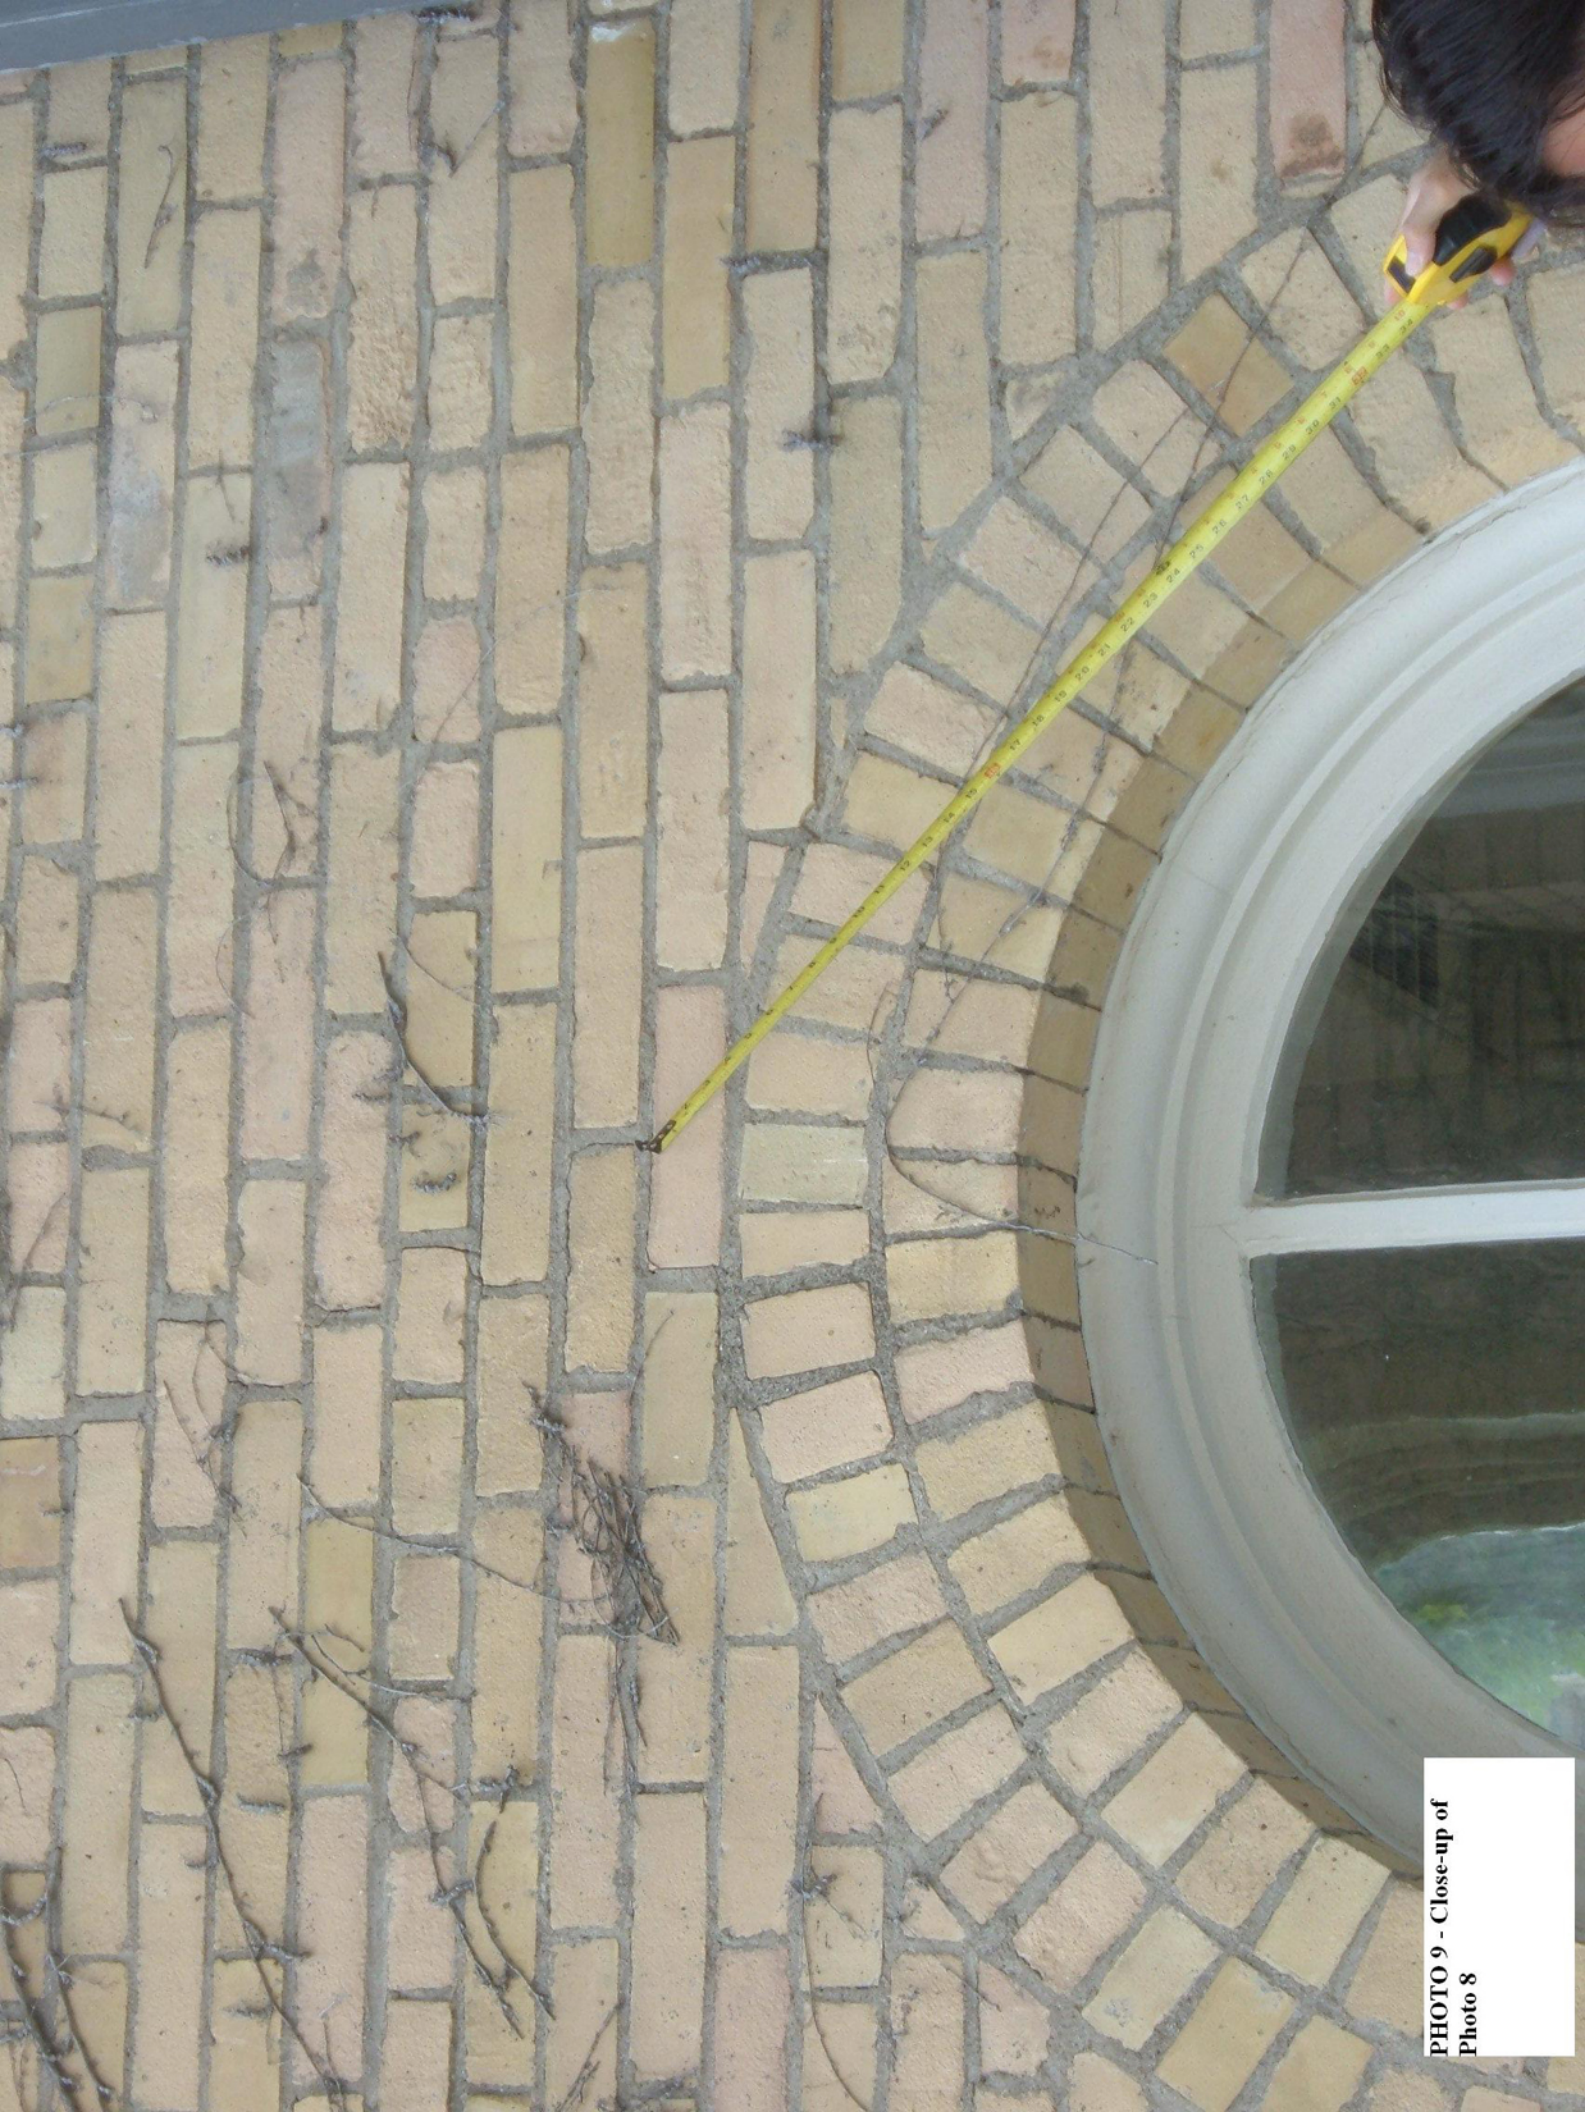
PHOTO 9 - Close-up of
Photo 8

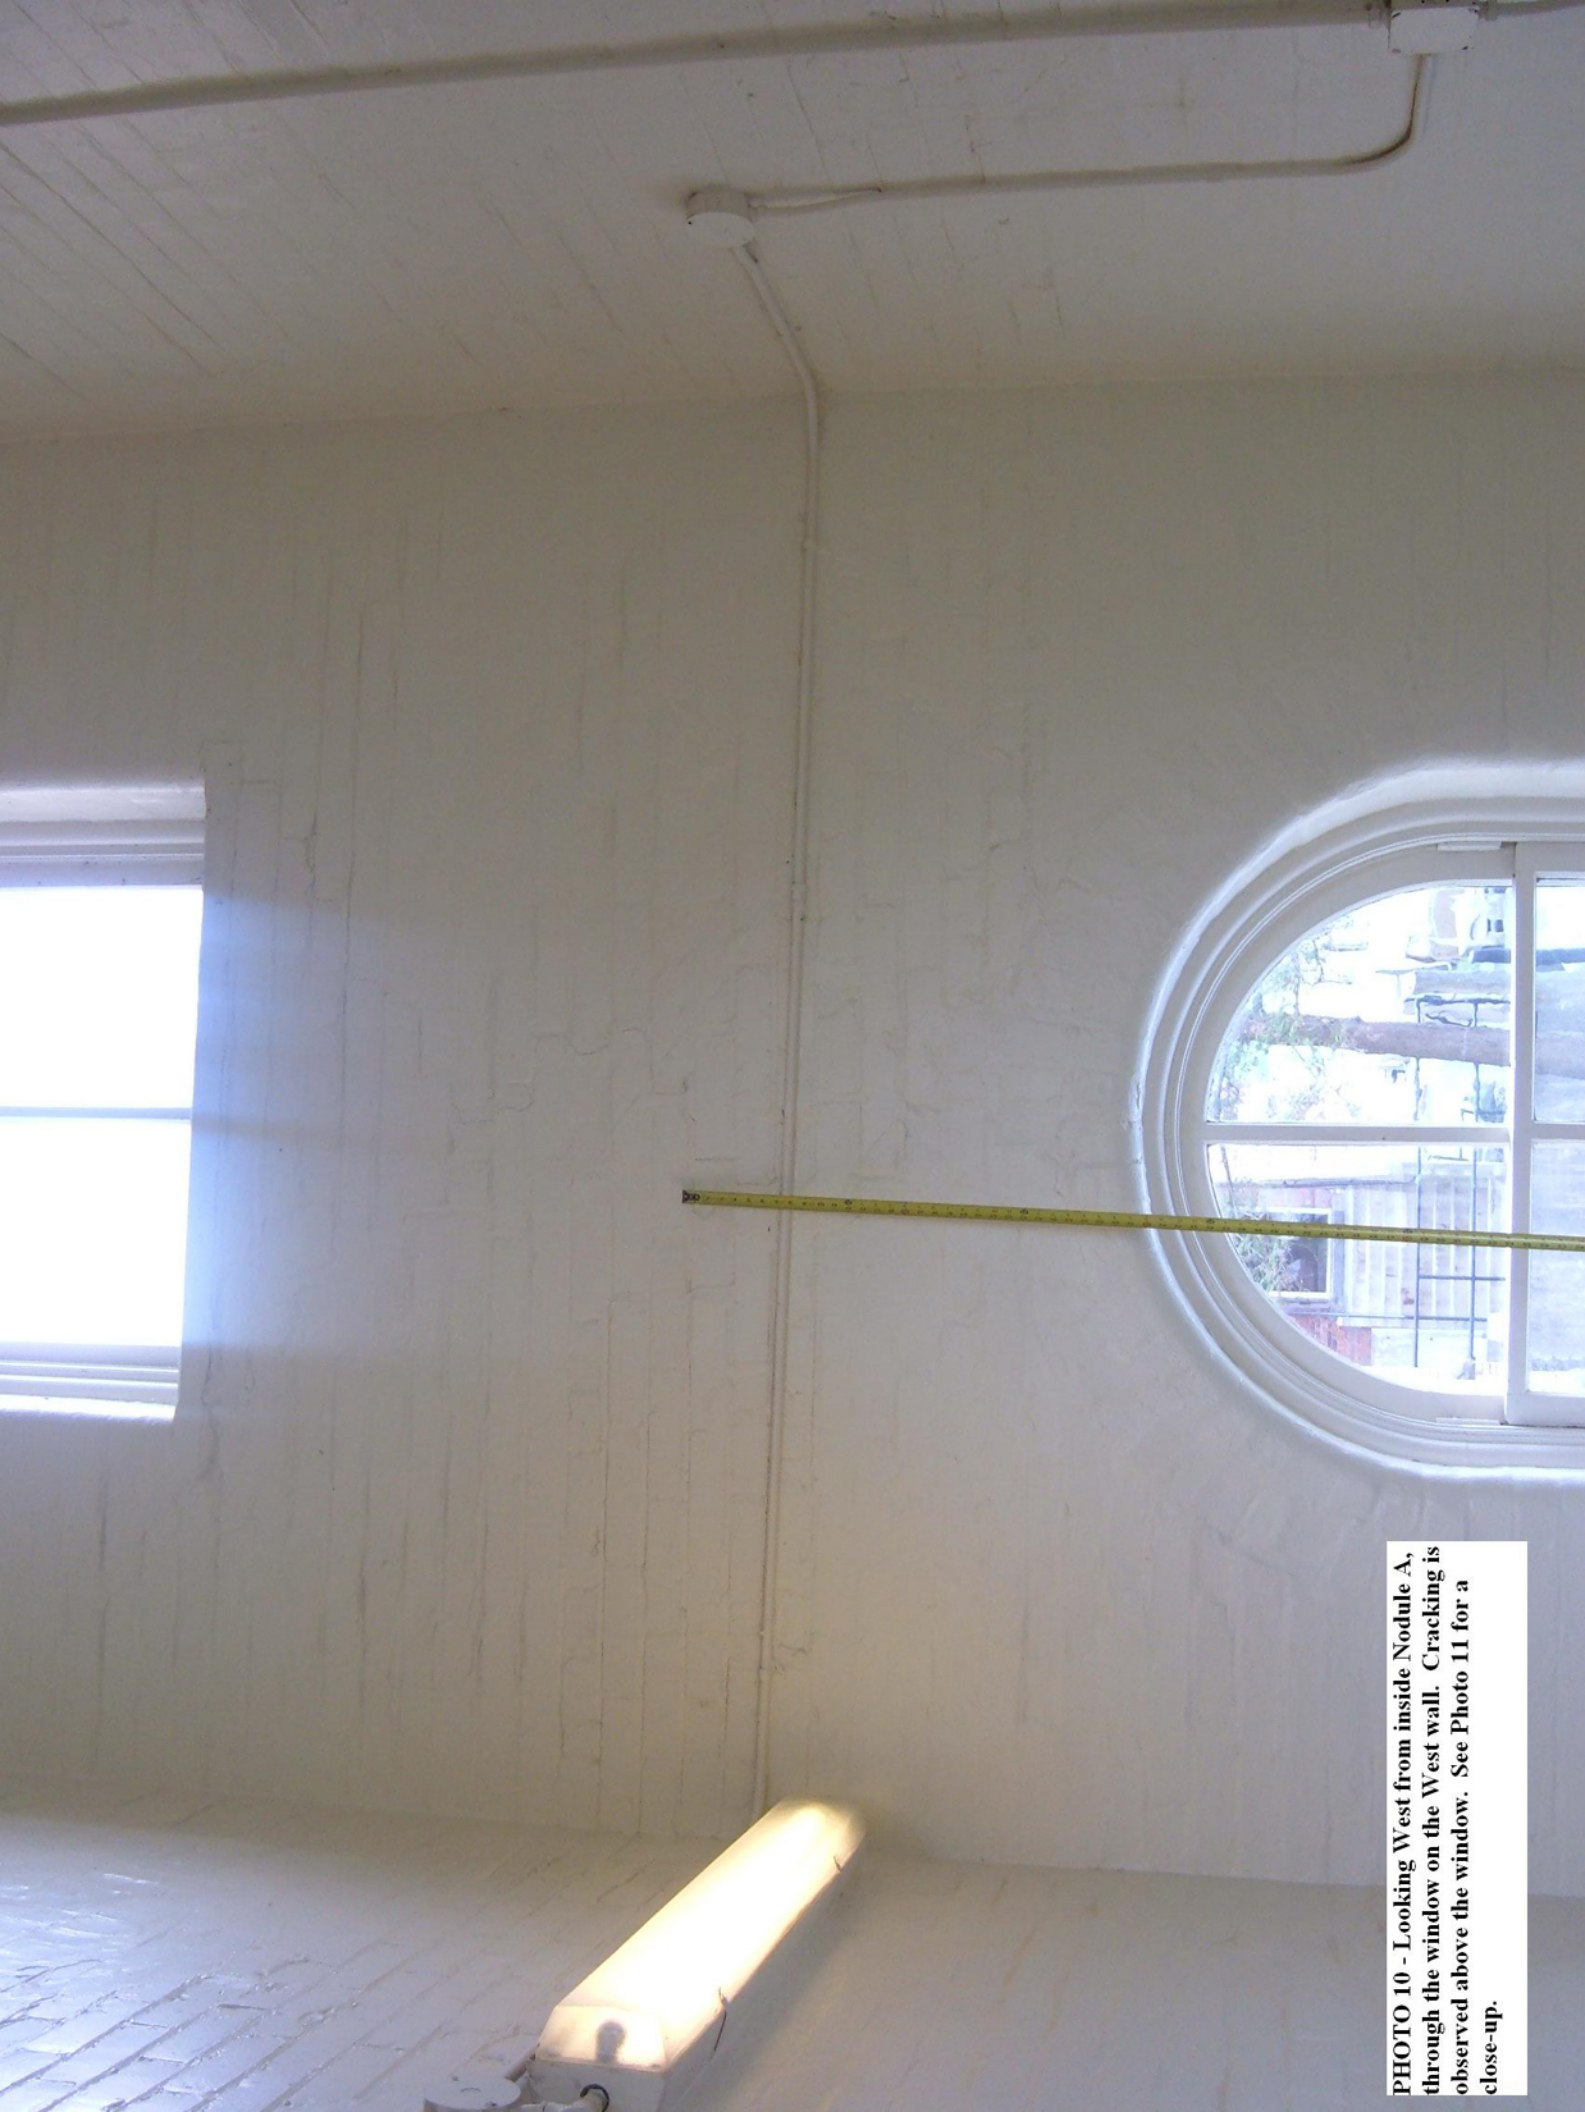
PHOTO 10 - Looking West from inside Nodule A, through the window on the West wall. Cracking is observed above the window. See Photo 11 for a close-up.

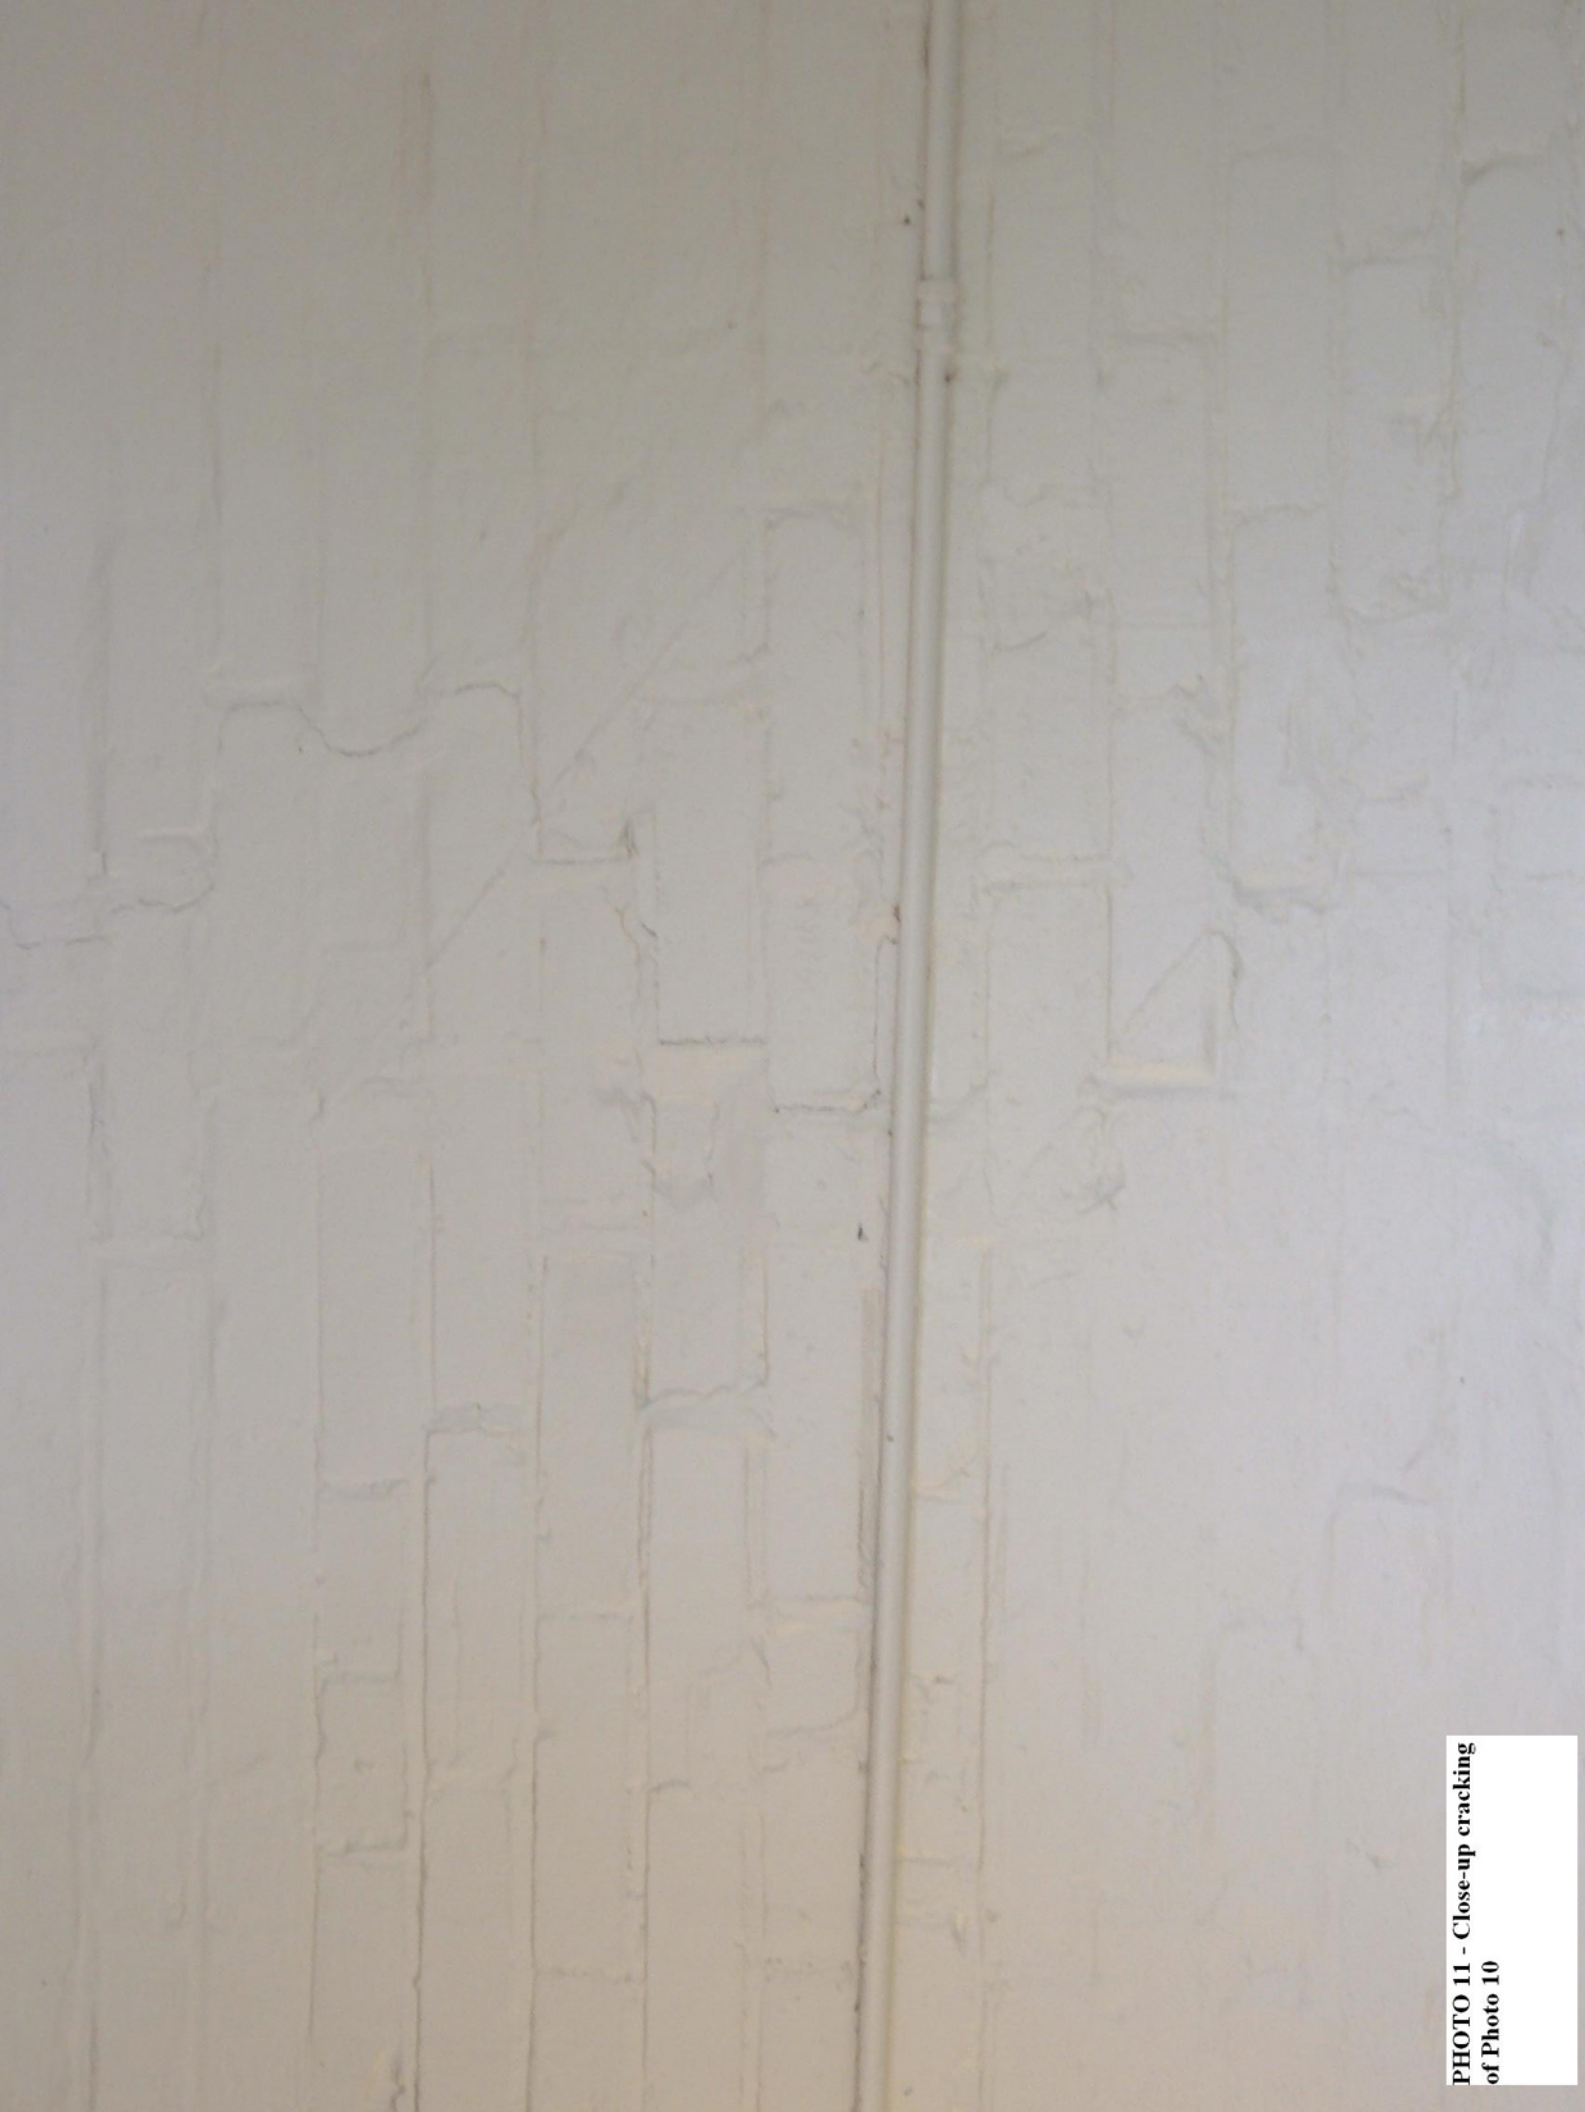
PHOTO 11 - Close-up cracking
of Photo 10
