Appendix 2

Egress diagram for the Mui Ho Fine Arts Library in Rand Hall

Prepared by Jonathan Ochshorn Nov. 25, 2020

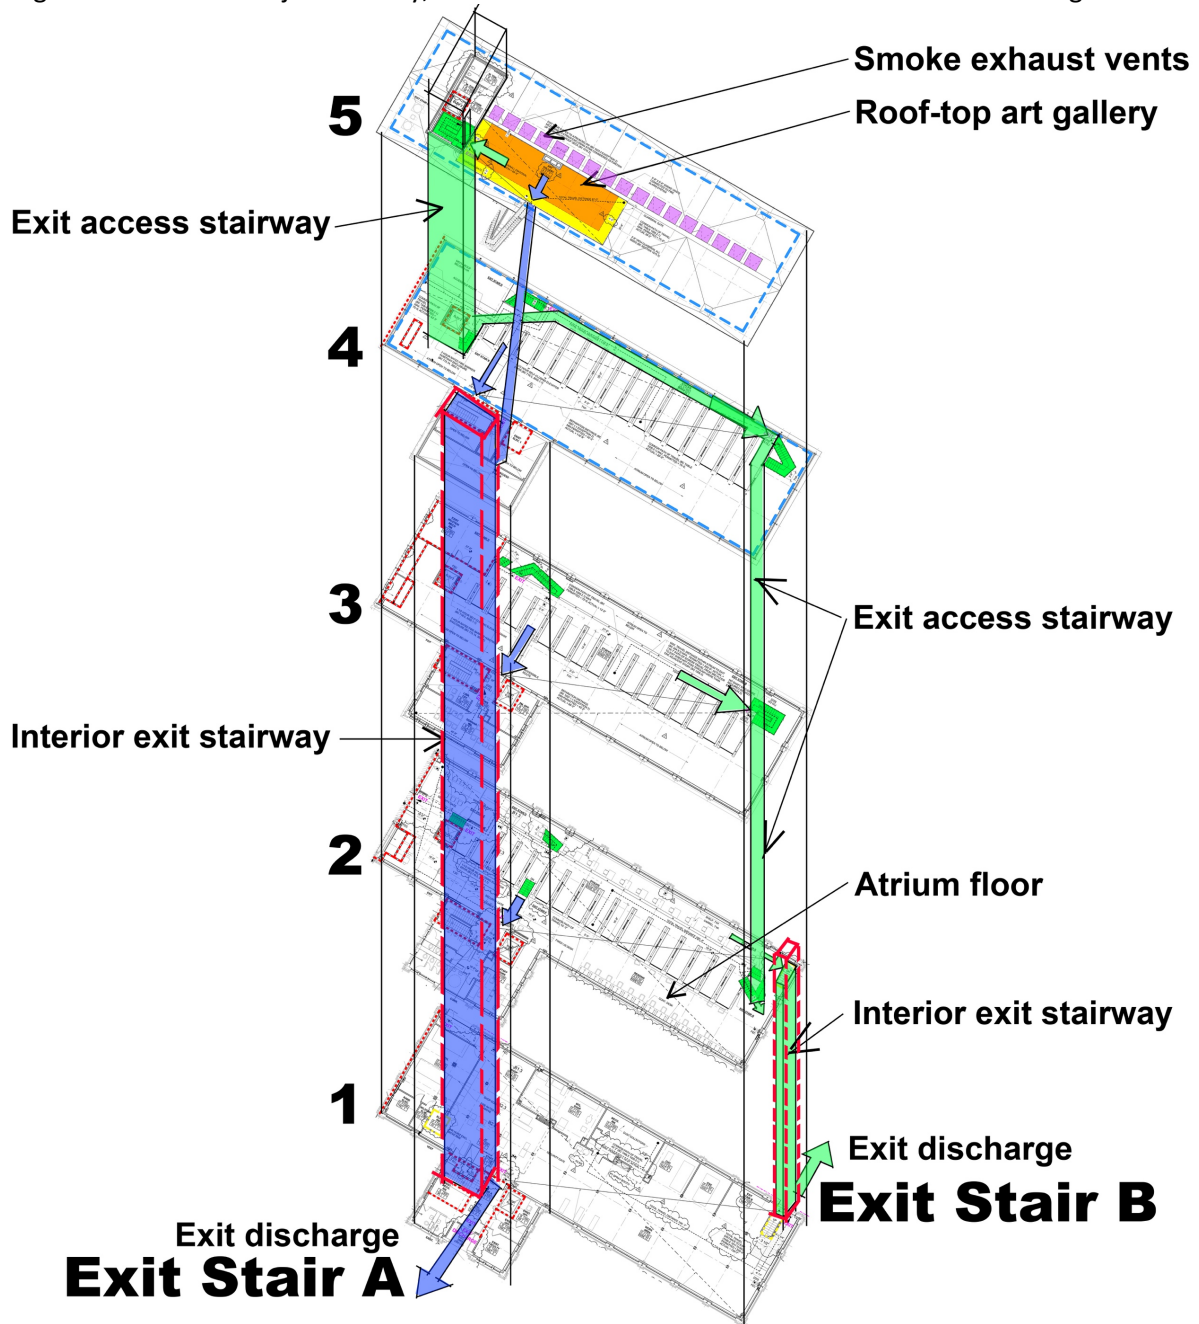
Egress diagram: Mui Ho Fine Arts Library

Both means of egress systems in the Mui Ho Fine Arts Library contain exit access stairways and interior exit stairways. The means of egress containing *Exit Stair A* (shown in blue) is compliant. The means of egress containing *Exit Stair B* (shown in green) is noncompliant because its path of egress travel passes through more than one adjacent story, in violation of Section 1006.3 of the 2015 NYS Building Code.

Appendix Figure 2.1 Schematic diagram showing means of egress systems in the Mui Ho Fine Arts Library in Rand Hall, Cornell University. Drawing by Jonathan Ochshorn based on life safety plans submitted by STV Architects.
